CAMADS Eskdale Mill Visit 27/09/2018

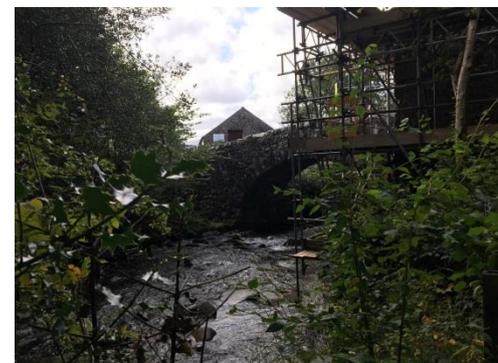
Whillan Beck flows below the mill and powers the Mill through the use of water wheels. The Beck is not to be disturbed as part of the conservation building work. Certain methods have been proposed by the companies involved. One of these involved the scaffolding on the barn, which directly interferes with the beck. To stop this, a ballasted scaffold system is in use. This system means that the scaffolding never touches the beck and cannot disturb it. It works through a counterweight system to oppose the scaffold weight over the beck, keeping it from toppling over. Another environmental issue is the use of lime pointing, as lime can affect the beck's PH and interfere with the wildlife there. There are adequate protections in place to prevent this from happening however, as scaffolding boards prevent the lime mortar falling into the beck and is monitored during **the curing period** in case the top layer becomes loose and liable to fall.

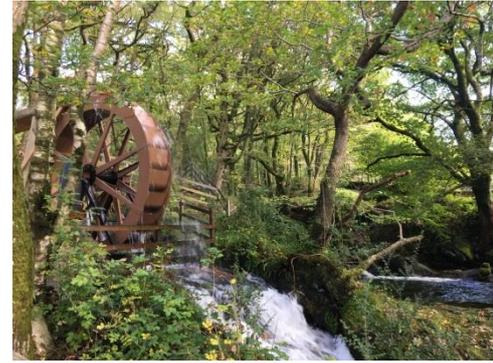
The Mill has 2 historical water wheels; they require additional conservation work alongside the building itself. The wheels themselves are metal cast with wooden paddles across them. Both wheels require work done to return them to working order. The metal has fractured in a couple of locations on both wheels and is to be traditionally re-cast. To help this, the paddles have been removed. This also helps so access can be gained to re-point the wall behind the wheels using different strength lime mortar. Some of these paddles have rotted and, for safety, the decision was made to replace all of them. A third water wheel was erected in 2017 to generate electricity for the mill and to show future visitors how water can still be harnessed to create power. An issue arose with this wheel in the form of noise pollution and was disturbing local residents. The issue was resolved by changing the angle at which the gears operated and **enclosing the generator**, this quietened the wheel, and allowed it to continue to operate.
