## Eskdale Mill Works Conservation Building Contract

### *Progress report following valuation meeting on 13<sup>th</sup> December 2018*

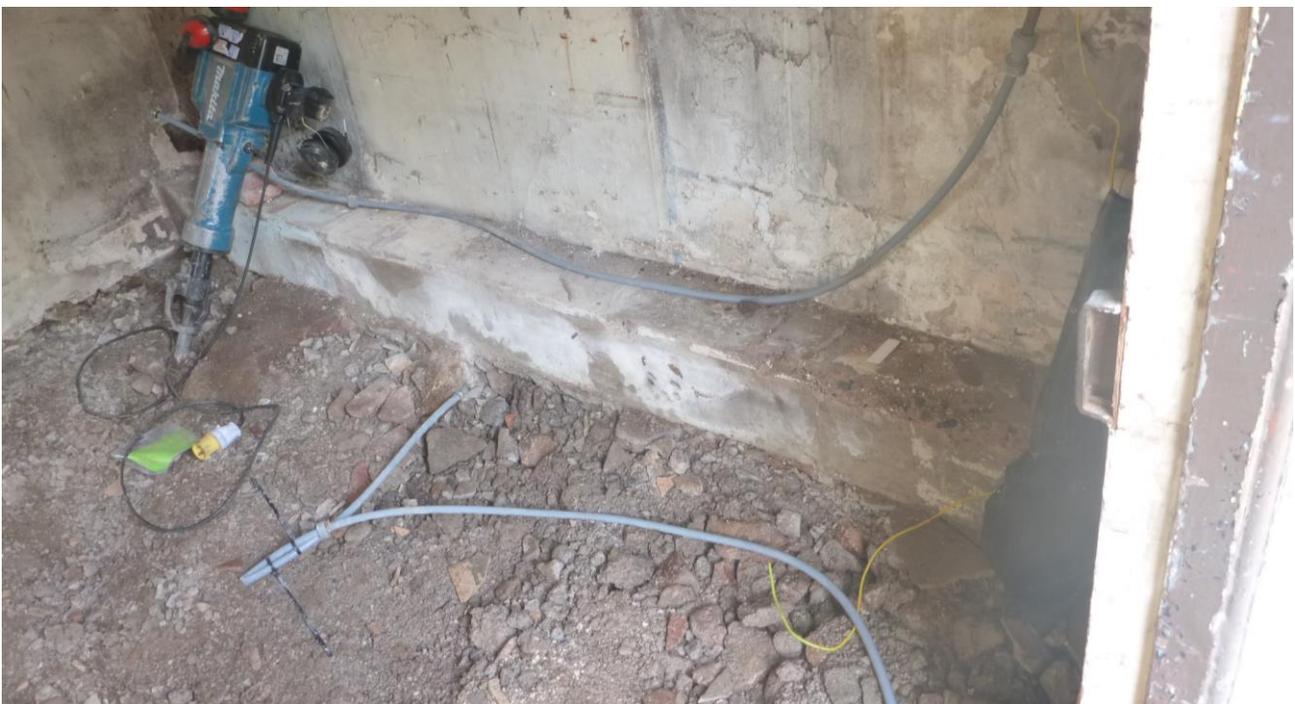
- A clay drain was found running from the back wall to the front door; this drain would have discharged water from the french drain below the surcharged ground to the rear of the cottage, running below the ground floor and ultimately soaking away in the cottage garden at the front of the cottage.
- Another drain was found between the kitchen and the living room which may have discharged water from the north-east side of the external French drain into the drain discharging onto the garden, although this is not certain.
- At the bottom of the rear wall to the living room a slate course was discovered, which would have functioned as a DPC.
- At the bottom of the rear wall in the kitchen, a concrete underpinning was unearthed. It was agreed that the underpinning should not be disturbed (since it may be structural and also preventing water ingress from the fell).

*Image showing the concrete haunch at the bottom of the north wall to the kitchen, 7<sup>th</sup> August 2018*

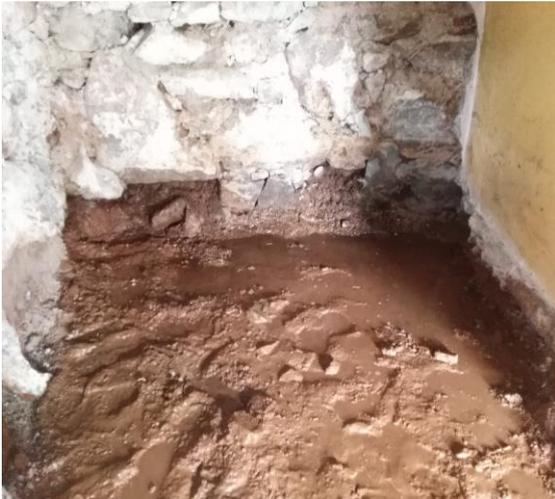
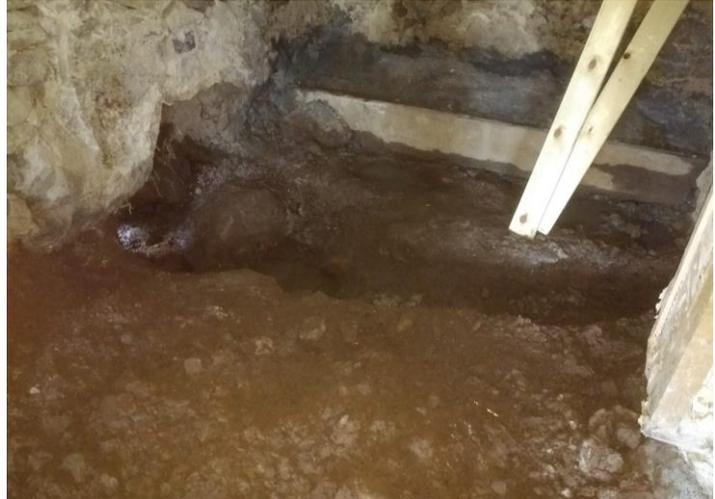
All the above-mentioned elements indicated the risk of water ingress into the living room and after periods of continuous rain whilst the floor was excavated this indeed occurred.

*Left hand side image: water ingress at the base of the north wall to the living room, 20<sup>th</sup> September 2018. Right hand side image: temporary haunch to the base of the wall preventing water ingress and trench for new internal drain, 9<sup>th</sup> October 2018*

During the Development Stage of the project, a French drain installed at a deeper level running along the north and west elevations of the cottage discharging onto the garden had been specified. However, after the on-site findings, it was agreed to incorporate a second barrier against water penetration by building a small concrete upstand at the base of the wall to the living room along with a new internal drain below floor level to drain the area (included in Architect's Instruction no. 6). This internal drain discharges onto the new external French drain right below the window to the west gable of the cottage as shown below.

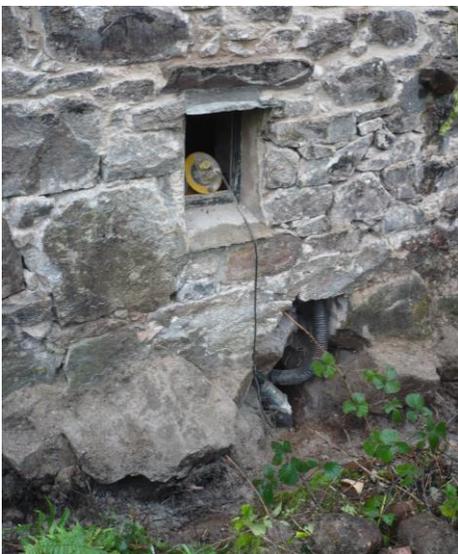
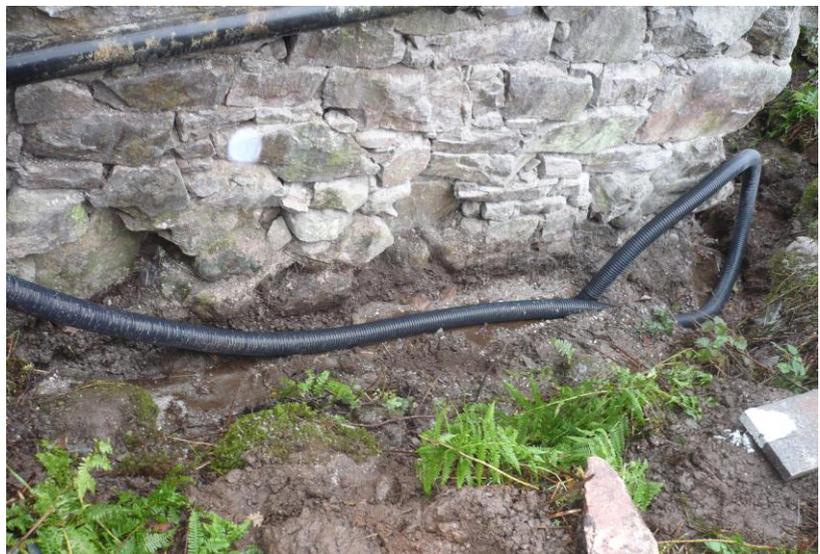
*Left hand side image: connection point of the internal drainage to the external French drain (west elevation). Right hand side image: French drain to north elevation under construction, 26<sup>th</sup> October 2018*

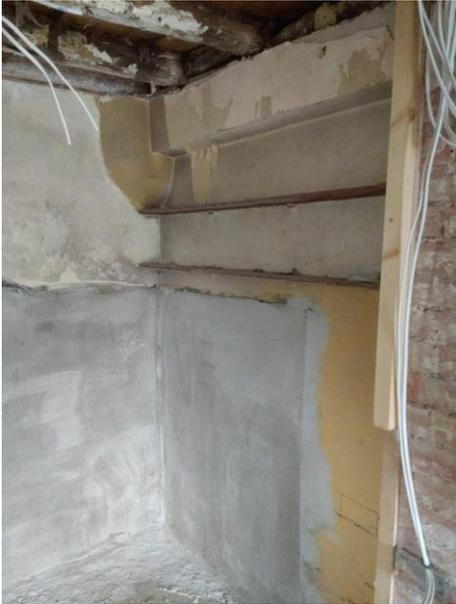
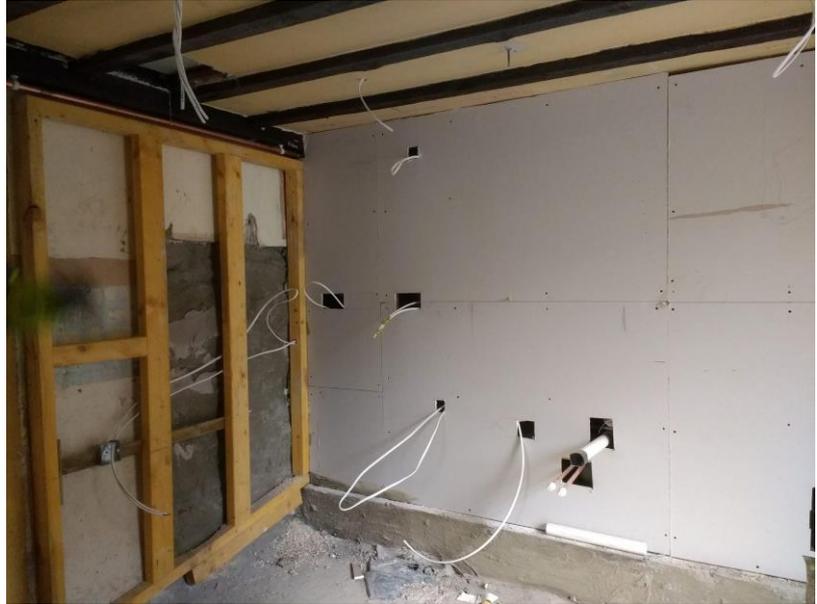
*Left hand side image: tanking to north wall and return to living room. Right hand side image: dry lining to kitchen area showing the tanking below and the first fix of electricity. 22<sup>nd</sup> November 2018*

As a third line of defence against internal dampness (after the external French drain and the internal drains and concrete upstands) it was agreed that those two areas of the north wall (living room and kitchen) would benefit from tanking. Sovereign's Hey'di K11 system was then specified in AI no. 6. Finally, a studwork dry lining was incorporated to the kitchen walls over the tanking to allow for the services to be installed without puncturing the tanking protection (AI no. 11).

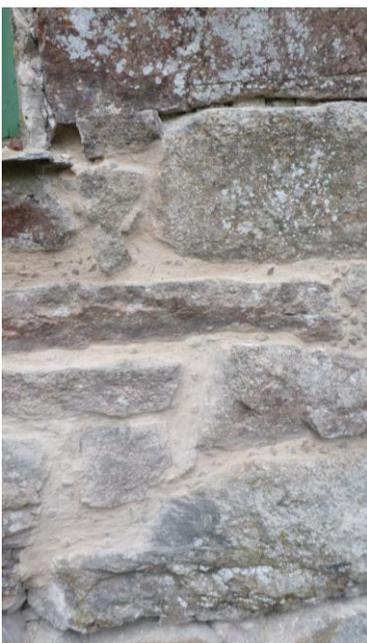
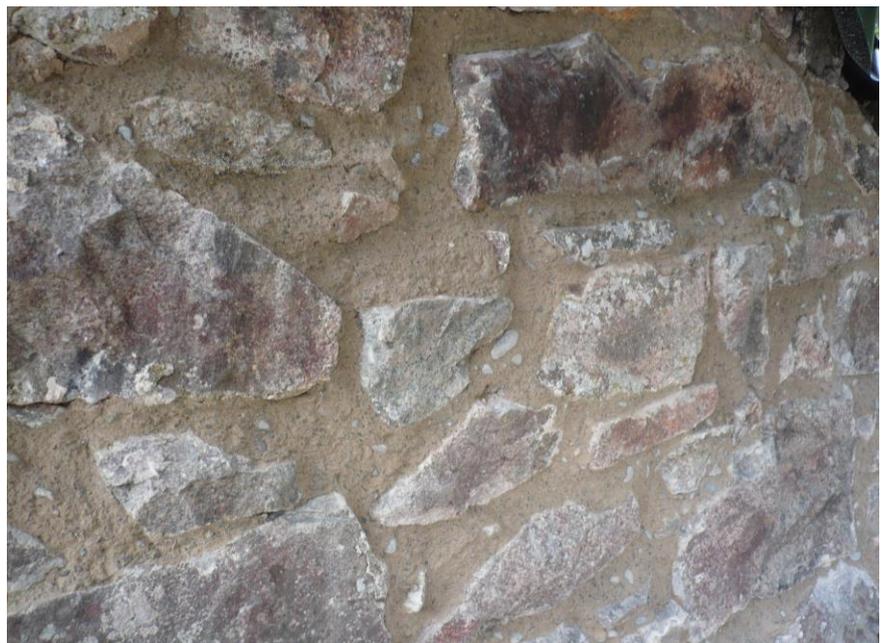
*Left hand side image: first sample of lime pointing deemed as unsatisfactory, 7<sup>th</sup> August 2018. Right hand side image: sample of approved lime pointing at the top of the eastern gable, 6<sup>th</sup> September 2018*

For the repointing works, several samples of lime mortar pointing were tested before reaching a mix that would be satisfactory. The original specification asked for 1:2.5 with 1 part of NHL 3.5 or 5 and 2.5 parts of Cardewmires sand, since it is locally sourced in Cumbria. However, the sample sand did not have a satisfactory spectrum of particle sizes and so it was decided to vary the mix to 1:1:1.5 with 1 part of NHL 3.5 or 5, 1 part of Cardewmires sand and 1.5 parts of ballast sand (up to 20mm sand/gravel mix from the Overby quarry).

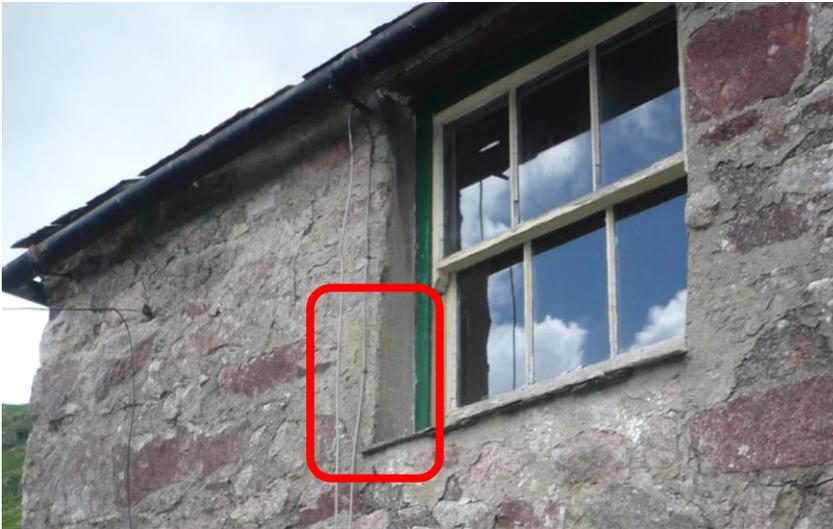
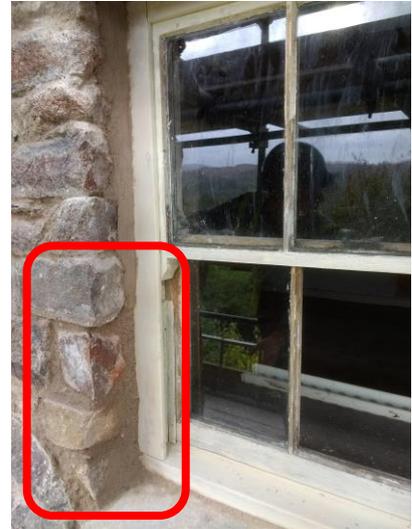
During the lime repointing works, a small area of brick work with cement mortar forming the bottom left corner of a first floor window was discovered and replaced with salvaged stone.

Left hand side image: western jamb to window no. 5 showing area of brickwork covered in cement, 14<sup>th</sup> July 2016.

Right hand side image: western jamb to window no. 5 showing new masonry, 9<sup>th</sup> October 2018

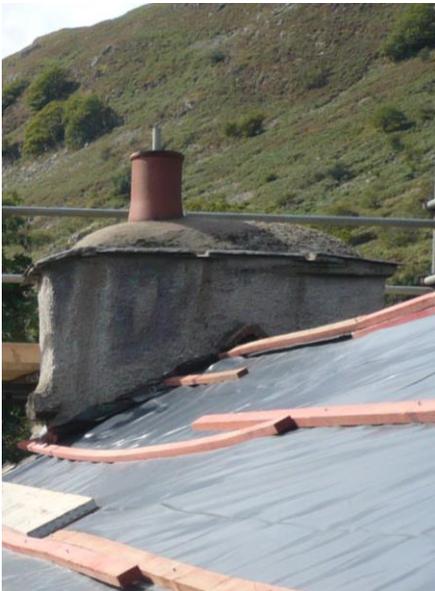
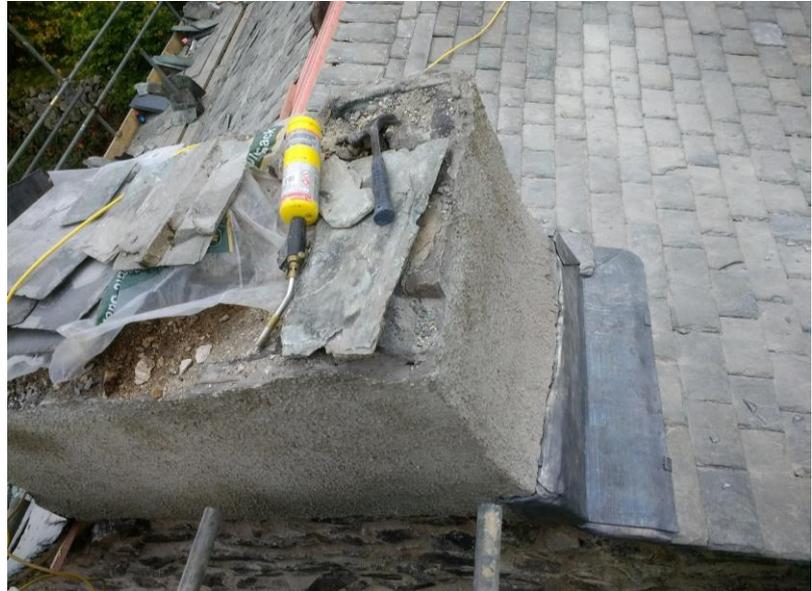
Left hand side image: western chimney with cement flaunching, 6<sup>th</sup> September 2018. Right hand side image: western chimney after hacking off the cement flaunching, 9<sup>th</sup> October 2018

Works to the chimneys included the incorporation of lead soakers and flashing at roof abutments and the removal of an oversized cement flaunching to the western chimney (AI no. 6).

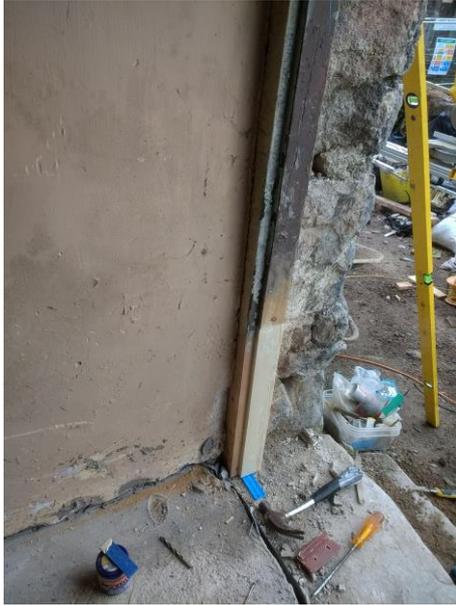
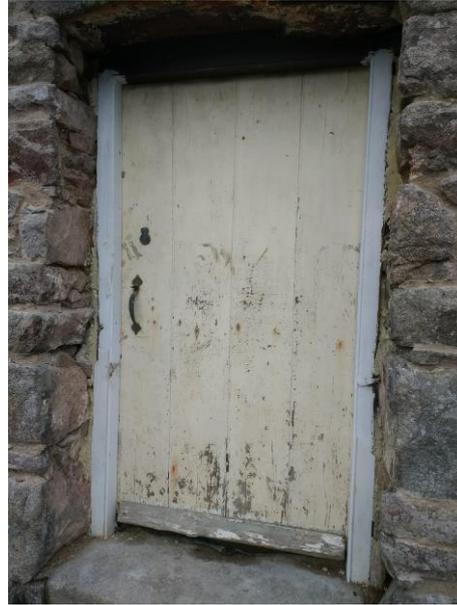
Left hand side image: splice of splice joint between new bottom timber section and existing door frame to front door, 22<sup>nd</sup> November 2018. Right hand side image: image showing the refurbished door frames on 13<sup>th</sup> December 2018

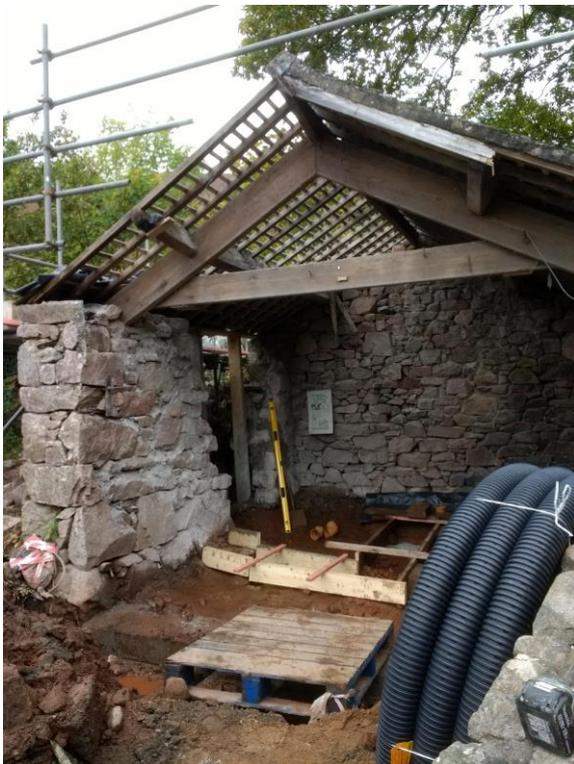
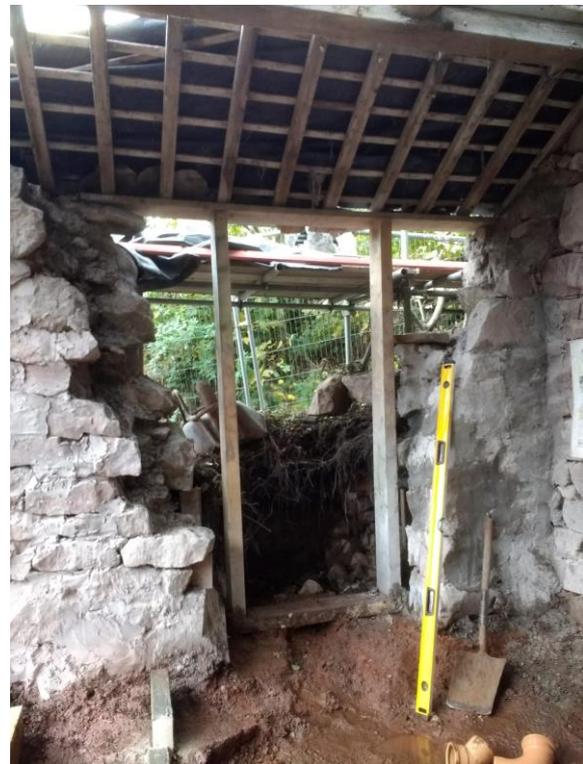
The cart shed is built into the bed-rock of a bankside and installing an external perimeter french drain was not a viable option. The Development Stage specification included for tanking the masonry external walls with Sovereign's Hey'di K11 system, but during the excavation of the floor water from the fell seeped through the rear wall, which was similar to what happened in the cottage).

*Left hand side image: general image of the cart shed with the western pitch stripped off, the ground floor excavation and the concrete foundation to the new south elevation. Right hand side image: masonry opening for doorway into new wheelchair accessible toilet, 9<sup>th</sup> October 2018*

A new drain was introduced below floor level to drain the area (AI no. 10).

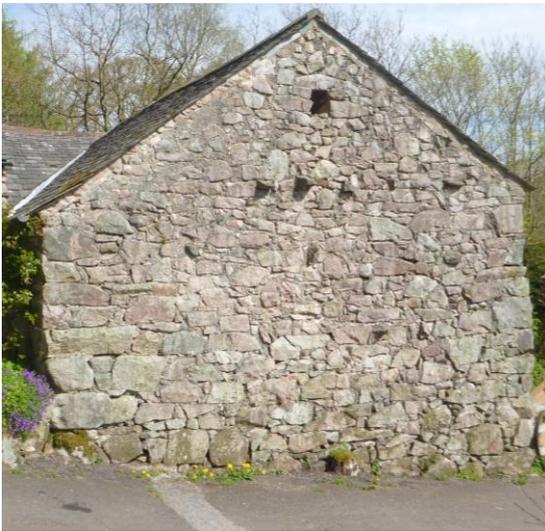
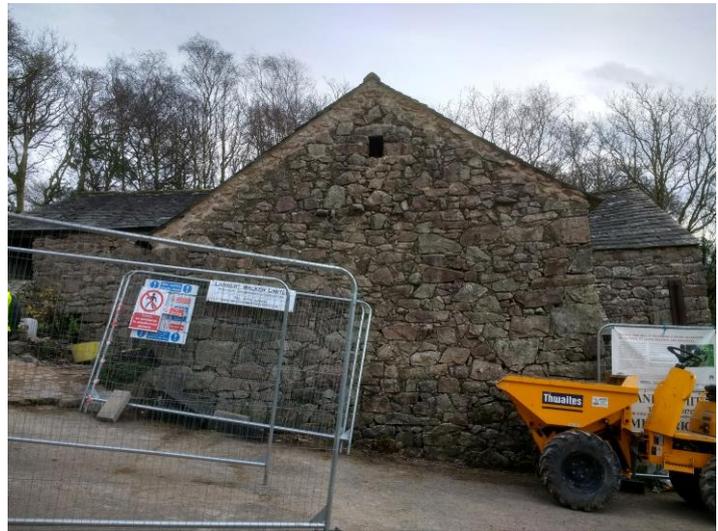
Western gable to Exhibition Room. Left hand side: image taken on 5<sup>th</sup> May 2016 before works commenced. Right hand side image: taken on 13<sup>th</sup> December 2018

The masonry of the Mill buildings resembles a dry wall construction in that almost no mortar is visible in the masonry joints. Therefore, the architect specified that the external walls would be deep-tamped with NHL 3.5 lime mortar (areas of voids would be filled by pinning or galleting) in order to reduce water penetration into the wall while retaining the appearance of the buildings. Consolidation works below the roof verge were also undertaken.

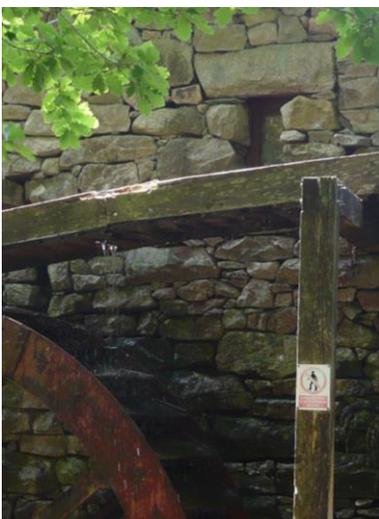
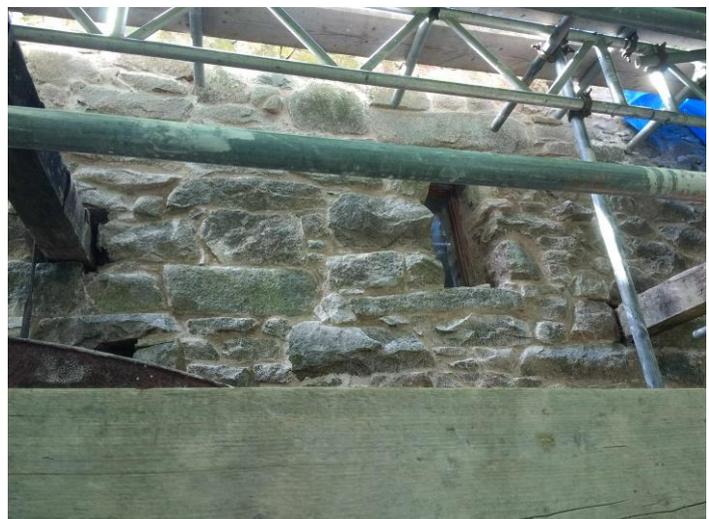
Image of southern wall around the south-west opening. Left hand side image taken on 8<sup>th</sup> June 2016. Right hand side image taken on 30<sup>th</sup> August 2018

A different approach was taken with regards to the east wall, where the 2 no. waterwheels are located. This elevation is exposed to the splashing of water almost continuously, and therefore a lime pointing using NHL 5 mortar was specified.

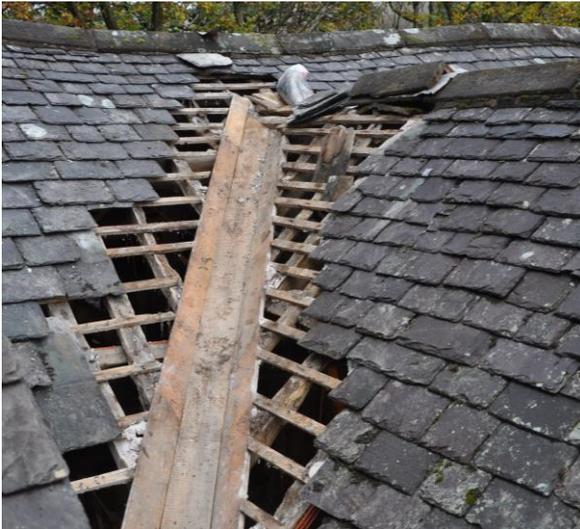
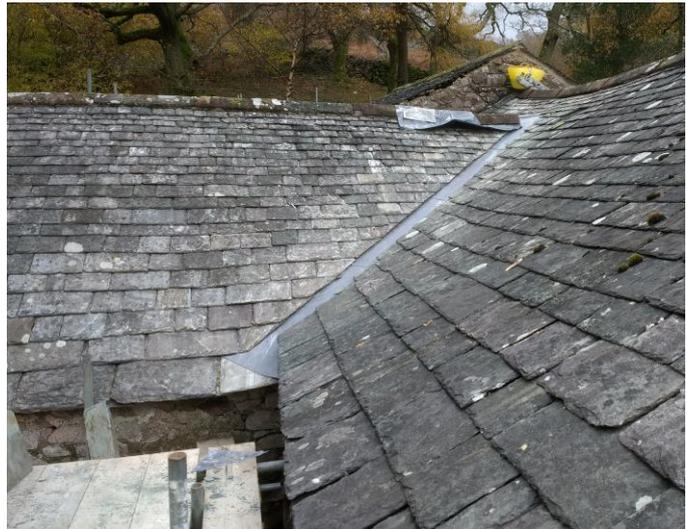
1. Replacement of the perished lead valley gutters between the Exhibition Room and the Milling Room.

*Left hand side image: northern valley gutter under construction, image kindly supplied by Maurice Steele. Right hand side image: finished southern valley gutter. 6<sup>th</sup> November 2018*

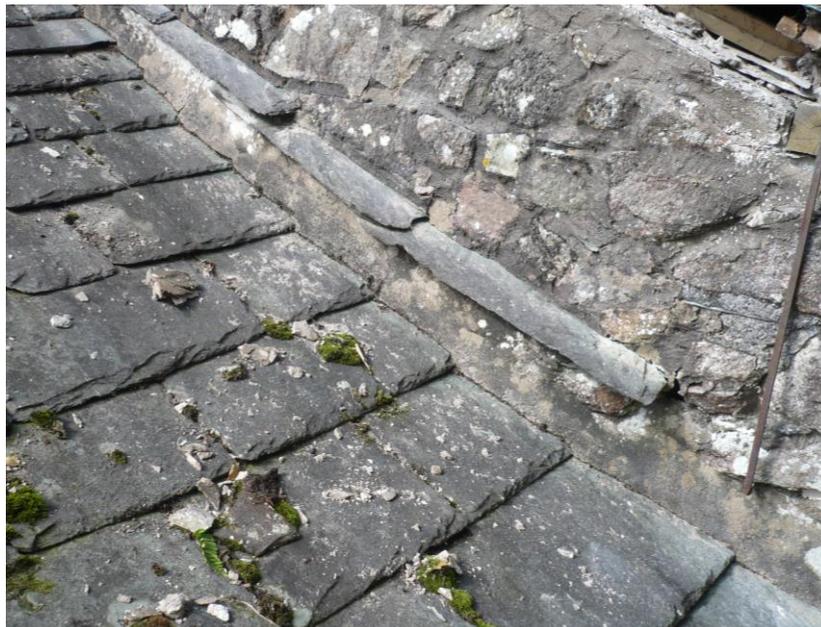
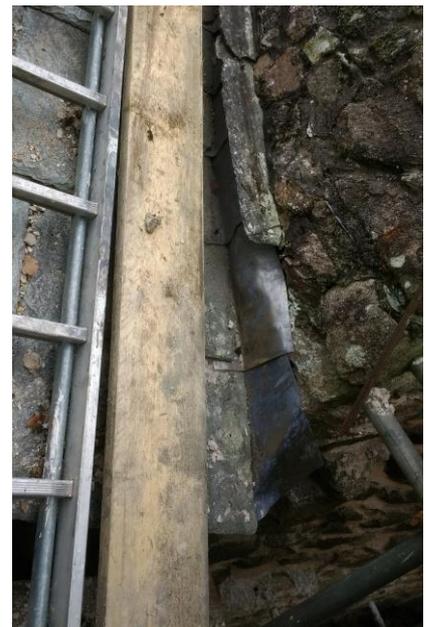
*Abutment between the Milling Room roof and the southern gable of the Drying Room. Left hand side image taken on 6<sup>th</sup> September 2018. Right hand side image taken on 6<sup>th</sup> November 2018*

2. Incorporation of lead soakers and flashings between at the abutment between the Milling Room roof and the southern gable of the Drying Room.

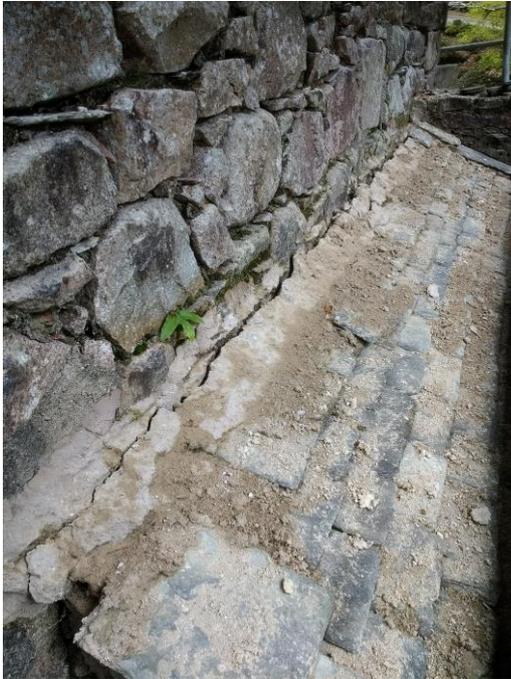
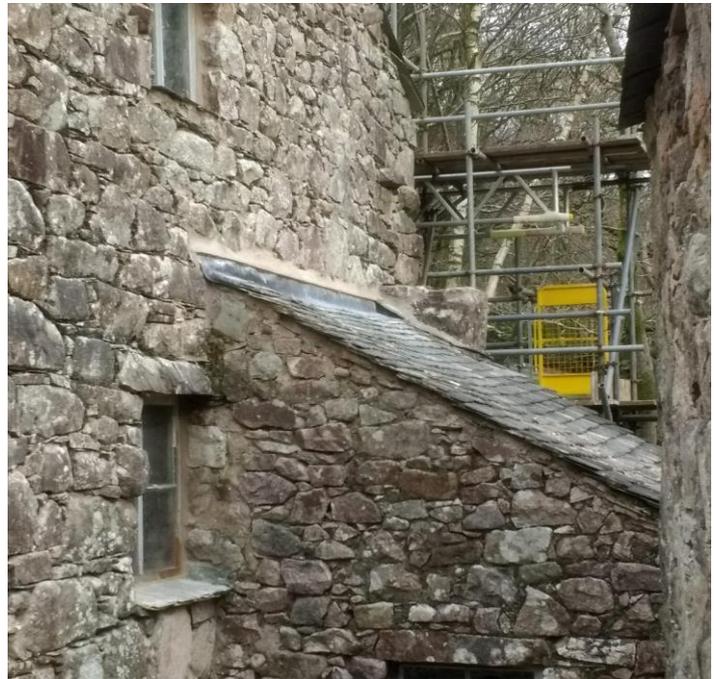
Abutment between the bakehouse roof and the southern gable of the Milling Room. Left hand side image taken on 6<sup>th</sup> November 2016. Right hand side image taken on 13<sup>th</sup> December 2018

3. Incorporation of lead flashings to abutment between the Bakehouse roof and the southern gable of the Milling Room.

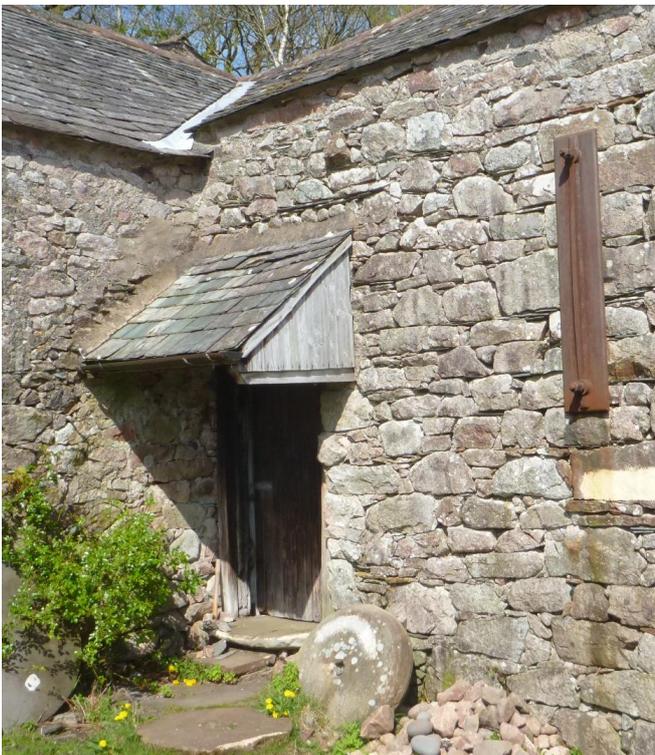
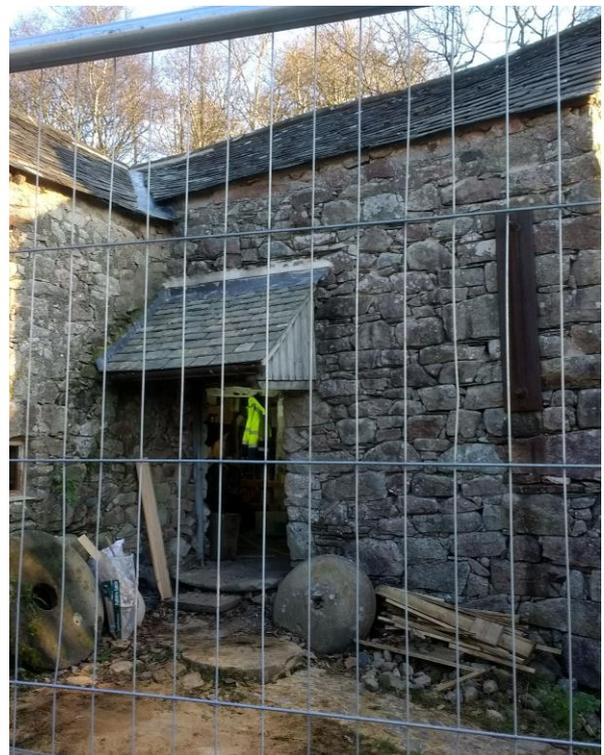
Abutment between canopy and mill walls. Left hand side image taken on 5<sup>th</sup> May 2016. Right hand side image taken on 22<sup>nd</sup> November 2018

4. Incorporation of lead soakers and flashings to abutment between canopy and mill walls.

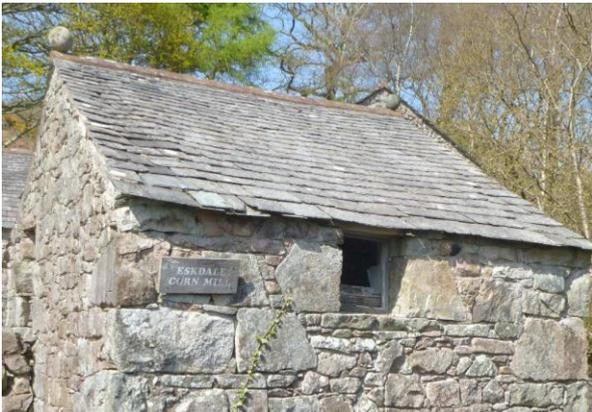
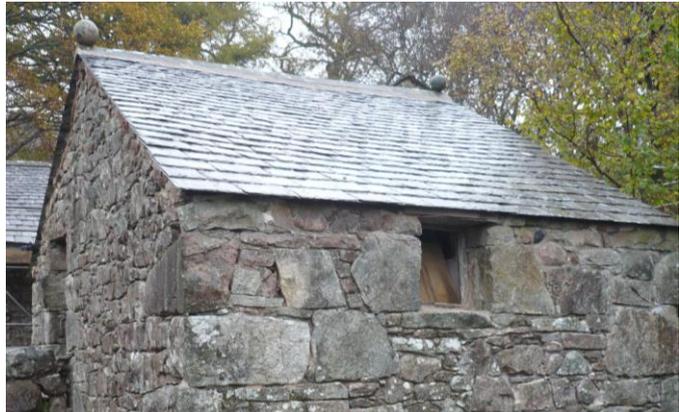
During a site meeting with the roofing subcontractor on 7<sup>th</sup> August 2018, the possibility of retaining the eastern end of both roof pitches was considered. Slates had moved along the western elevation due to unsatisfactory roof verge and wind and rain action. However, an inspection carried out on 27<sup>th</sup> September revealed that the roof was suffering from “nail sickness” and total re-roofing was required.

South pitch to stable/hayloft. Left hand side image taken on 5<sup>th</sup> May 2016. Right hand side image taken on 26<sup>th</sup> October 2018, showing the new roof overhanging the western gable

Both roof pitches were re-roofed with salvaged slates fixed onto new battens. The stone finials to either side of the ridge have been retained.

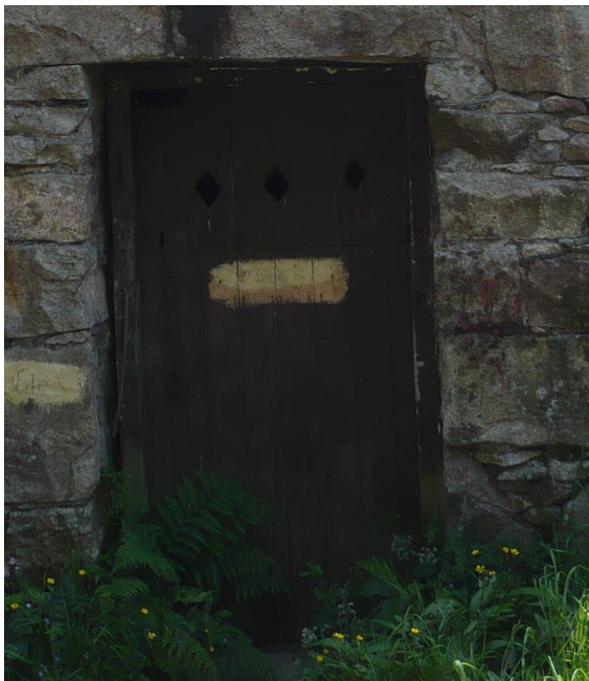
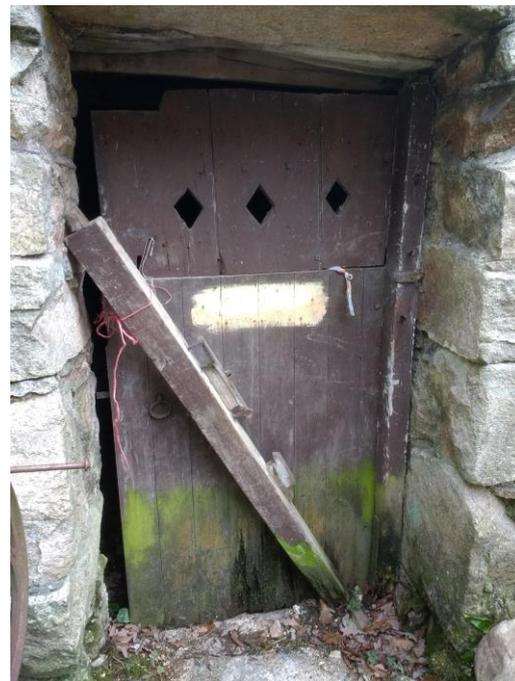
When the condition survey was undertaken in August 2016, the external door giving access to the stable was still in a repairable condition. However, this past two years the door has been exposed to water running from the courtyard in such a quantity that the door frames have completely rotted away and the lower leaf is not in a repairable condition.

Stable door. Left hand side image taken on 9<sup>th</sup> June 2016. Right hand side image taken on 13<sup>th</sup> December 2018, showing the current condition of the joinery

A new stable door matching the existing will be incorporated. In order to minimise the direct contact between the timber and surface water, a stone threshold will be installed (AI no. 6).
