ESKDALE CORN MILL MACHINERY AND MILLWRIGHT PROGRESS

December 2018

3. Progress – work to December 13th 2018

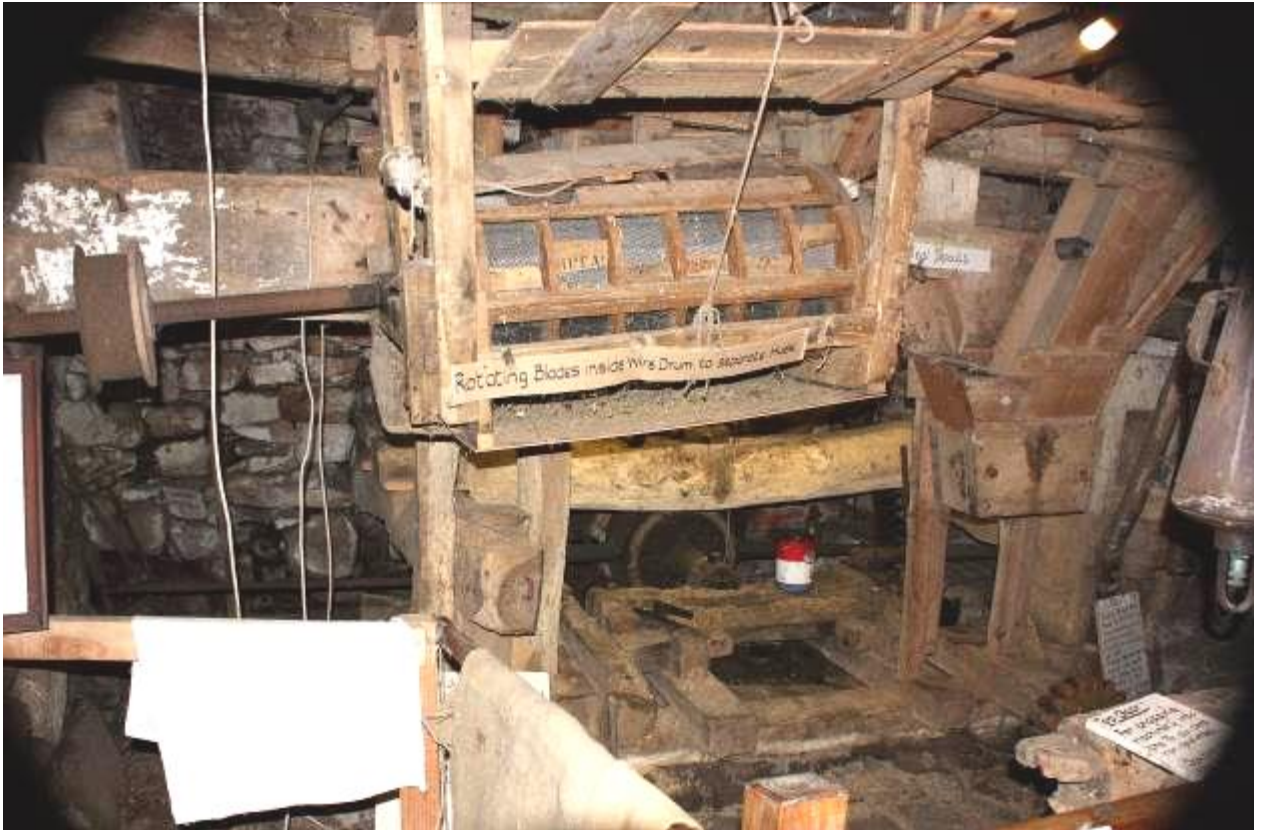
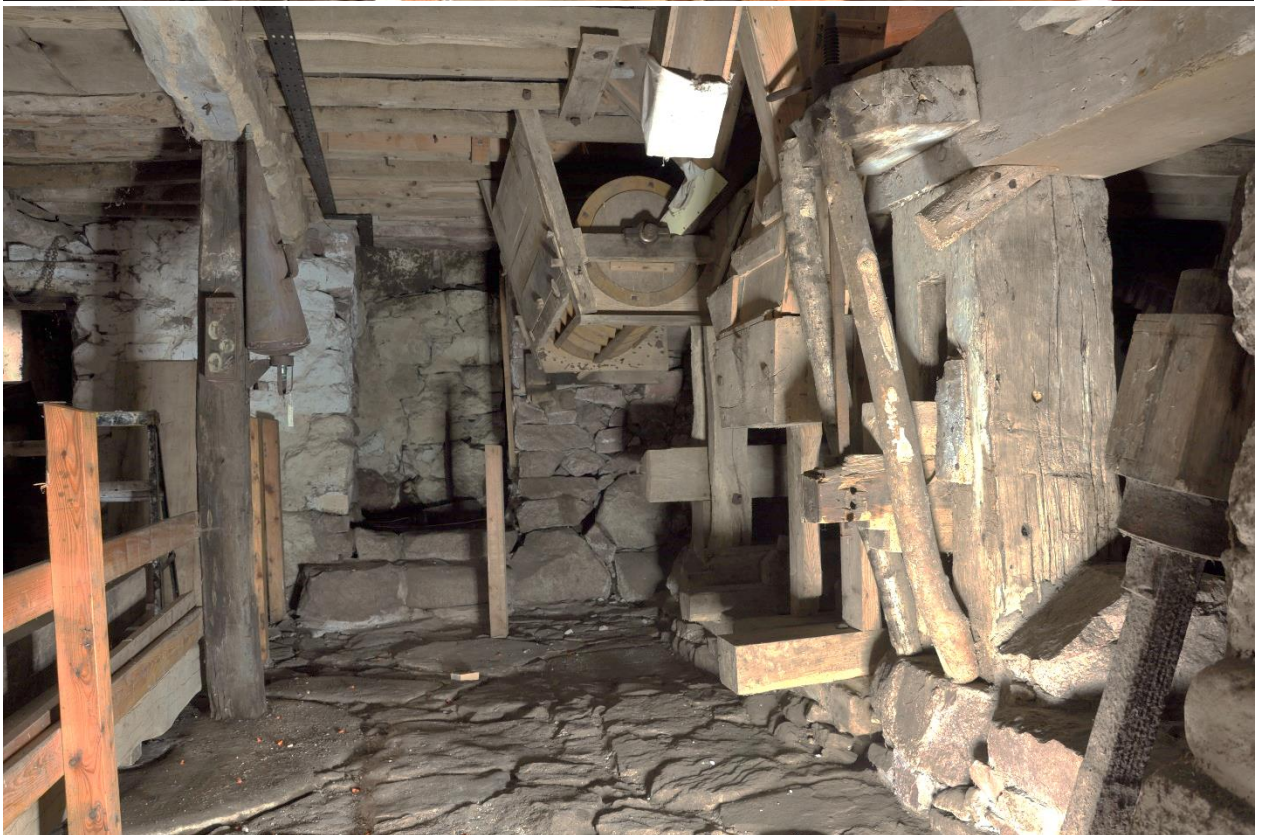
7. The wire machine has been thoroughly opened, cleaned throughout and re-assembled securely. The brass bearing bushes have been serviced. It has been found that the drive shaft for the belt to the wire machine is not suitable to take the weight of the drive gear and new wooden pulley. Another shaft was found on site and was intended to be used. However, the millwrights stated that it would be more cost-effective and a better use of time to replace the shaft with a new unit as the used item would require quite a lot of machining and metalwork to fit the existing drive gears correctly.

7 Before and after the Millwright cleaning and inspection of the wire machine. S Hobbs / Maurice Steele

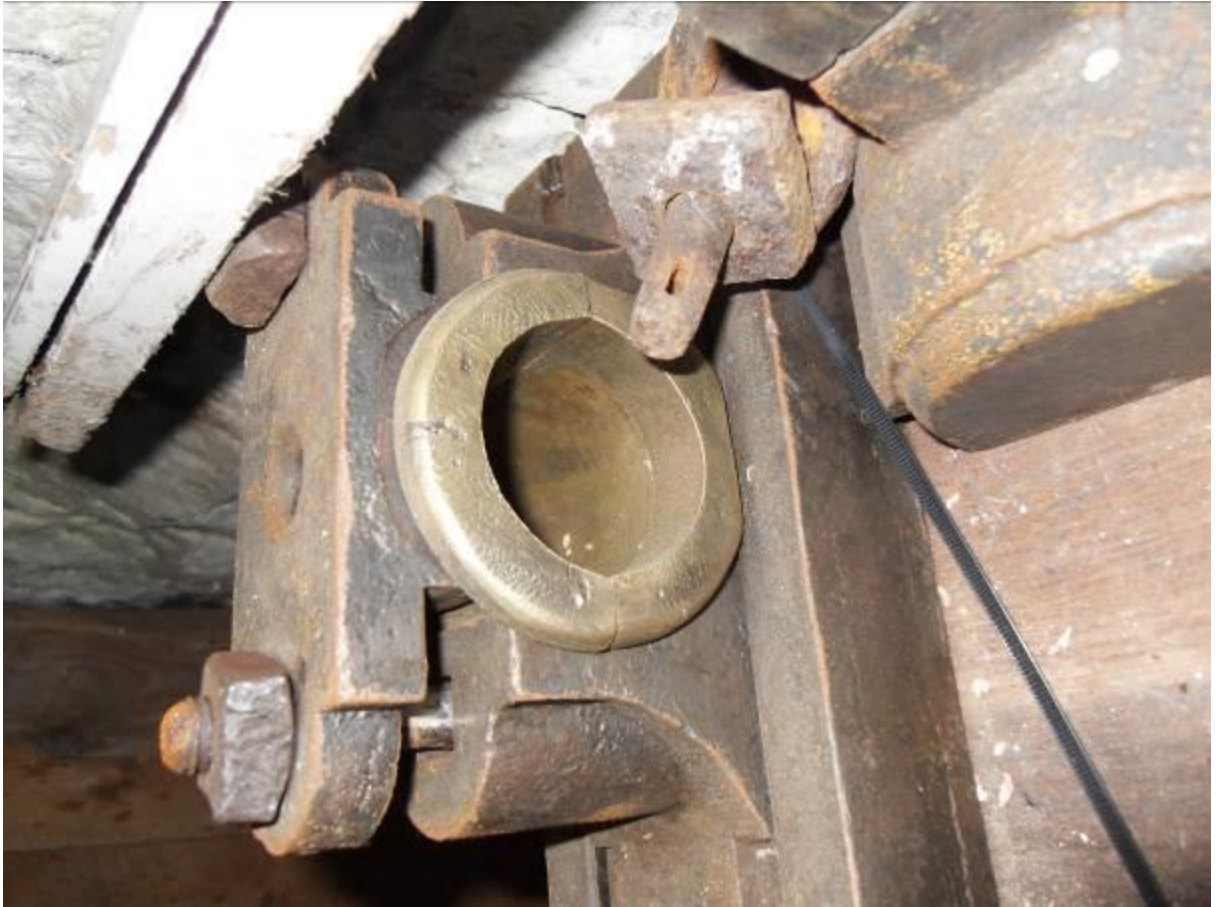
8. The right hand lay shaft has had new bearing shells cast by the millwrights and are custom made. This is done by making a bespoke wooden pattern to fit the bearing blocks and shaft exactly. These are slightly oversize and are used to produce a pattern in casting sand and when removed, leave a void where molten metal is poured. The will produce a metal cast bearing shell that will shrink when cooled. Final machining is done on a lathe and was due to be done the 3rd week of December.

8 An example of a new bronze/brass bearing shell in its block.

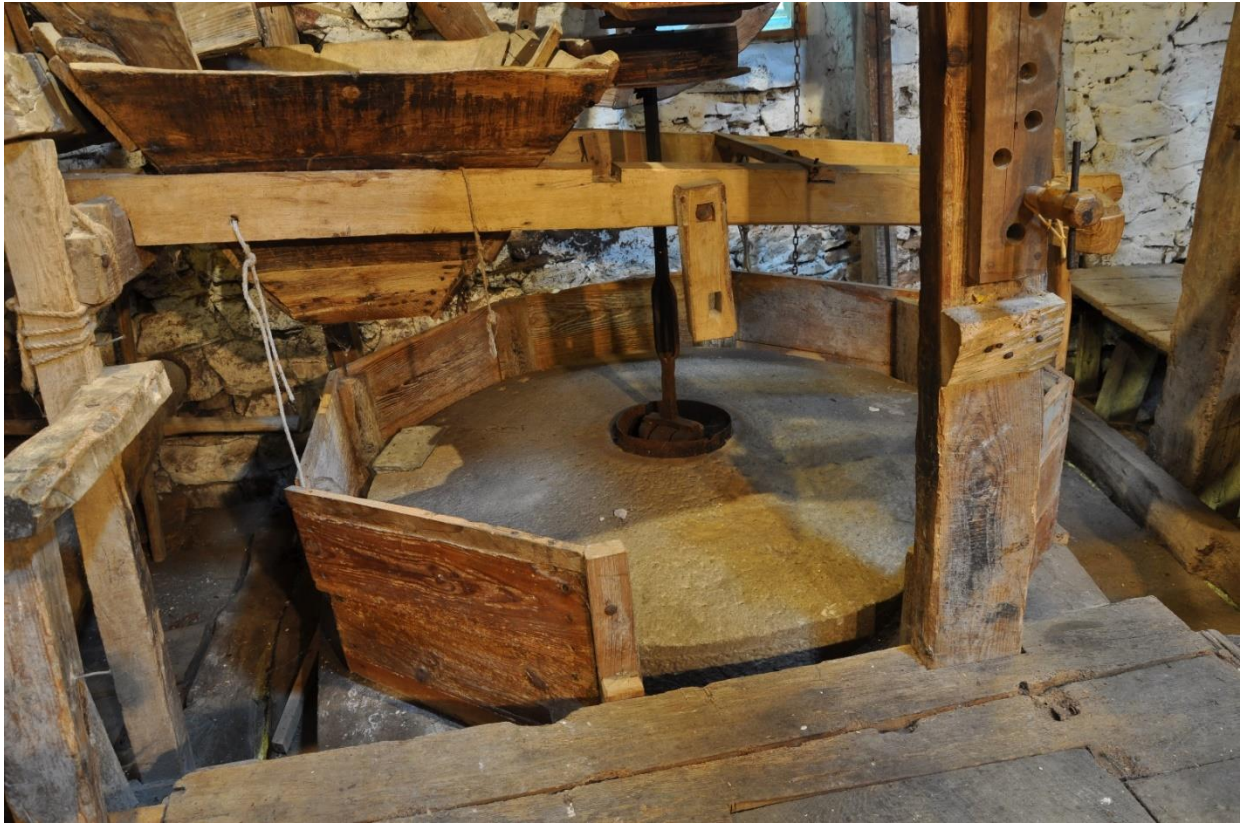
10. The upper millstone 'shoe' has been taken away for repair and timber selected for repairing the tun casing.

10 Upper mill stone and furniture - Maurice Steele

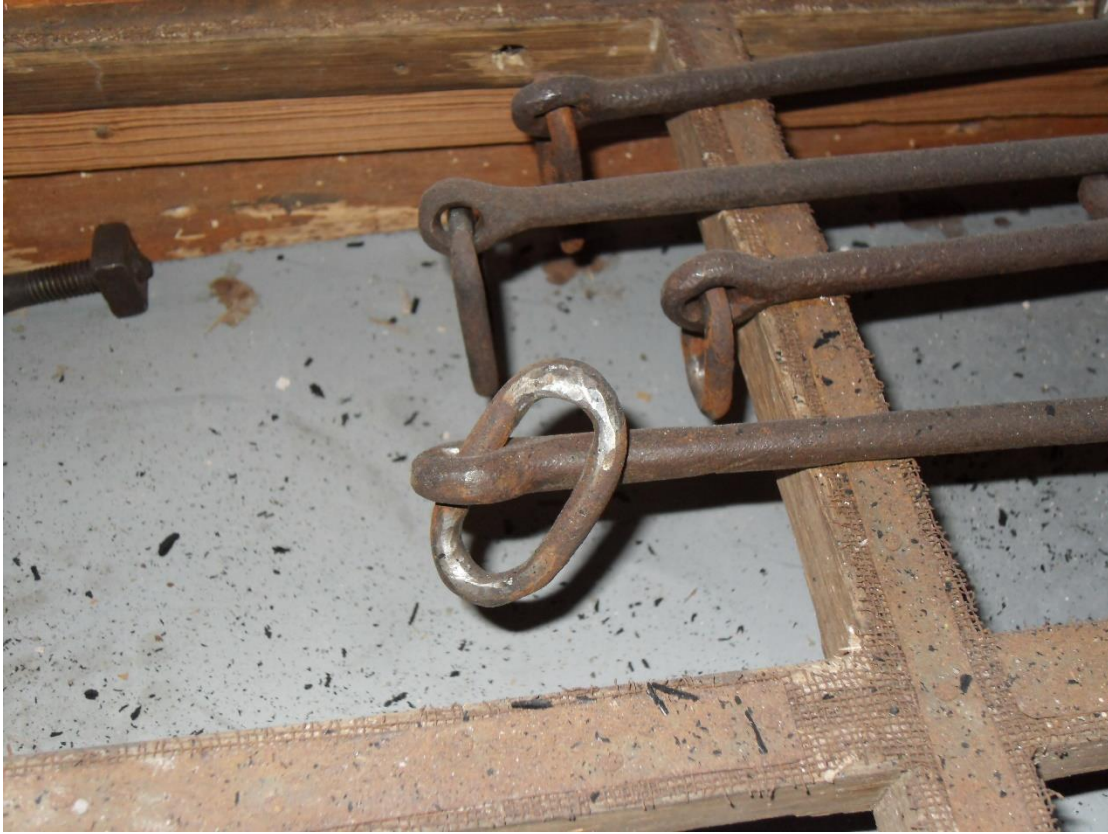
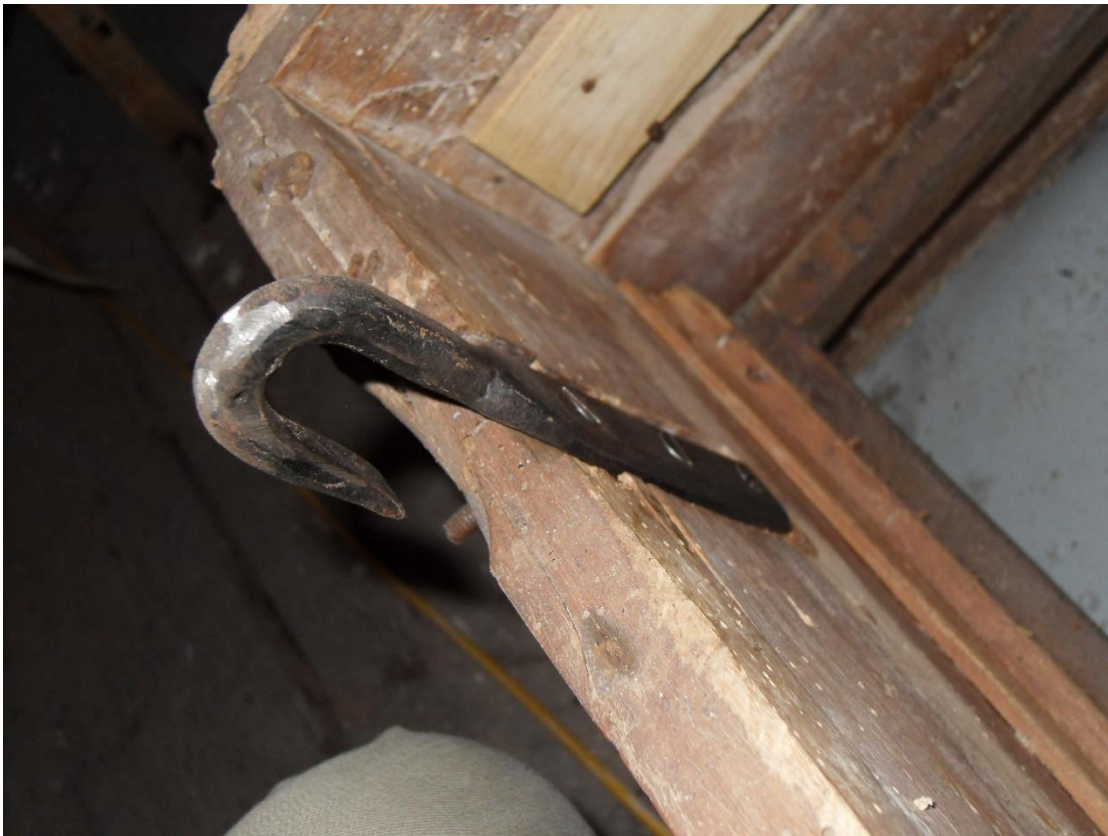
11. The metal hoops, hooks and straps for the jog-scry have been repaired and, as can be seen in the pictures, are repaired to a very high quality and look as good as new.

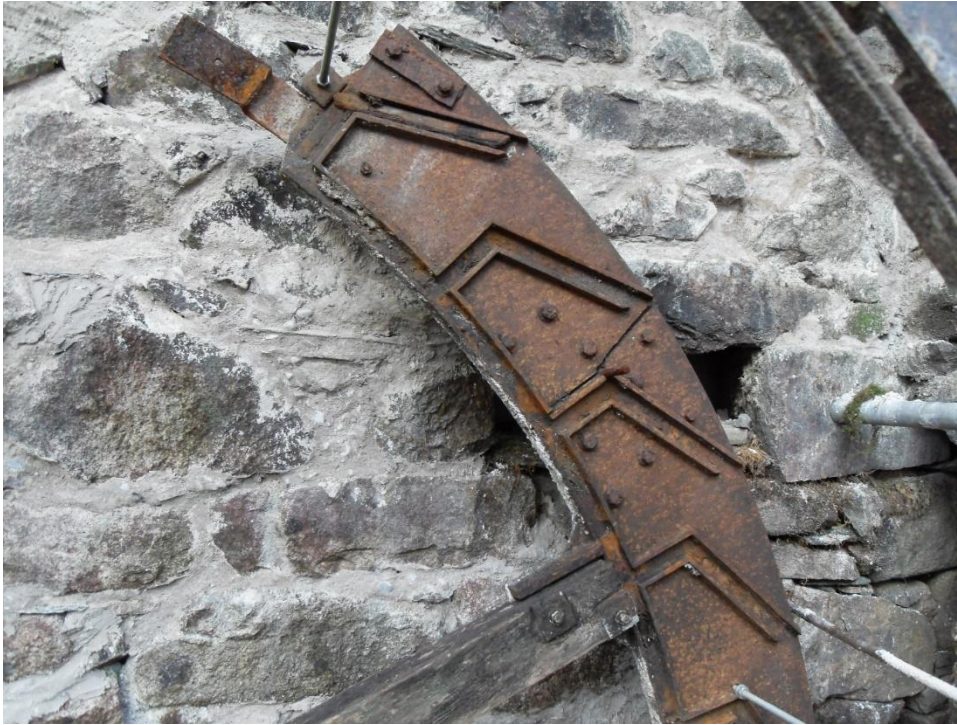
12. The upper waterwheel has had the most work undertaken on it so far. The timber has been stripped off the castings, enabling inspection of the cracks in the shroud castings. Originally the specification called for metal patches to be used to secure the cracks, as per historic repairs to the wheel. This was intended to preserve as much of the original wheel as possible. However, the millwrights found there was a substantial amount of work needed to repair the cracks and suggested having the worst of the cracked castings replaced with new cast iron shroud sections. The Trust has agreed that the repair would be longer lasting and more secure than using the original repair method without detracting from the history of the wheel. The old cracked castings will be retained on site. The millwrights have had new patterns made and provided picture evidence of this work that is often a specialist job. Having new cast sections has required the budget for repairs to be increased but has also saved labour time meaning the work is on schedule.

12 Upper wheel showing a crack in the cast rim section. 12a The waterwheel with rotten paddles April 2016.

The millwrights are also producing bespoke bolts, nuts and studs (fixings) that will fit the square holes of the waterwheel perfectly and replacing the old, incorrect hexagon fixings from the last restoration. The bespoke fixings replicate those that would have been blacksmith made when the mill was built.

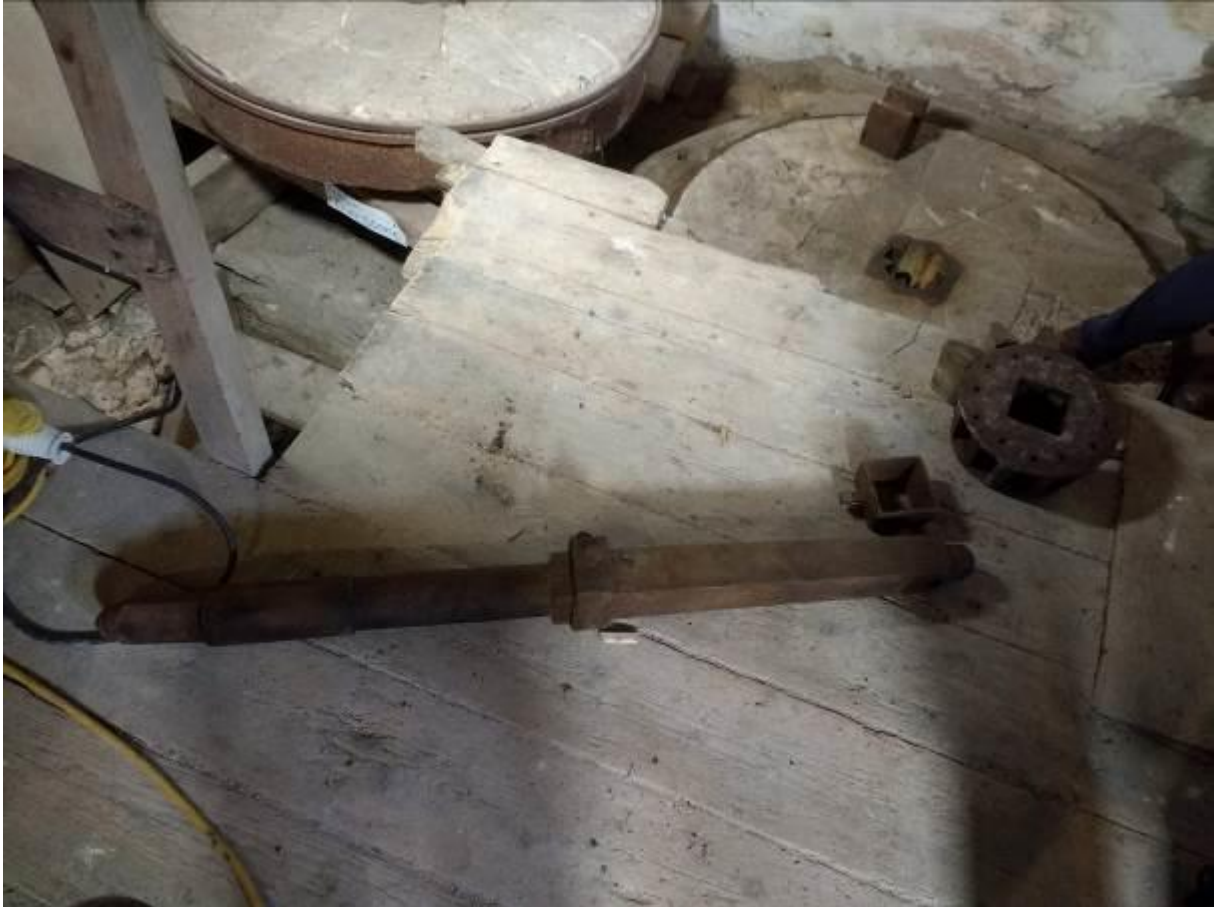
13. The stone nut has been taken off site for measuring as new cogs are required. The spare cogs that were in the mill in 2016 have not been found, so hornbeam timber has been sourced for their replacements. The millstone shaft that has been placed in the lower mill for decades has been found not to match the existing stone nut. Although this was a surprise, and requires extra un-budgeted work, the millwrights are confident this can be adapted to fit the existing stone nut and will work without further modifications to the millstone bearing housing. The adaptation work has been started.

13 The lower millstone shaft and stone nut prior to alteration

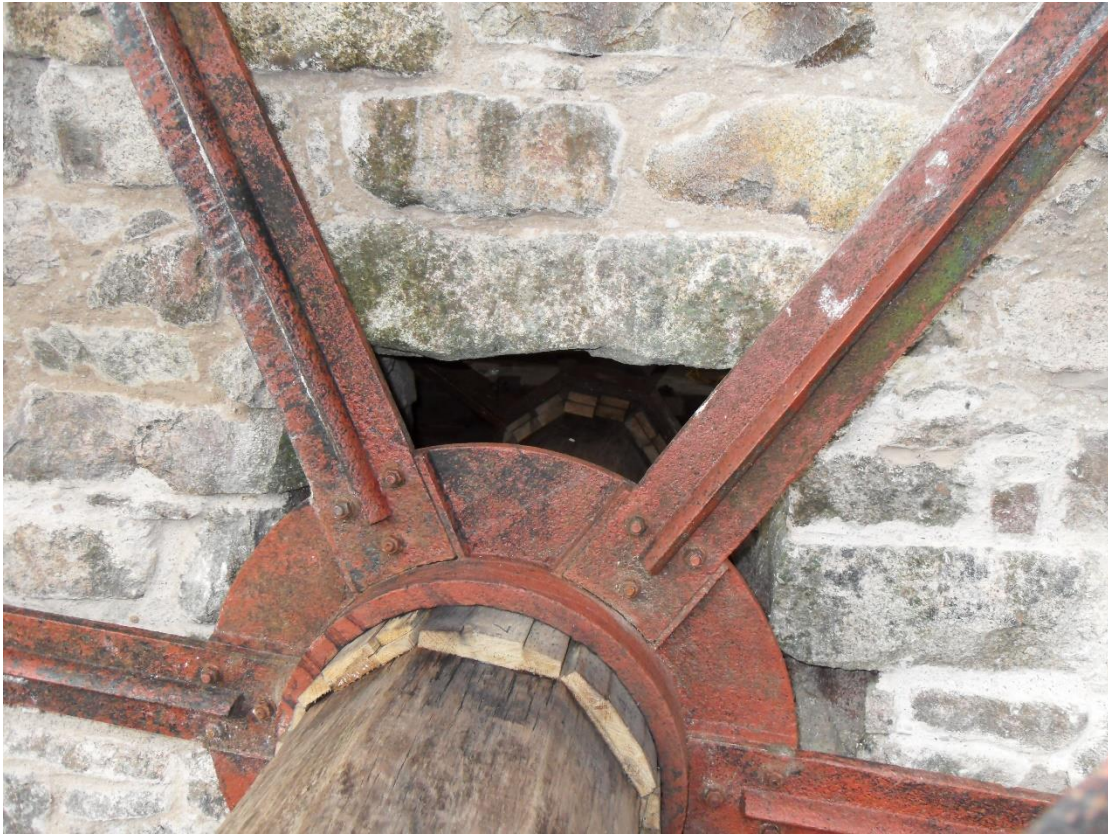
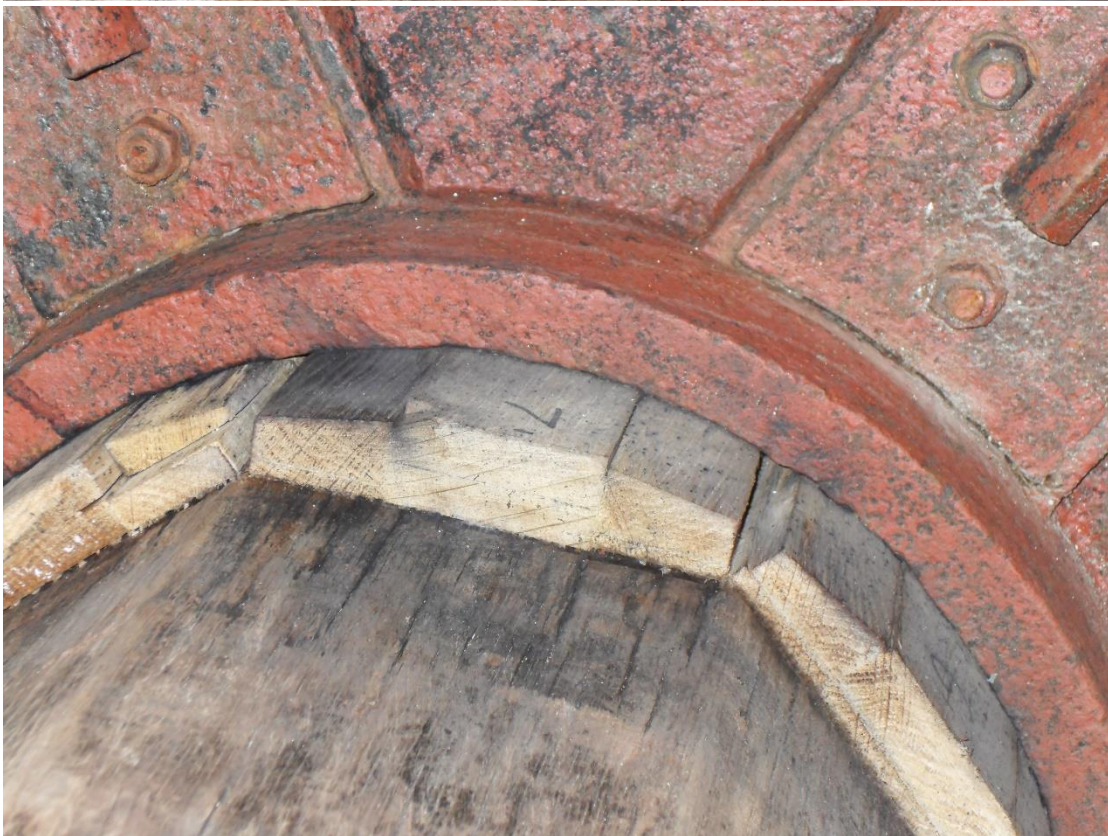
14. Work to the lower waterwheel shaft has been completed to a high standard and is the first time the waterwheel has been secured to this timber shaft. The timber shaft was a replacement that made its way to the mill in 2004 and was never completed.

Oak wedges were cut to fit between the wheel and hexagonal shaft and driven in from either side of the waterwheel hub castings. As well as holding the wheel to the shaft, they are also used to align the wheel so it does not run eccentric to the shaft.

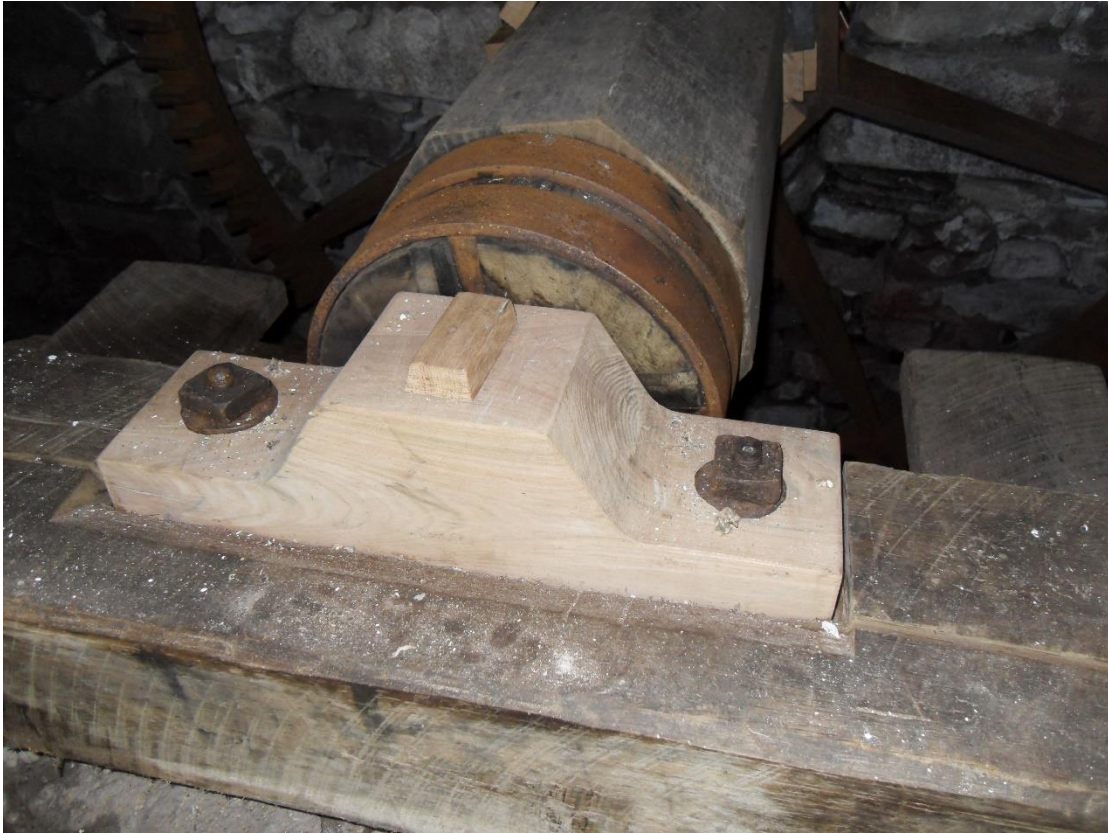
15. Two new wooden caps have been produced as covers for the lower waterwheel bearings. The work has been completed to a high standard.

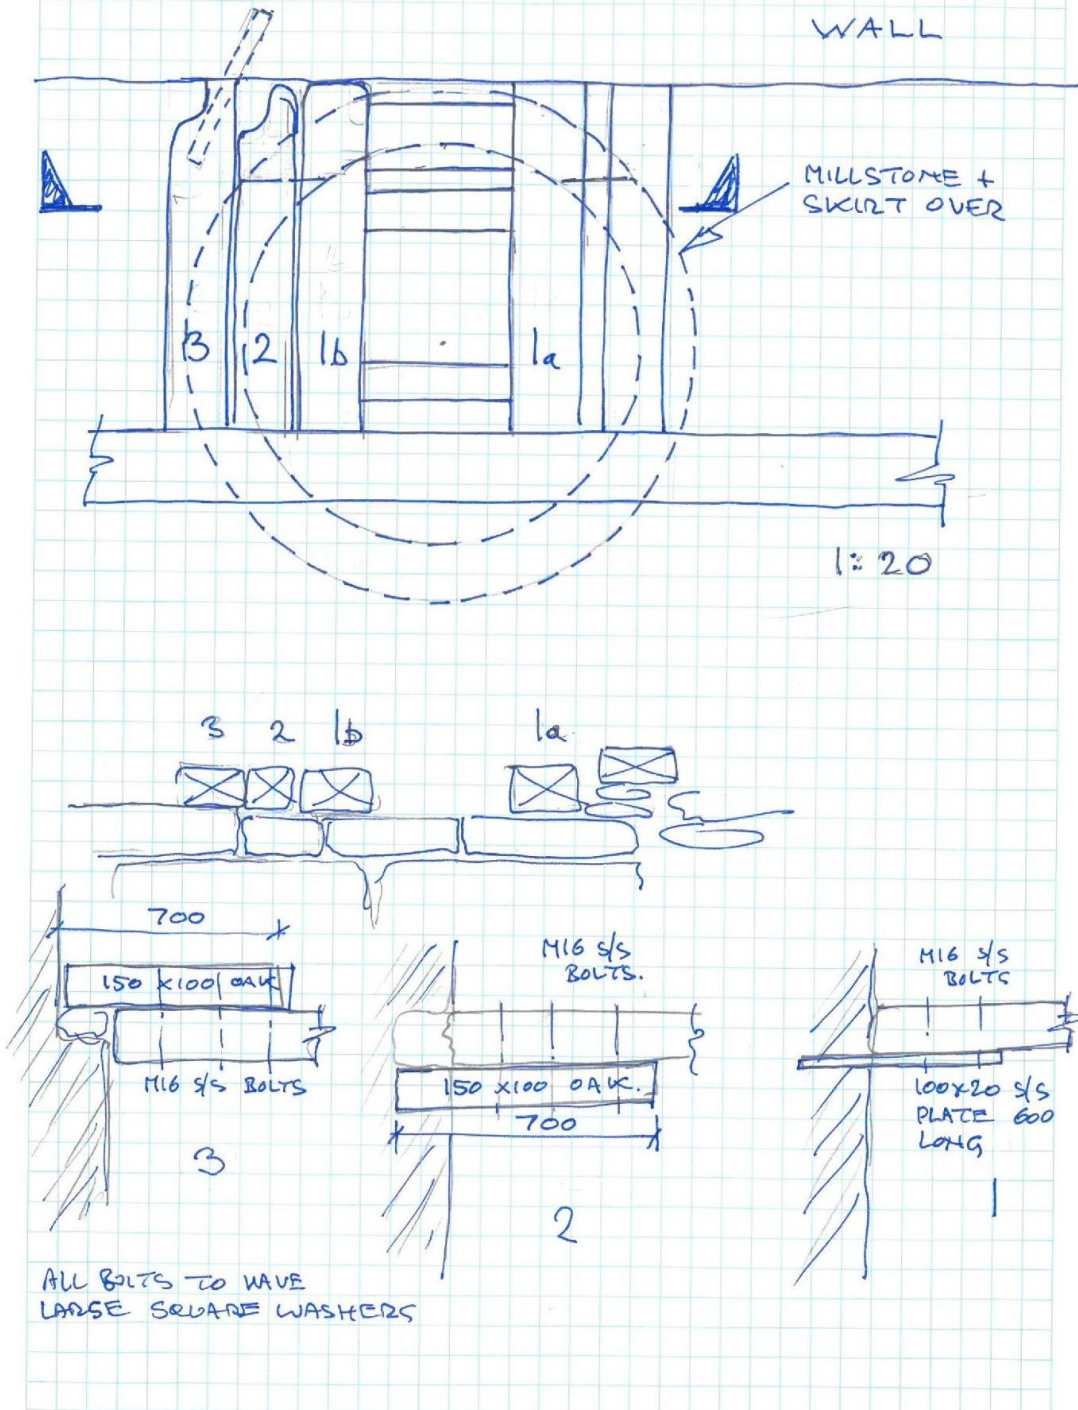
15a Structural Engineer's Repair Design

Some rotten timber has been found next to the outer wall where damp has set in. This was discovered after the removal of some debris and millstone furniture and a suitable repair method has been designed by the conservation structural engineer as shown below.

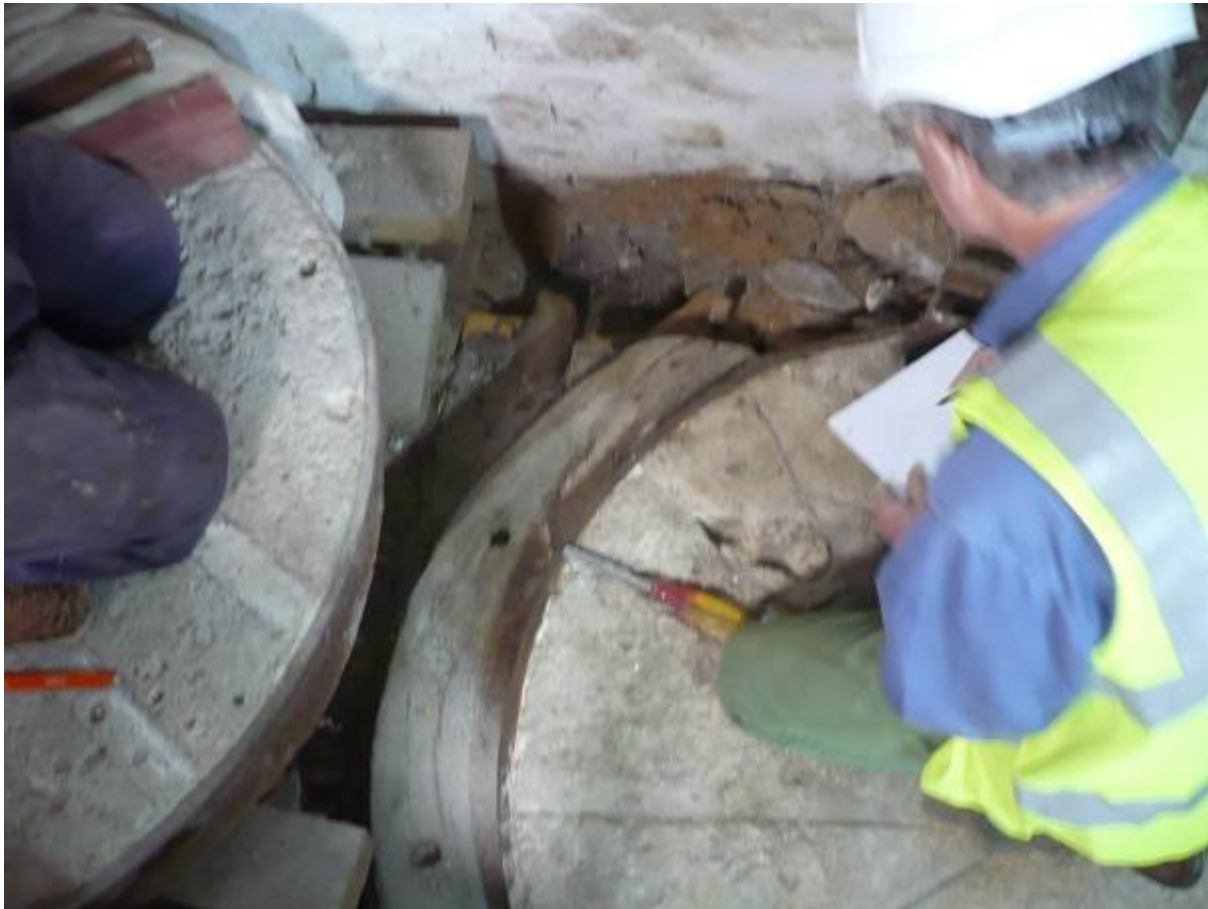
15b Inspection of the rotten timbers of the hurst frame by the outer wall.

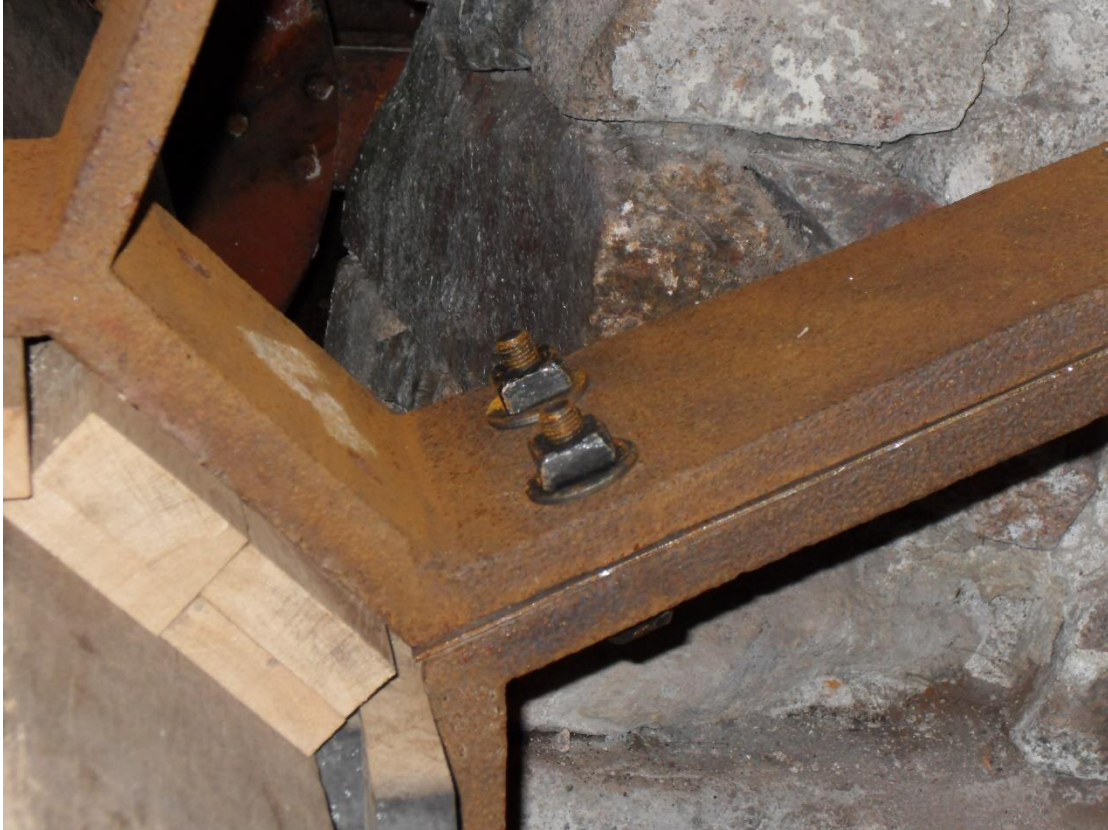
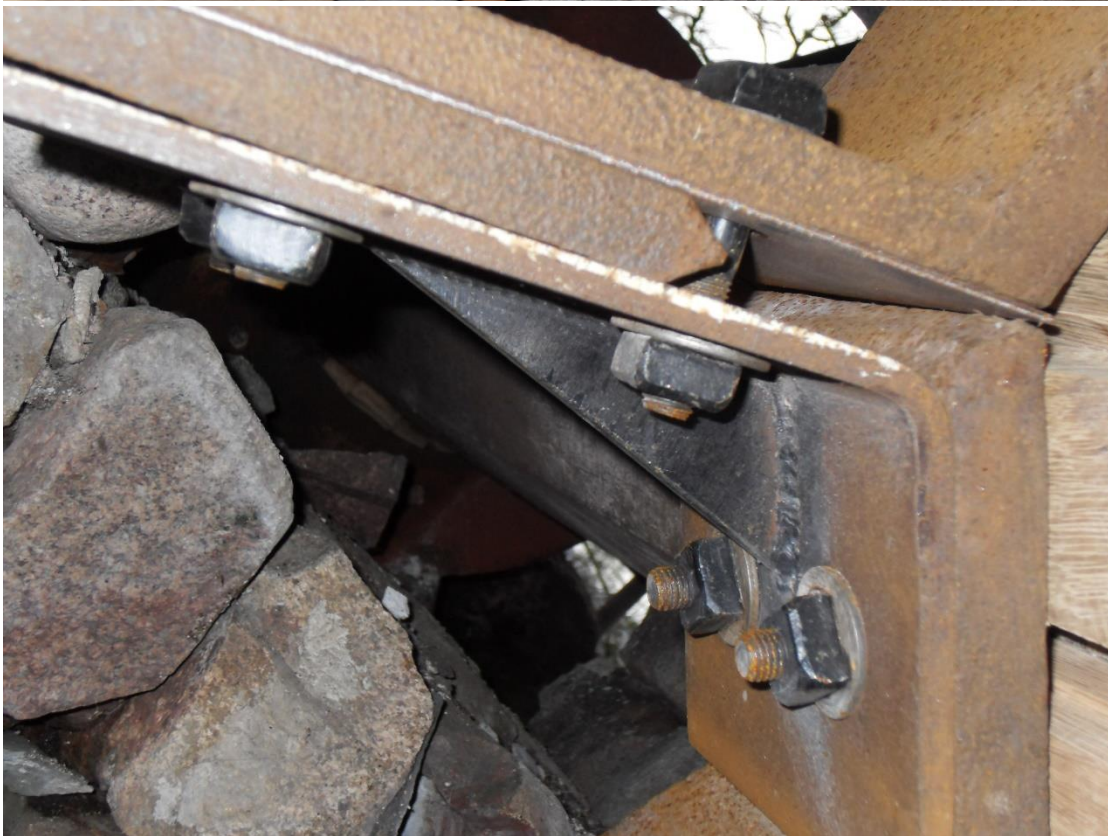
16. The pit gear in the lower part of the mill has now been securely fitted to the waterwheel shaft. Like the waterwheel, oak wedges have been made to fit between the casting and the hexagonal shaft. New square-head fixings have been made especially to bolt the two halves of gear together. However, the metal repair section that was made to repair a broken section of the gear was found not to be strong enough for the job. The millwrights have carried out the extra work of re-inforcing the repair section with a fillet of metal welded to it.

16a and b A repair section after being strengthened by the millwrights.

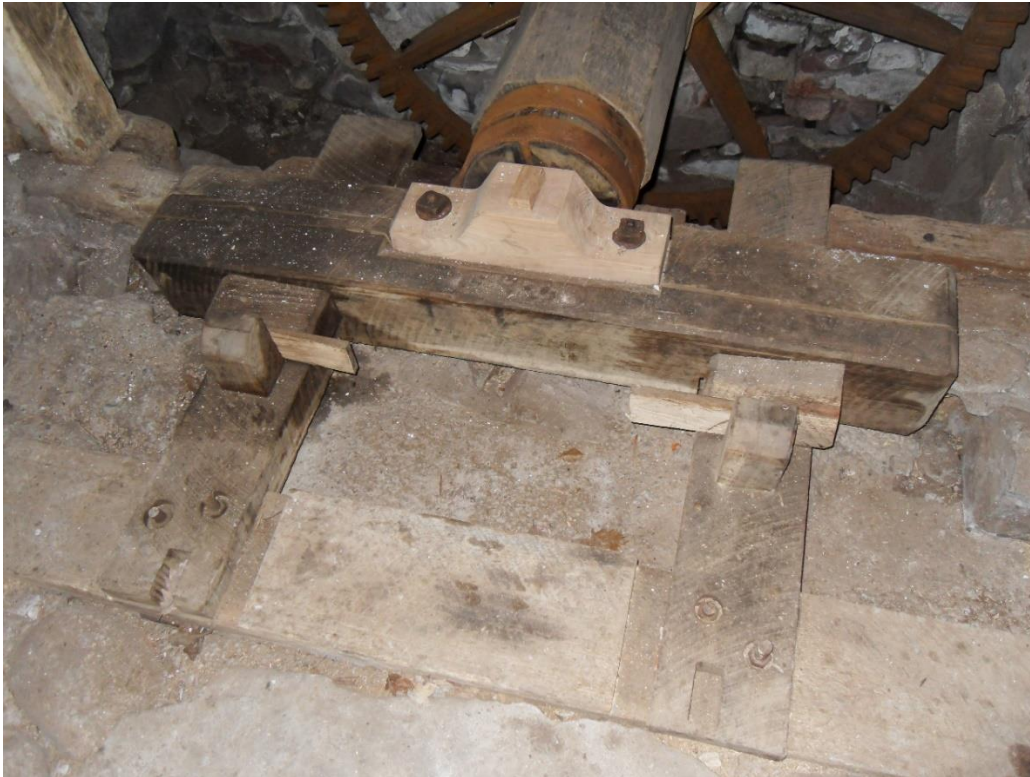
17a The cleaned bearing and new cover.

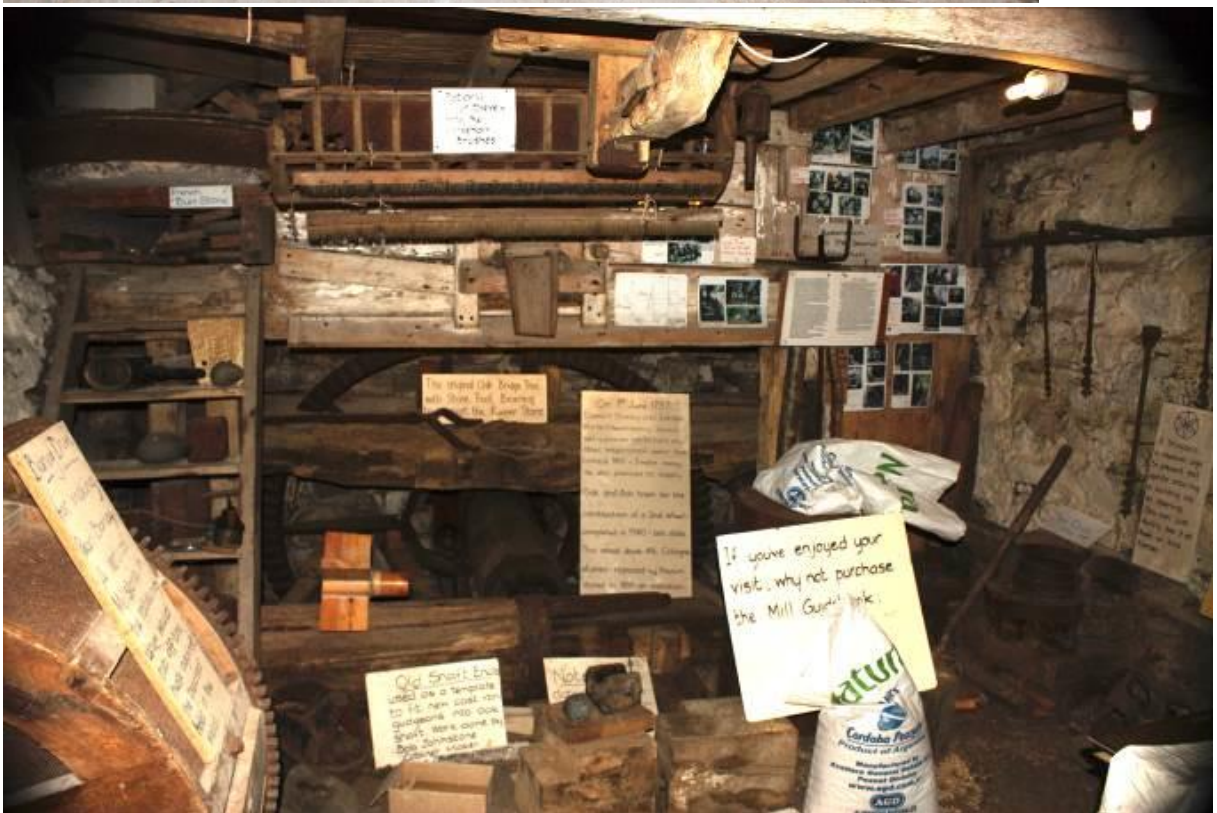
17. The lower hurst frame has been thoroughly cleaned of years of dirt, grime, grain and rodent faeces. Unnecessary and incorrect wedges and pieces of timber have been removed. Suitable replacements have been found and fitted to secure the inner waterwheel bearing timbers. The rotten bridge tree has been removed for a new one to be made by the main site contractor.

17b Before the restoration, the machinery was hardly visible.

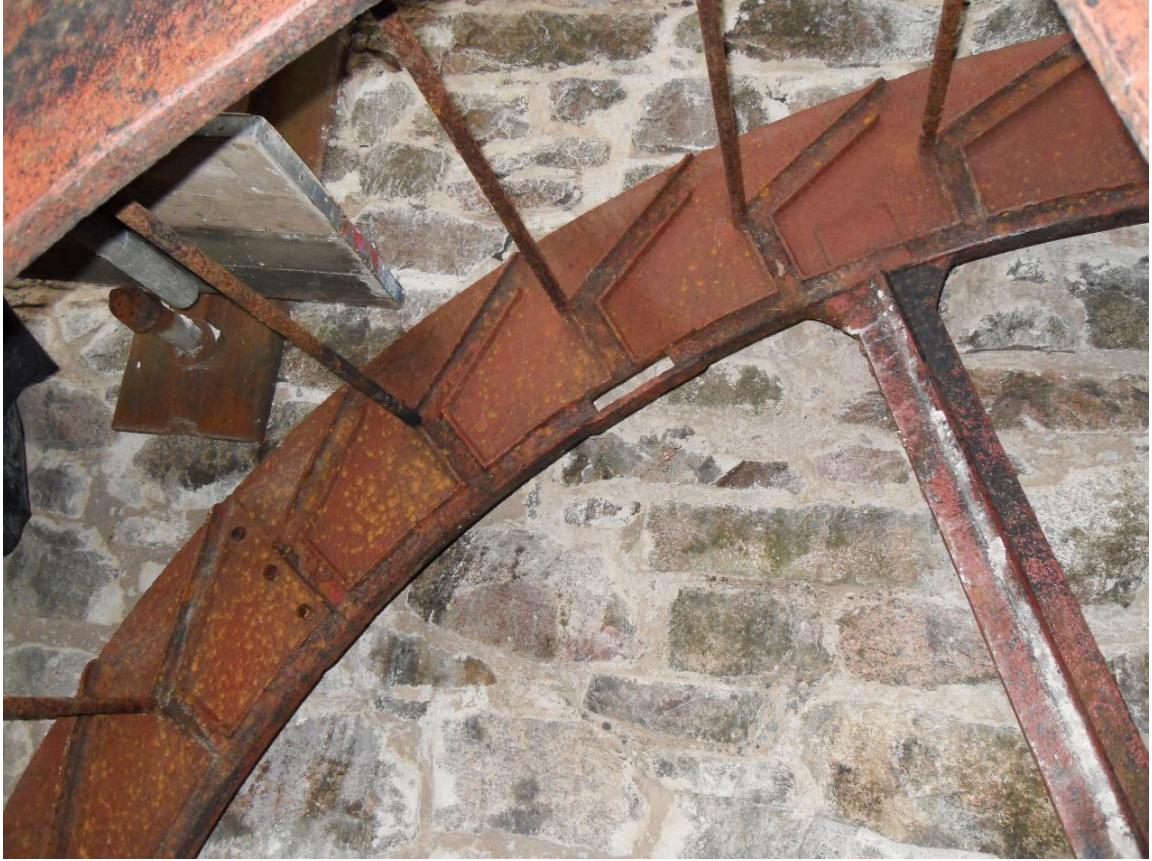
18. The lower mill French burr stones have been cleaned and inspected ready for re-dressing of the furrows.
19. The lower waterwheel has been stripped of the rotten timber buckets and sole boards, cleaned and is waiting to be re-built with new larch timber when it has been supplied to site. The metal tie rods have had their protruding ends trimmed to a safe size, which is more aesthetic and is how they would have originally been made.

19 Lower waterwheel after rotten timber removal and metal work clean.

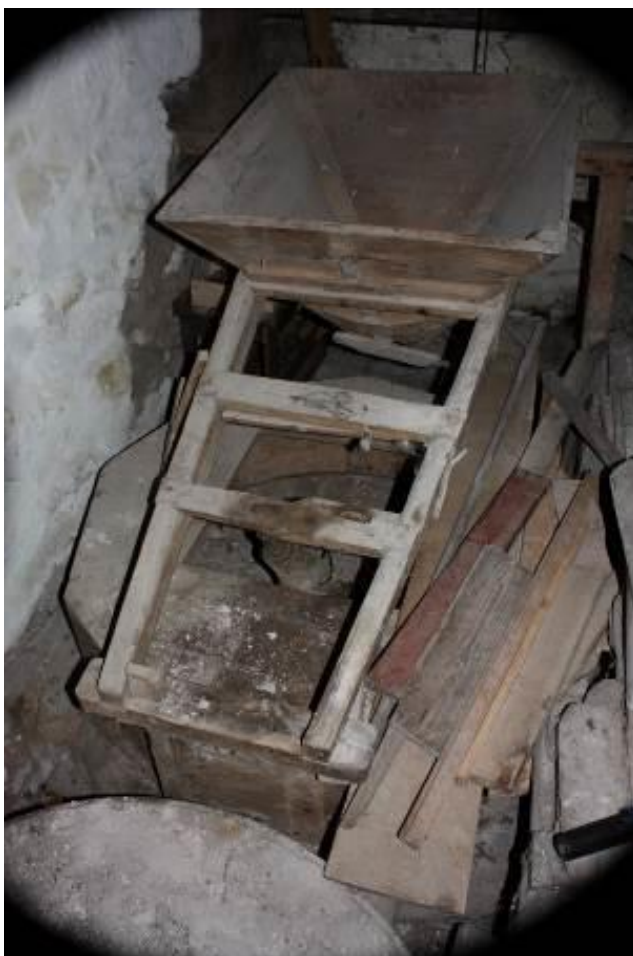
20. Work to the millstone furniture of the lower mill is nearly 50% complete. The majority of the work will be done in the millwright's workshop. New parts have to be made to replicate the remnants of the old furniture which cannot be repaired and the tun casing repaired and upgraded to meet local environmental health regulations for food produced by the millstones.

20 An example of the lower millstone furniture before millwright work
