Eskdale Mill Works Conservation Building Contract

Progress report – December 2018 to June 2019

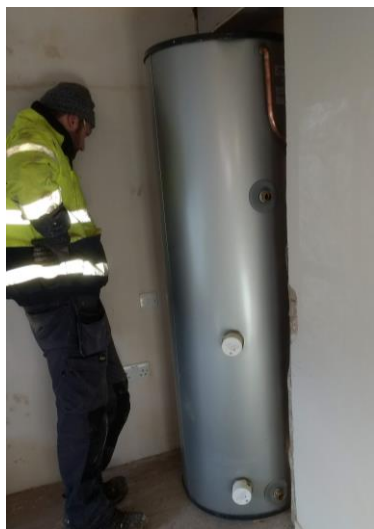
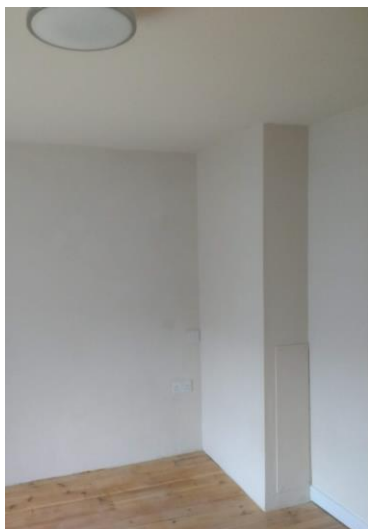
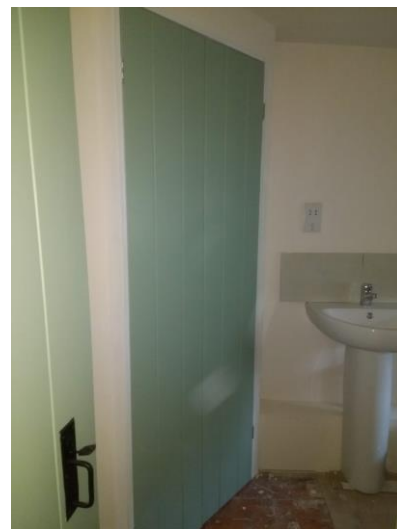
Left hand side image: position of hot water cylinder on 8th January 2019. Central image: view of the hot water cylinder cupboard from the western bedroom on 24th January 2019. Right hand side image: view of the hot water cylinder cupboard from bathroom on 24th January 2019

The bathroom layout had to be slightly revised to accommodate the new hot water cylinder, which was installed between the western bedroom and the bathroom. The minimum space required was taken from the bedroom and the new tank was surrounded by insulation to provide an acoustic barrier.

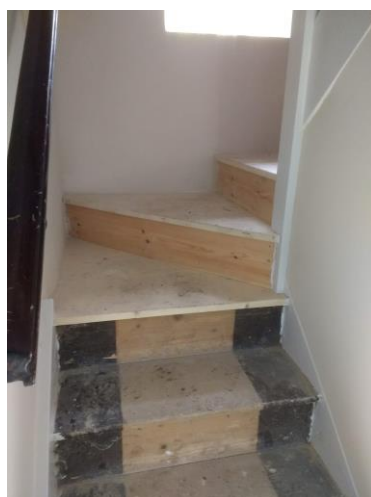
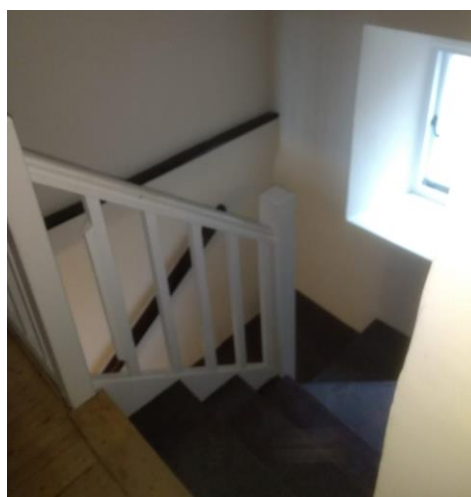
Left hand side image: staircase on 24th January 2019. Right hand side image: staircase on 1st March 2019

The staircase layout was modified as per Development Stage design, to provide wider treads (facilitating the access to the first floor) and to enable the incorporation of thermal insulation to the wall in the future.

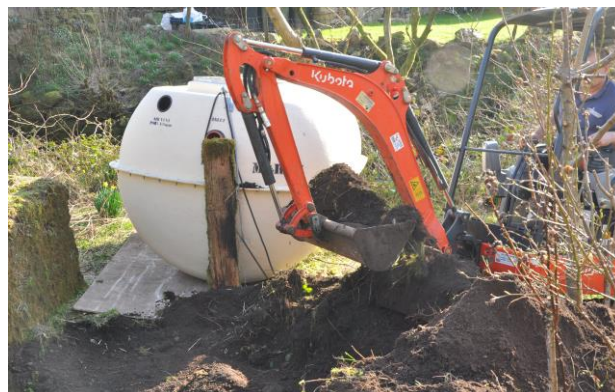
Image of the new sewage treatment plant being installed on 25th February 2019

The existing septic tank was replaced with a proprietary sewage treatment plant. The redundant septic tank was retained as a primary tank for the new system.

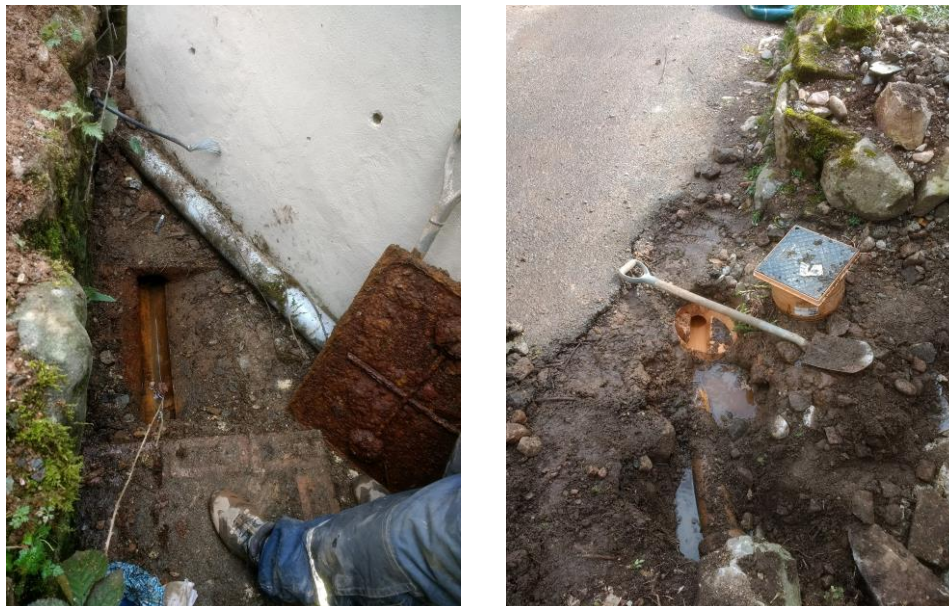
Image of foul drainage arrangement behind the outbuilding on 14th March 2019

When this connection was undertaken, a leak from groundwater into the foul system was detected by the main contractor. The specialist contractor (Mennie Services Ltd) undertook a camera inspection in April 2019 and advised the following:

- A section of foul drain behind the outbuilding required CIPP structural bridge lining techniques to be undertaken to seal the leaks.
- A redundant gully behind the outbuilding required sealing off.

These works were successfully undertaken and both drainage systems (foul and surface/ground water) are now separate and working properly.

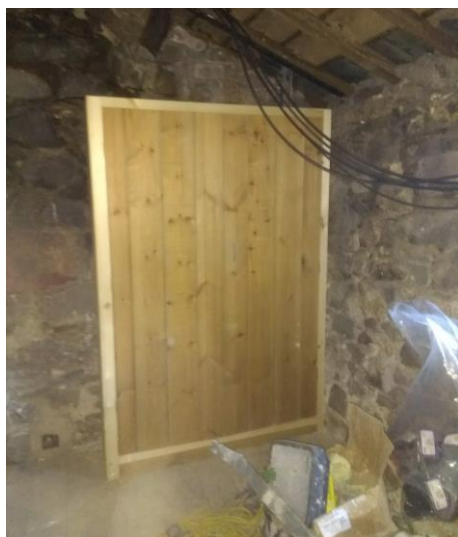
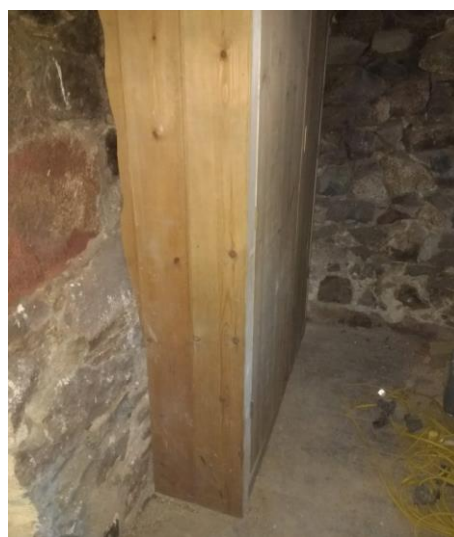
Images taken on 8th January 2019

The existing distribution board was located in the peat store and it used to suffer from damp related issues during the wet months of the year. It was agreed that a better position for the distribution board would be in the Drying Room and this change was included in Architect's Instruction no. 14. This new location also allowed for centralising the light switches, which are now protected inside a cupboard accessed only by the mill manager and volunteers.

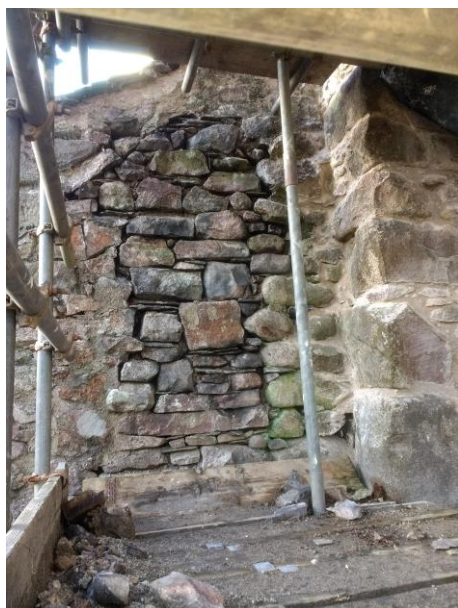
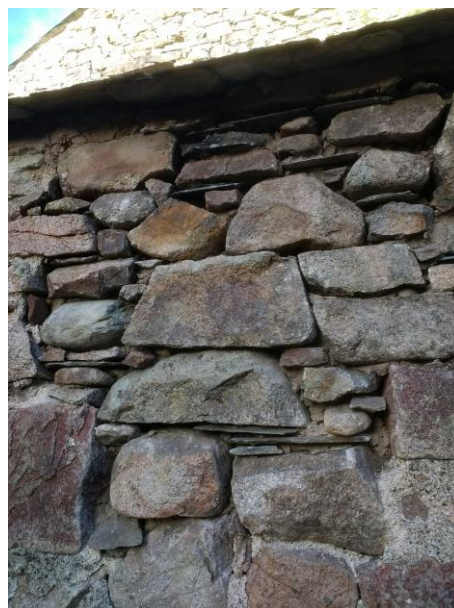
Rebuilding of 2 sections of the bakehouse walls was required to ensure the stability of the building. Works to the bulge to the south elevation had already been included during the Development Stage. Structural issues to a section of the east wall were discovered from the scaffold and rebuilding works were incorporated in Architect's Instruction no. 21 – Rev 1.

Left hand side image: rebuilt section of eastern wall to bakehouse. Right hand side image: rebuilt section to south wall to bakehouse. Both images were taken on 8th January 2019

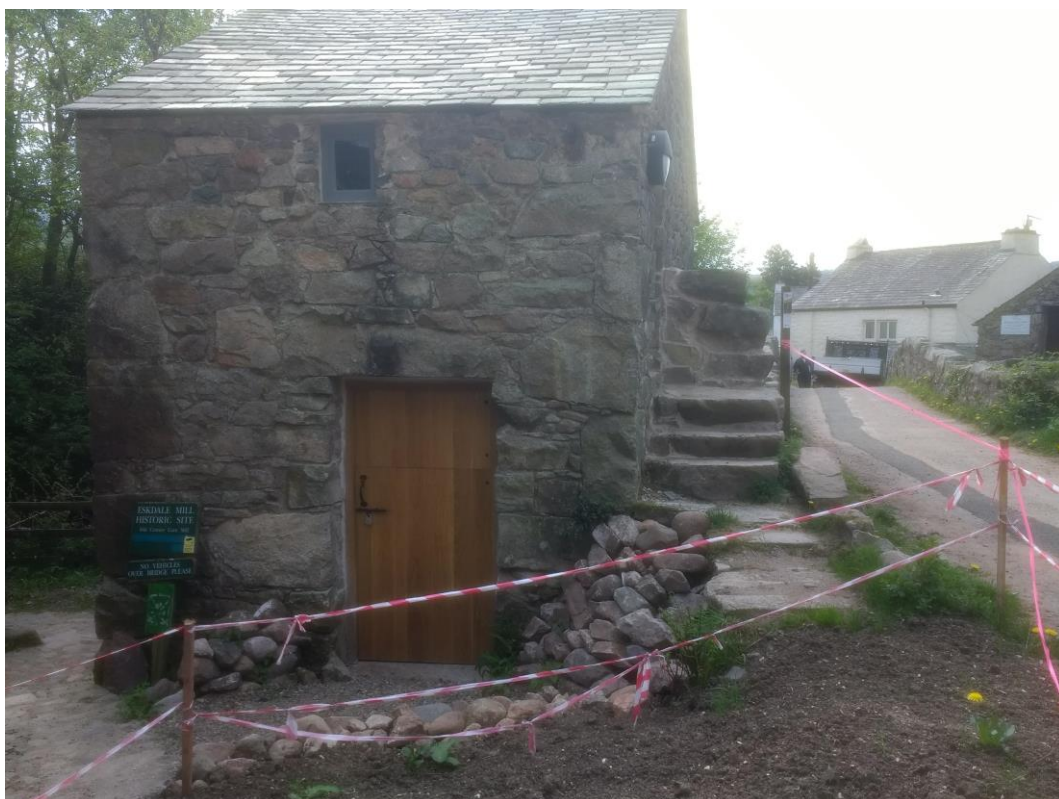
Image of the stable / hayloft on 24th April 2019

Masonry works to re-set the external steps up to the hayloft and their parapet wall were undertaken to provide a safe access.

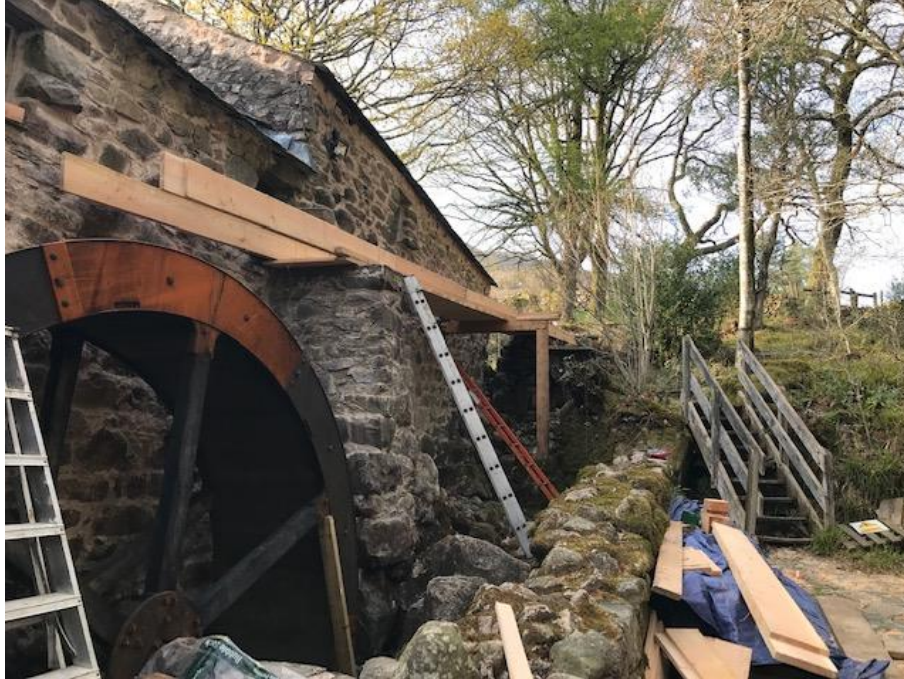
Image of launder works on 16th April 2019

Ian Smith was the appointed contractor to rebuild the launder trough and the launder gates to operate the waterwheels.

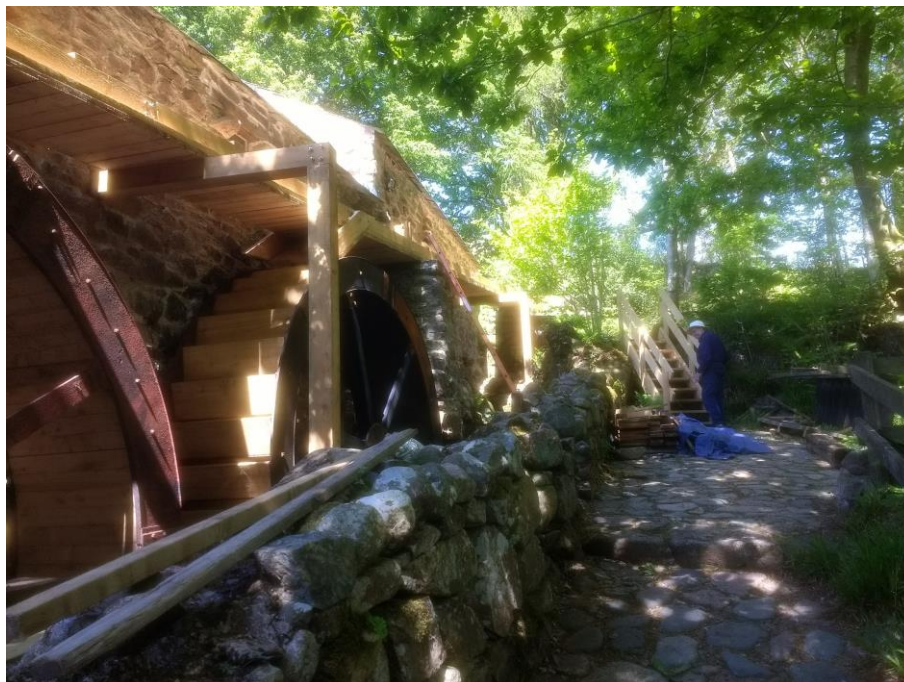
Image of finished launder on 15th May 2019

The operating mechanisms and the internal peg board were fine-tuned by the Millwright contractor. They also included an overspill to the side of the launder to protect the building from splashing water.

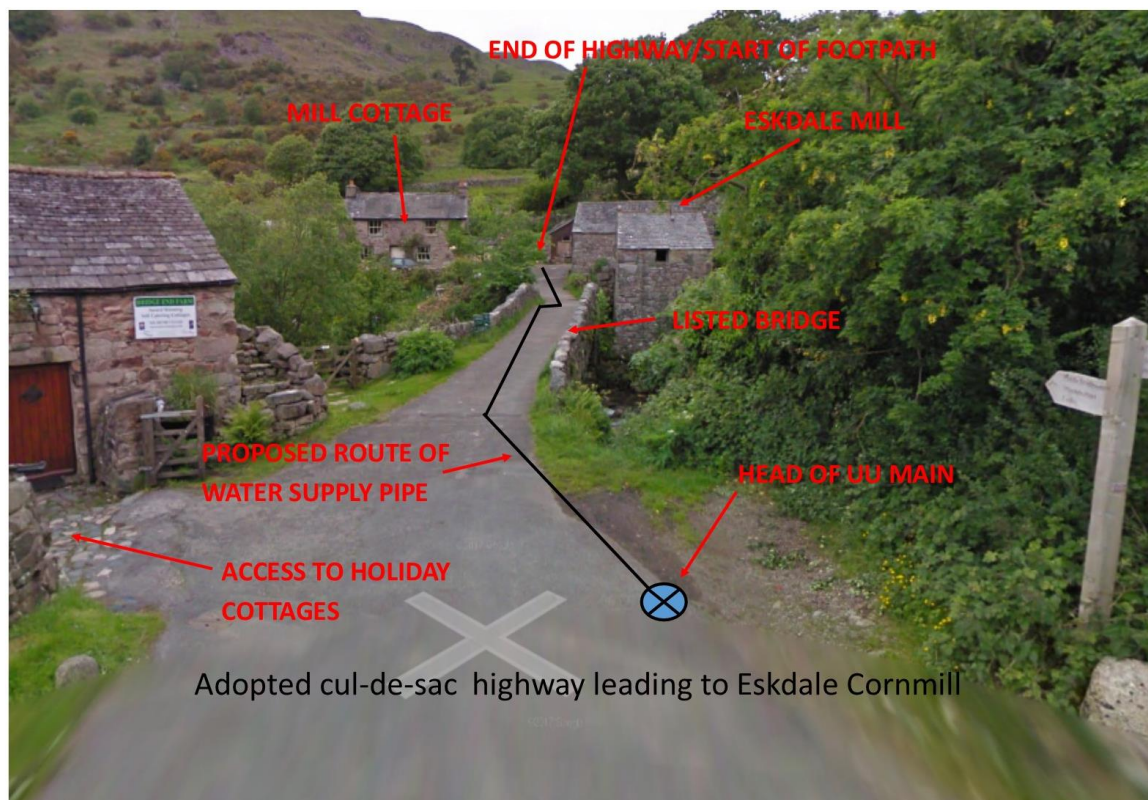
The mains supply provided by United Utilities finishes some 10m south of the bridge. Due to the presence of bedrock very close to the ground, an insulated service pipe was proposed from this point to serve the cottage and the cart shed. This pipe includes an electric element, controlled by a thermostat to only provide heat to the pipe when the temperature of the ground reaches minus 3 degrees C. A private water meter has been installed in the outbuilding of the cottage for billing purposes.

Route of water supply pipe from the head of United Utilities main up to the Mill and the Cottage

The work was undertaken by Ashcrofts Plant Cumbria Ltd during early April. This was undertaken under licence from Cumbria County Council as the road over the bridge is a public highway. The water supply was finally connected by United Utilities in early May and this was followed by commissioning of all the appliances, hot water cylinder etc.
