# ESKDALE CORN MILL MACHINERY REPAIR EVALUATION

July 2019

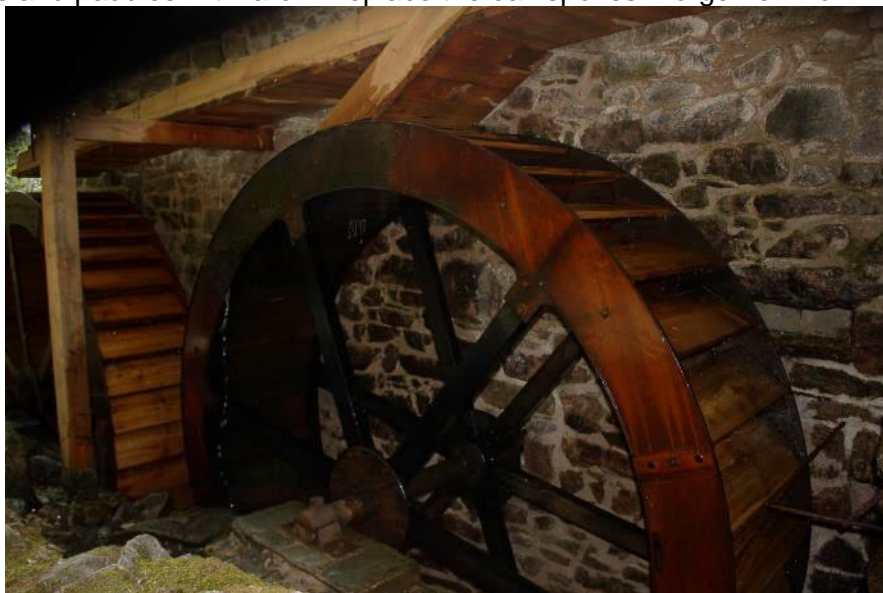
#### 1. Upstream Waterwheel

The upstream waterwheel has been completed to a high standard and to enable its continued use has had some new shroud plates cast from iron to replace brittle parts that could have failed over time. These parts will blend in very well and have a subtle date mark cast onto them. The new larch wood fits perfectly and the wheel works well.

Works completed: Replace the bronze wheelshaft bearings. Replace six cast iron shrouds. Replace the sole boards, backboards and paddles with larch. Replace the oak spokes. Forge new iron fixings.

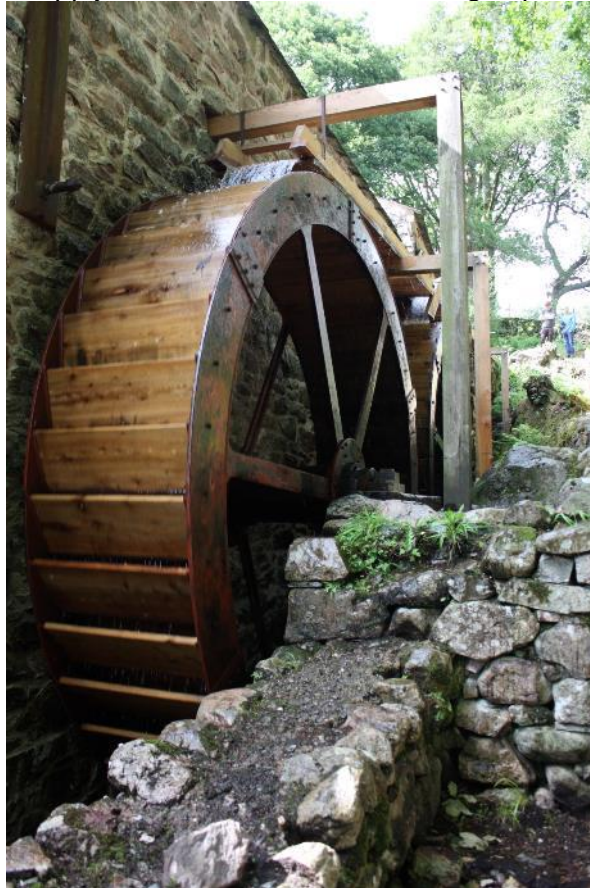
## 2. Downstream Waterwheel

The repair to the lower waterwheel is fantastic and to a very high standard. This wheel has not been properly used for a century but is now visually and mechanically stunning.

Works completed: Replace the sole boards, backboards and paddles with larch. Replace the oak wedges securing the wheel to the shaft. Supply new inner and outer bearing caps.

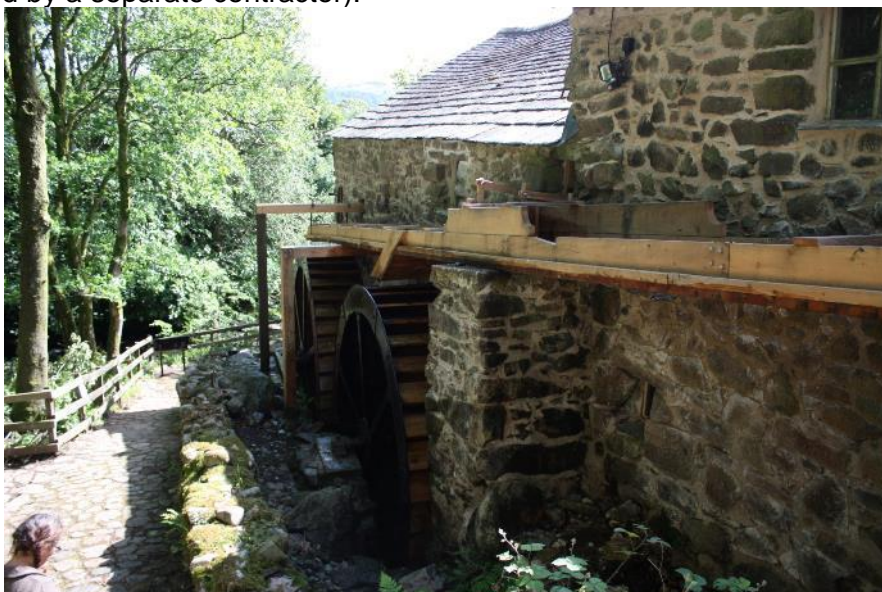
## 3. Launder

The new larch wood launder (above) was much needed and completed to a good standard and used a design tried and tested to overcome some shortfalls of the previous launder installed by Cumbria County Council over 3 decades ago. It now provides water to both working waterwheels with a new sluice gate arrangement designed to provide safe use of the machinery by staff and volunteers.

Works completed: Rebuild and adapt the water controls in the launder and install supports and details (launder constructed by a separate contractor).

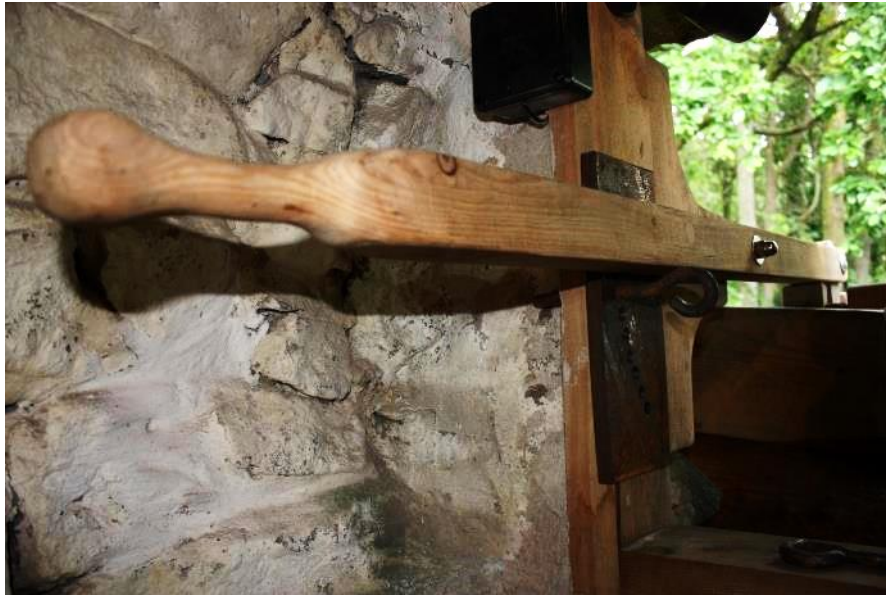
Janes Ltd, Millwrights made the necessary improvements to the new sluice gate arrangement. Their expertise and experience were put to good use once the renovated machinery was turning and they saw some changes were necessary. Above picture shows how they manufactured a sluice gate lever peg board from old parts of the waterwheel castings to give the operator accurate control of the water flow, again to a high standard.

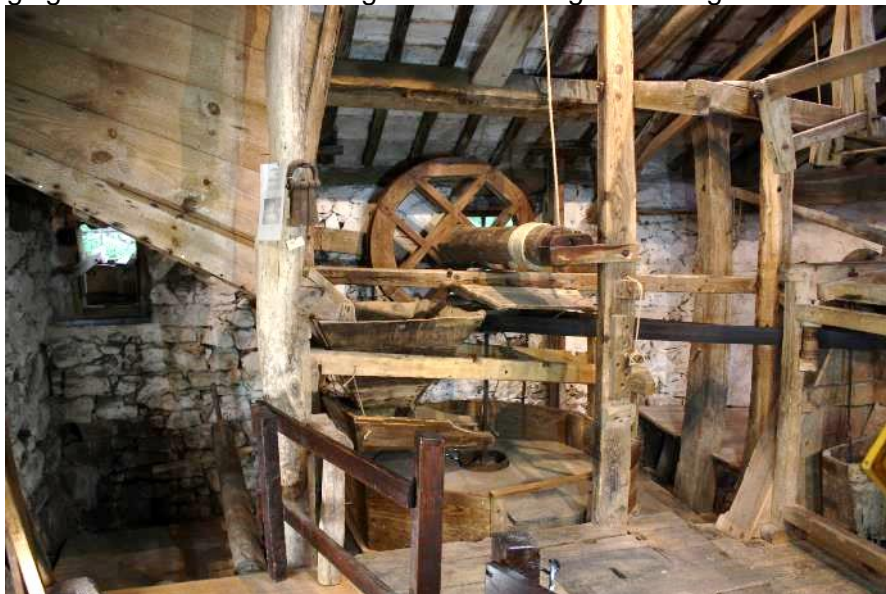
### 3. Upstream Machinery

To a first time visitor, the machinery of the upstream part of the mill may not look like it has had a lot of work done to it. But that is part of the point of the millwright's work. It retains the charm that made this mill special, but it is now very clean, safe and functional and had lots of work sympathetically carried out.

In addition to the mechanical and wooden parts overhauled are the additions of battens across the tun case above the rotating millstone. I suggested this to provide an extra potential safety barrier as it is expected more volunteers of different ages and abilities to be trained to run the mill.

Works completed: Raise the runner stone and clean the stones. Replace the timber bearings in the bed stone. Repair the kiln chute and hopper. Repair the tun and shoe. Re-construct the millstone furniture. Install a new crook string. Overhaul the stone drive. Supply and fit new hornbeam cogs in the stone nut. Refix the stone drive disengaging arm. Overhaul the bridge box. Re-wedge the bridge tree.

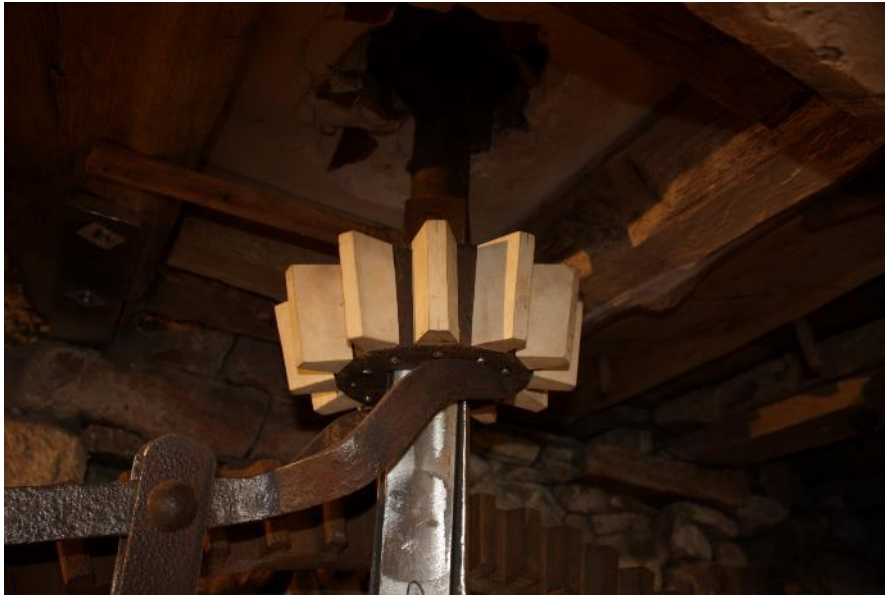
Pictured above is a re-cogged stone nut and re-instated disengagement lever with new wooden bearings hidden above inside the bedstone.

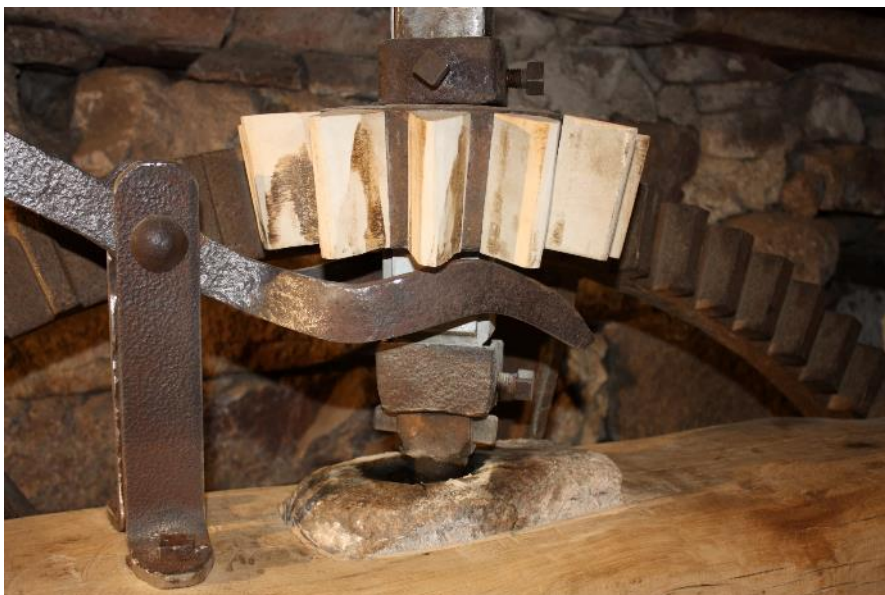
#### 4. Downstream Machinery

The machinery to the downstream part of the mill building has undergone major refurbishment. Parts of the machinery that were with the mill but not in place when restoration started were found to not fit. After 40 years of thinking these were from this mill some of them may have been salvaged from other nearby mills as they closed. We know that the downstream machinery hasn't operated since the 1930's and may have needed new parts. The millwrights came across issues with the mis-matched parts but made a suitable plan to adapt them and spent the extra time to make them work flawlessly. Pictured above is a rare stone foot bearing supporting the millstone spindle. It is fitted into a new bridge tree that the main site contractor supplied and finished off by the millwrights to make it fit in with the ancient woodwork surrounding it.

Works completed: Level, repair and re-dress the millstones. Replace the timber bearings in the bed stone. Repair, rebuild and fit the pit wheel. Replace a section of the curb around the millstone. Rework the new bridge tree. Refit the stone bearing in the new bridge tree (bridge tree supplied by the Main Contractor). Re-construct the stone drive. Supply and fit new hornbeam cogs in the stone nut. Re-wedge the bridge tree. Refit the runner stone. Repair the tun, horse, hopper and damsel. Construct a new shoe. Install a new crook string.

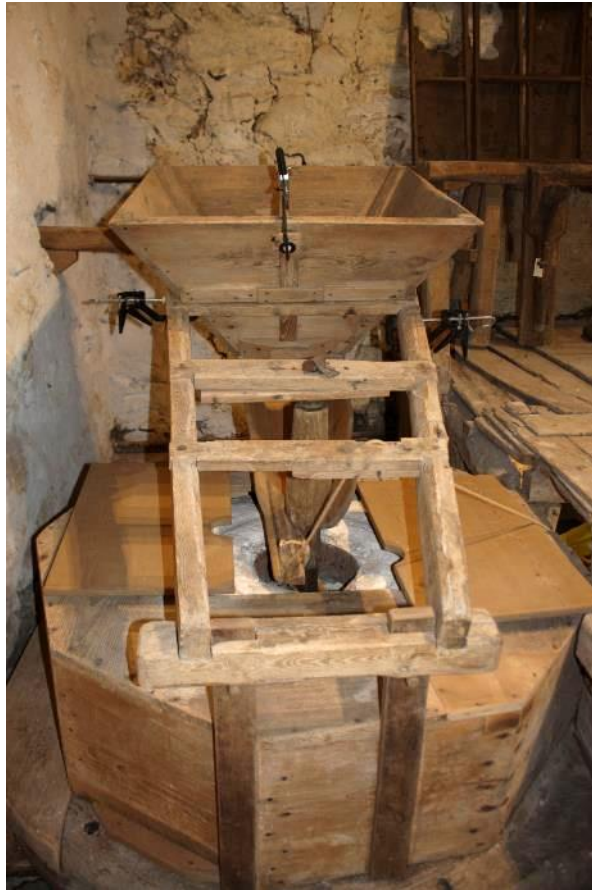
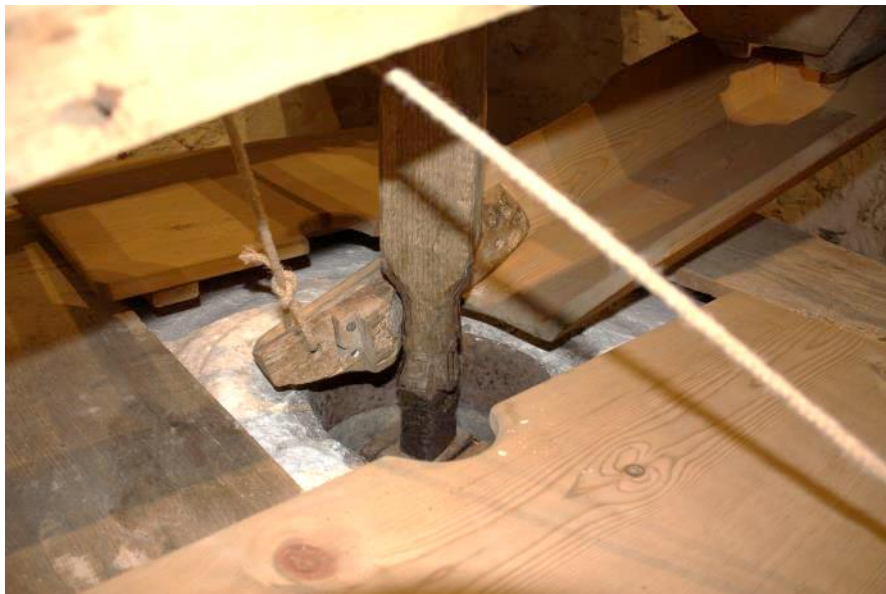
Above and below are details of the re-built tun casing and mill furniture that provides an opportunity for the milling process to be demonstrated and is designed to be cleaned out to negate the risk of contamination by rodents or insects.

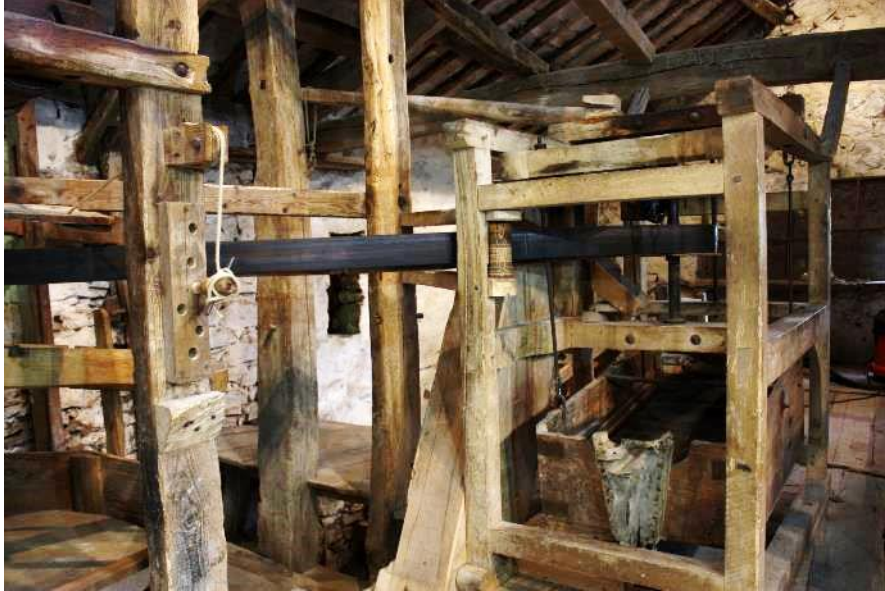
## 5. Jog-Scry

The millwrights have showed their multi-skilled talents by producing replacement iron mongery to match the traditional fixtures and fittings on the jog scry. The parts cannot be bought new and have to be hand made specifically for this setup. It is now in working order and will operate when the millstones are turned and can be easily viewed and heard by the visitor.

Works completed: Clean and repair the jog scry. Repair the support rods and eyes. Reinstall the drive belt.

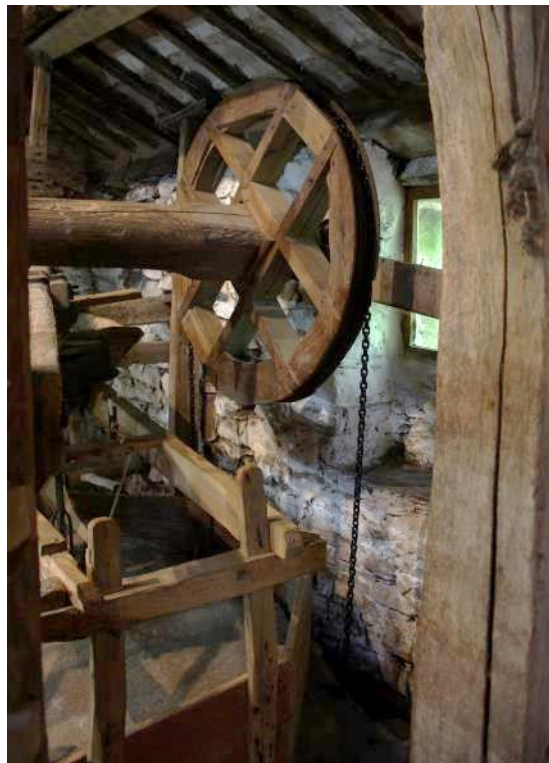
## 6. Sack Hoist

Again, work is finished to a high standard but not at first obvious to the eye, the sack hoist is now safe and secure with new rope and chain, whilst new wooden wedges secure it to the waterwheel shaft. The sack hoist is sure to be a popular feature as it can be demonstrated live to the public pulling sacks of grain through the trap doors in the floor.

Works completed: Replace the wedges securing the drive drum to the wheelshaft. Overhaul the sack hoist components. Supply and fit a new drive chain. Replace the operating cord and sack rope. Provide new hardwood toggles.

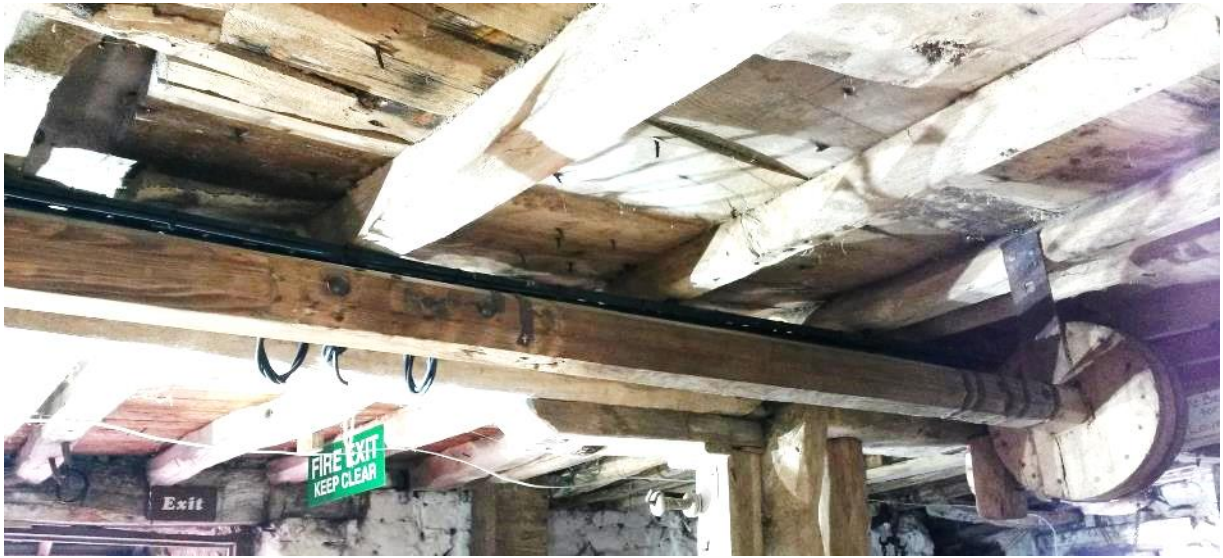
## 8. Overhead layshaft

Now a live working part of the mill, the millwrights have demonstrated their capable skills in woodworking and engineering to provide a overhead layshaft belt driven from the waterwheel.

Works completed: Splice a new section of timber into the shaft. Supply and fit a reclaimed journal. Make and fit a new collar. Refit the layshaft in the bearings and reinstall the layshaft drive.

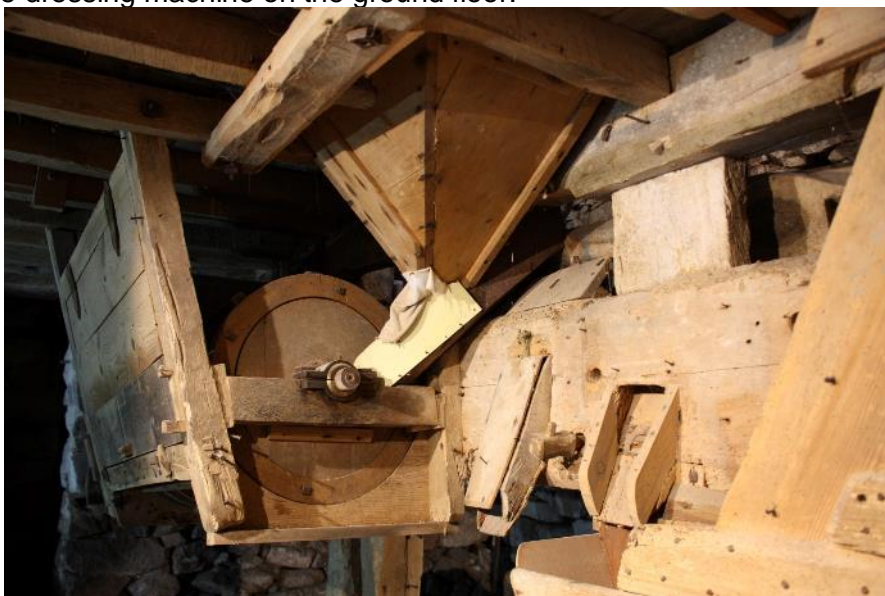
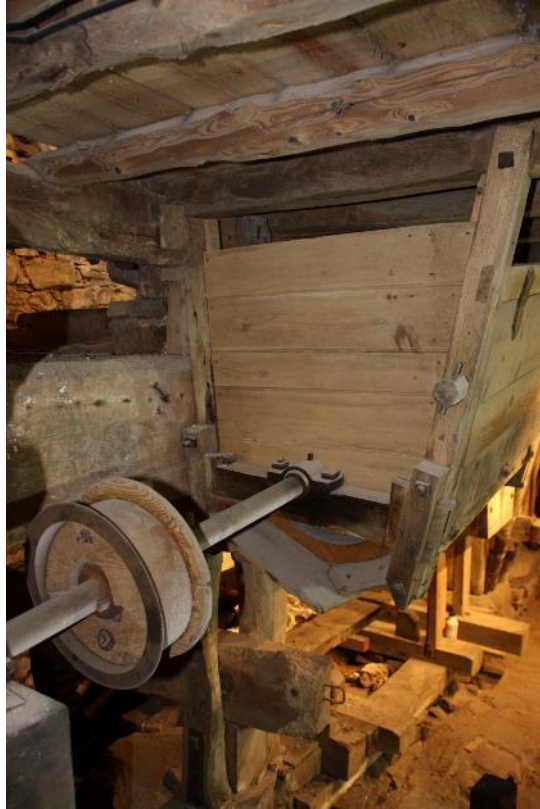
## 9. Dressing Machine

The dressing machine has been thoroughly cleaned and the woodwork made secure whilst the bearings have been cleaned and lubricated. Originally expected to have a new drive belt system turning this, again we have been unfortunate to find the parts of the mill thought to be original and just need refitting were not up to the task. Some could not be refitted without extensive alterations as parts of the mill have changed over the past 80 years as the use of the mill changed from grinding locally grown oats to generating electricity and then to a museum. However, this could be a task undertaken in the future should funds allow and the current situation gives the opportunity for the machinery to be turned by the hand of the miller.

Clean and repair the dressing machine on the ground floor.
