# ESKDALE MILL, BOOT, CUMBRIA

## Archaeological Photographic Survey

Client:  
Eskdale Mill and Heritage Trust

May 2019

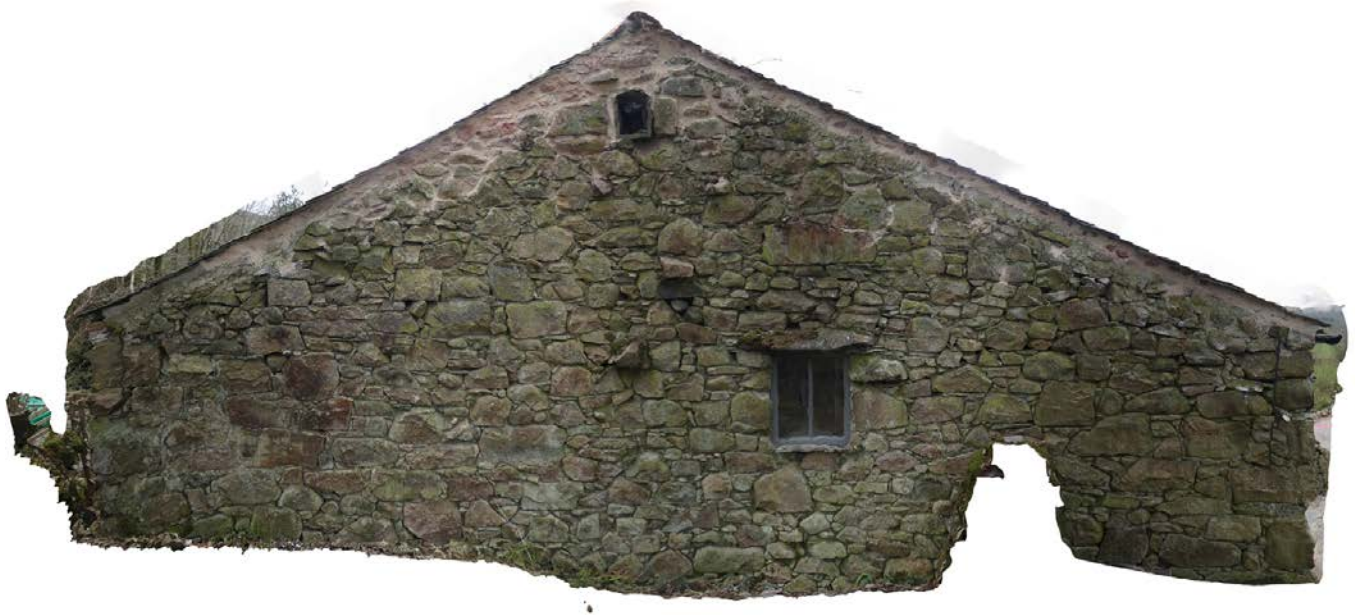
Plate 13: Ortho-rectified view of the main part of the north external elevation of the mill

4.2.1 **North External Elevation – Mill:** the main part of this comprised the wide gable end of the building (Plate 13), but it also included a return off the west elevation (Plate 14).

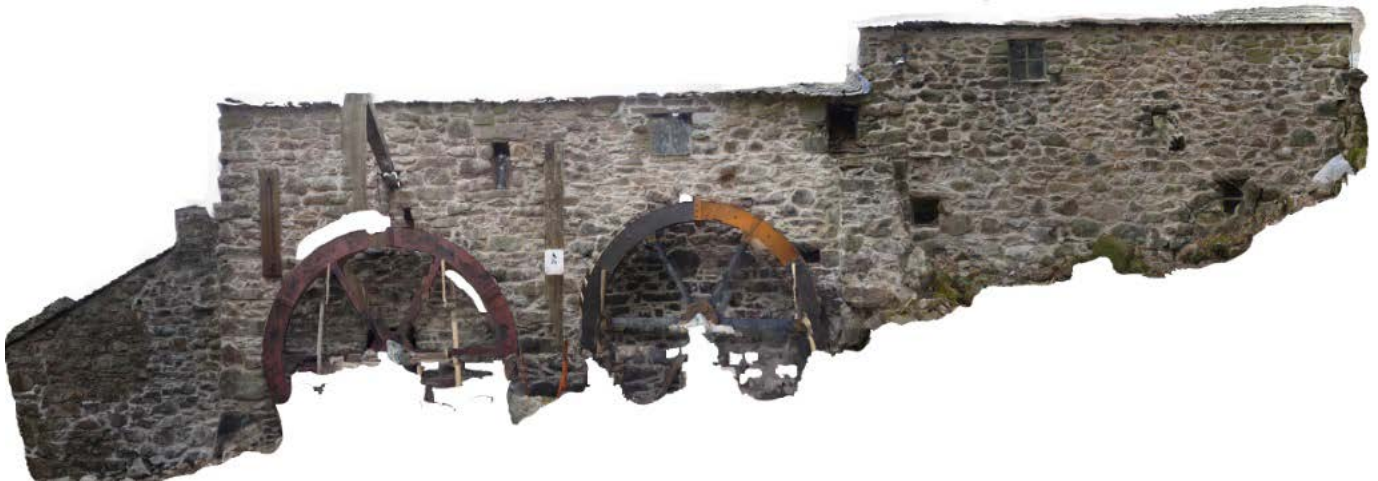
**Plate 15: Ortho-rectified view of the east external elevation of the mill**

**4.2.2 East External Elevation – Mill:** this comprised the whole of the east side of the mill; at the time it was possible to take this photograph (following the removal of the scaffolding) the two water wheels were in place but not the associated launder. As a result, this view is particularly useful in showing the butt joint between the earlier central part of the mill and the later north end and how the north end has been built on top of, and therefore extended, the earlier wall.

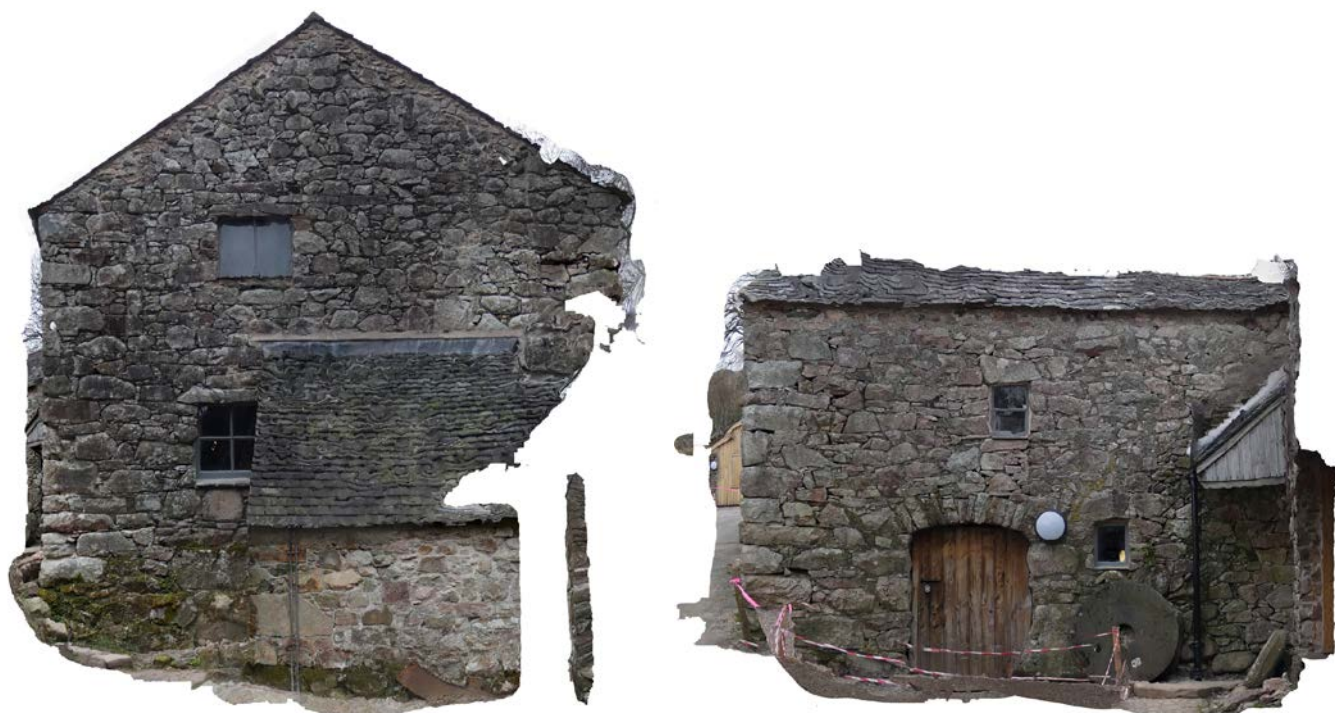
Plate 16 (left): Ortho-rectified view of the main part of the south external elevation of the mill

**4.2.3 South External Elevation – Mill:** this comprised the gabled end of the building, which is partially covered by a monopitch outshut on the east side (Plate 16). It also includes the opposite side of the return from the west elevation (Plate 17).

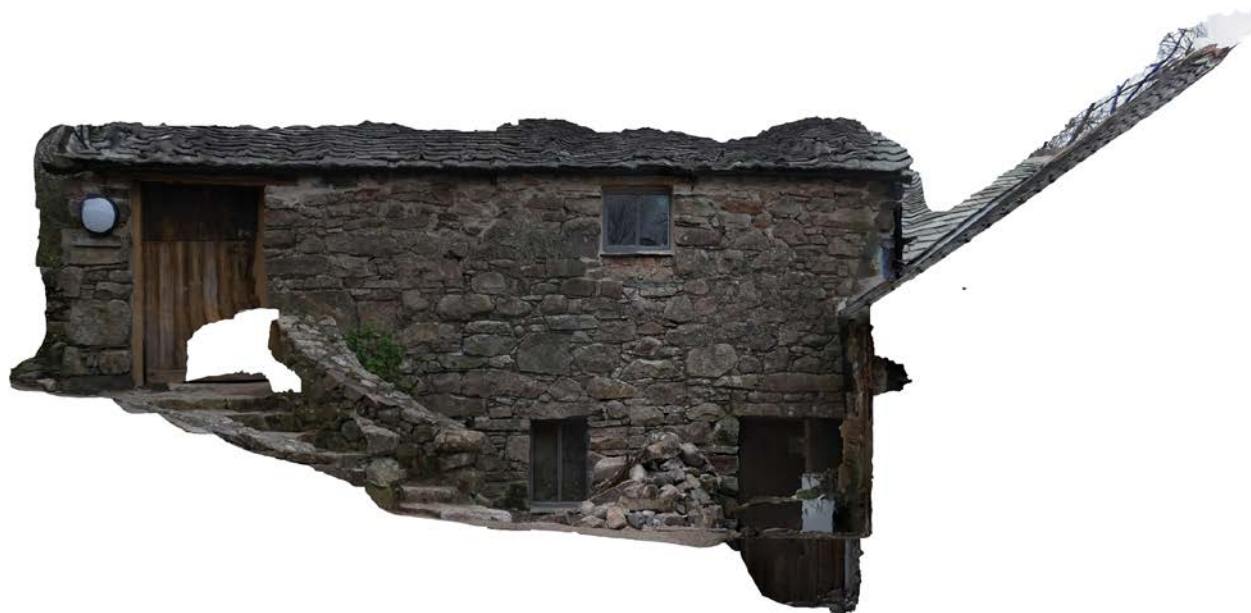
Plate 18: Ortho-rectified view of the north end of the west external elevation of the mill

4.2.4 **West External Elevation – Mill:** this comprised the main part at the north end, stepping up the slope (Plate 18), then the rest beyond the return to the west (Plate 19) and also the front of the small monopitch outshut at the south end (Plate 20).

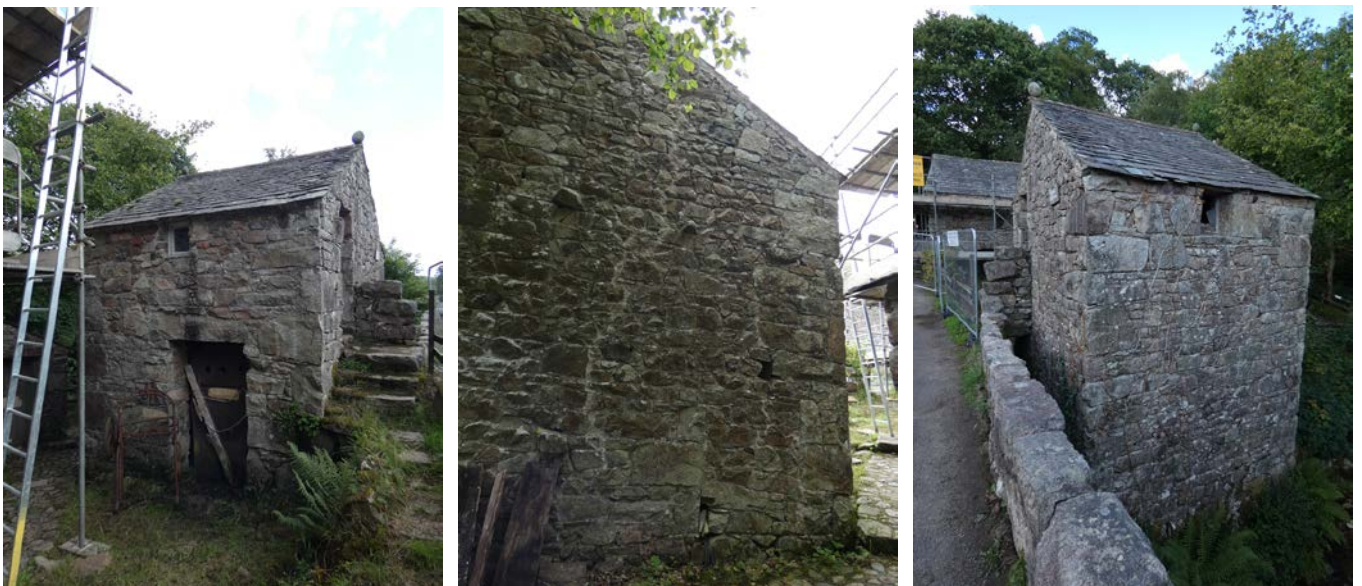
Plate 21 (left): The north and west external elevations of the stable

4.2.5 **Stable – External Elevations:** this was not covered by scaffolding at the time of the photographic survey so it was possible to take additional photographs of all the external elevations (Plate 21 to Plate 23), although these were probably unchanged from the time of the previous building recording. The apparent blocked doorway evident on the north side of the east elevation was the only feature of specific interest.

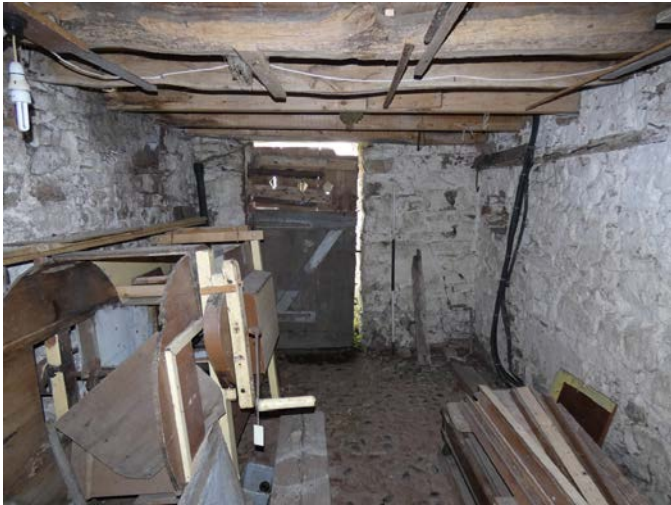
Plate 24: North end of the ground floor interior of the stable

4.2.6 **Stable – Internal:** some brief record photographs were taken of the interior of the stable, although this had presumably also changed very little since the previous building recording and it was somewhat cluttered with pieces of furniture and other objects (Plate 24 to Plate 26). The only real feature of interest was a plank and batten door on the north side of the west elevation at first floor level (Plate 27).

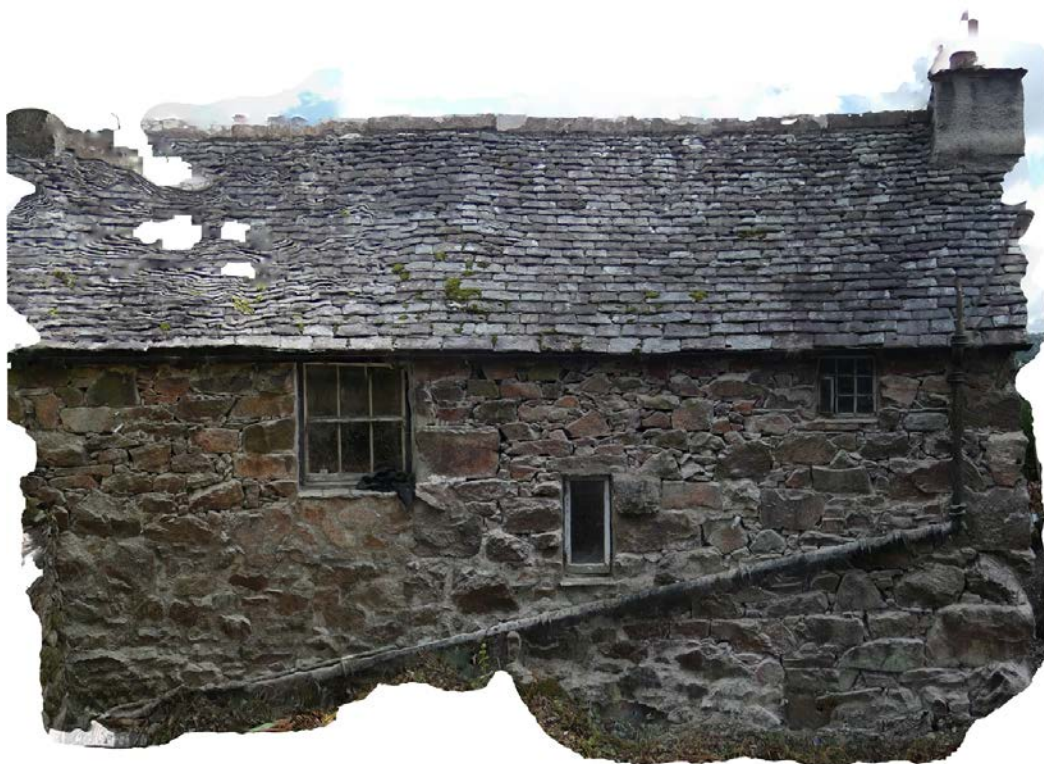
**Plate 28: Ortho-rectified view of the north external elevation of the cottage**

4.2.7 **North External Elevation – Cottage:** given the steep topography it was difficult to get pictures of the whole of the north external elevation of the cottage as it was obscured by the nearby bank. Nevertheless, it was possible to produce an ortho-rectified image of most of the elevation (Plate 28).

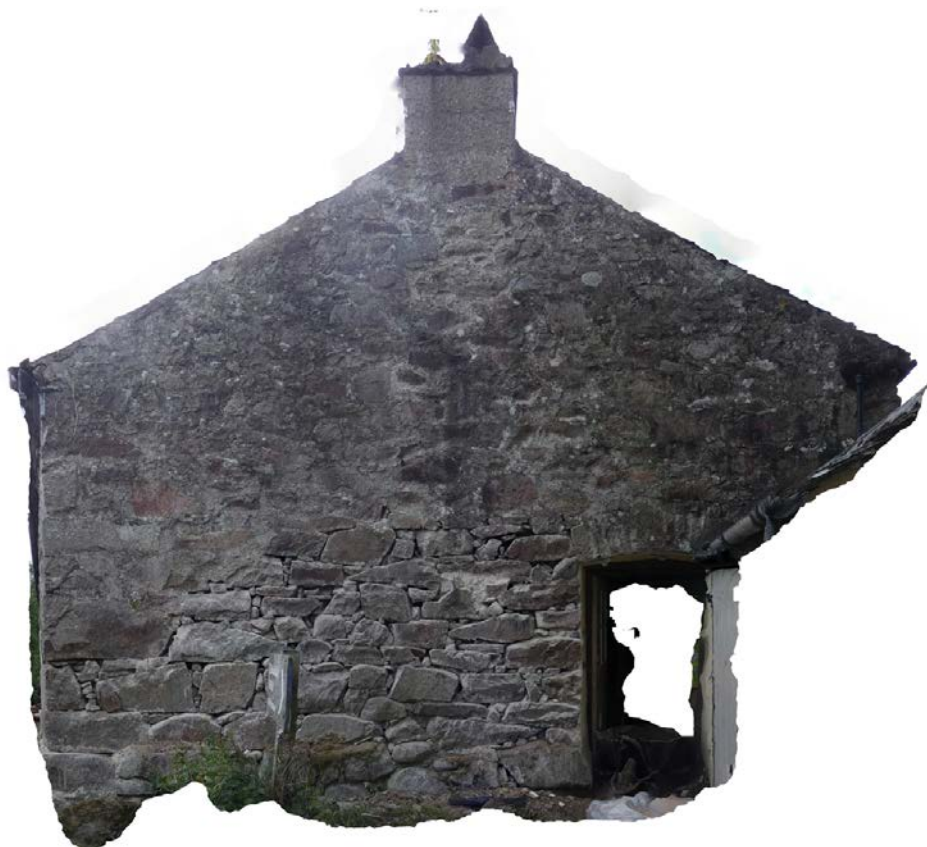
**Plate 29: Ortho-rectified view of the east external elevation of the cottage**

4.2.8 **East External Elevation – Cottage:** again, the topography made it difficult to get enough photographic coverage, although in this case this was primarily because of the attached monopitch outshut on the north side. Otherwise, a full ortho-rectified view of this elevation was obtained ().

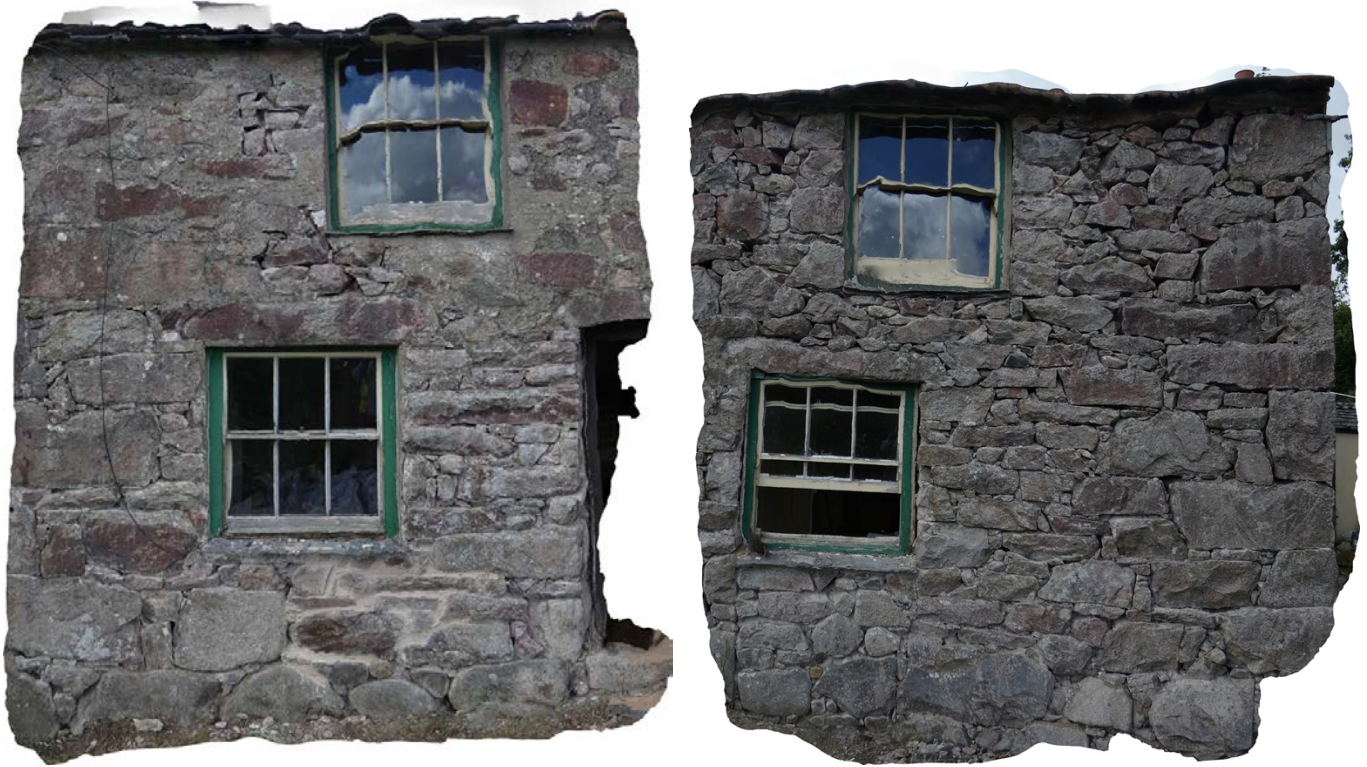
**Plate 30 (left):** Ortho-rectified view of the west side of the south external elevation of the cottage

**4.2.9 South External Elevation – Cottage:** again the topography, with a steep slope behind a boundary wall close to the elevation, made taking suitable photographs difficult and so it was only possible to produce an ortho-rectified elevation in two incomplete parts (Plate 30 and Plate 31). In addition, more general record photographs were also taken. Since the render and pointing had been removed prior to the photographs being taken some additional detail was shown up, principally that the eastern window had originally been a doorway before being partially blocked up.

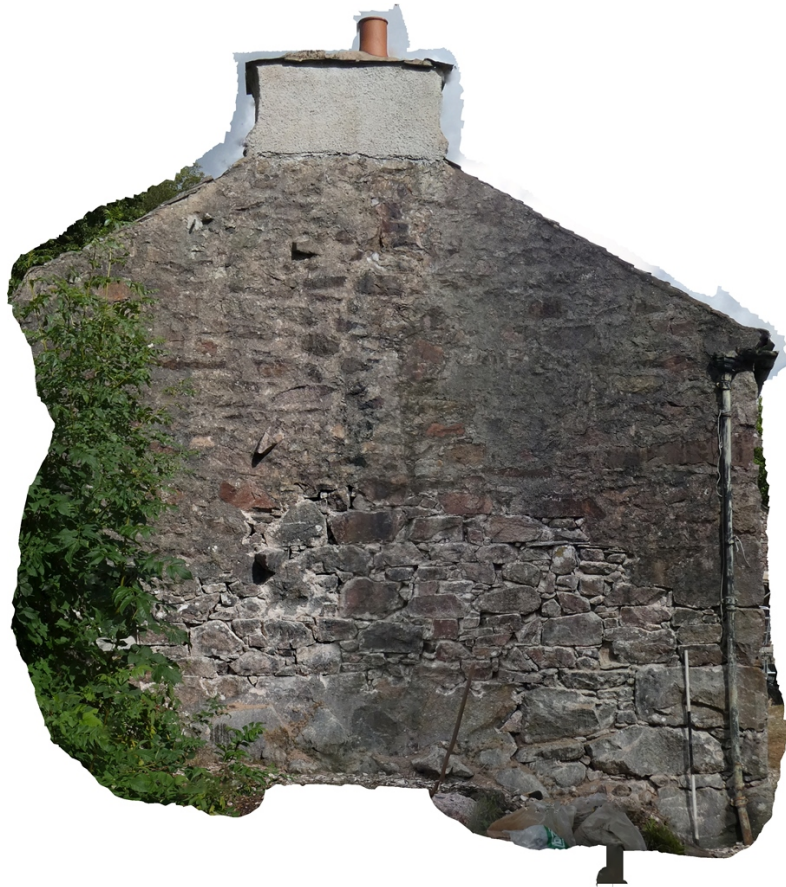
**Plate 33: Ortho-rectified view of the west external elevation of the cottage**

4.2.10 **West External Elevation – Cottage:** again, the topography and the presence of vegetation against the north side meant that getting a complete ortho-rectified view was difficult but it was at least partially possible (Plate 33).

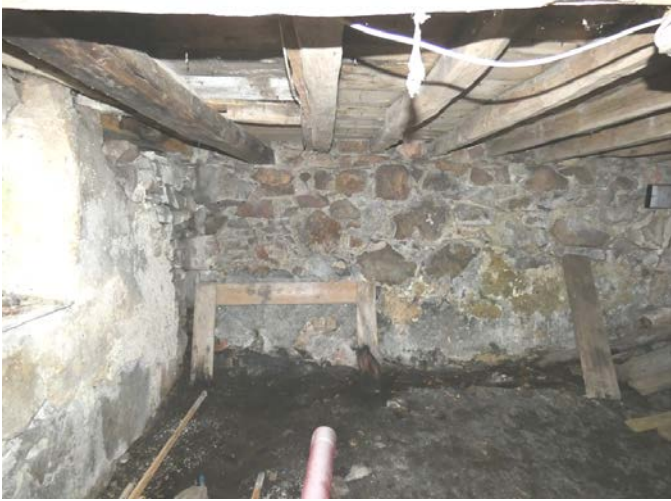
**Plate 34 (left): The west side of the north elevation in Room G1 of the mill**

4.2.11 **Room G1 – Mill:** the presence of large amounts of timber and other material stored in this room and the restricted space meant that producing complete ortho-rectified images of all of the elevations was impossible. Nevertheless, more general record photographs of all of the elevations were taken (Plate 34 to Plate 40) as well as further detailed views of the graffiti date at the entrance to the hearth of the drying kiln on the south-east side of the room (Plate 38); the stone tank in the north-east corner was largely obscured by timber (Plate 36).

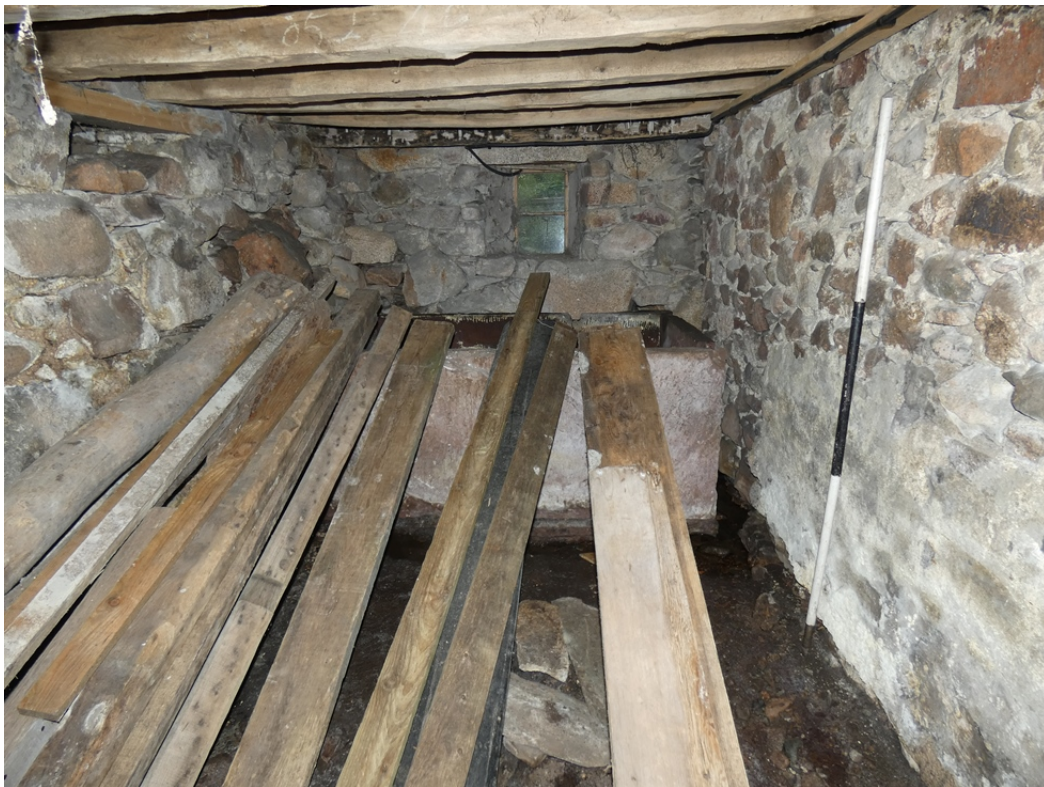
**Plate 36: The stone tank in the north-east corner of Room G1 of the mill**

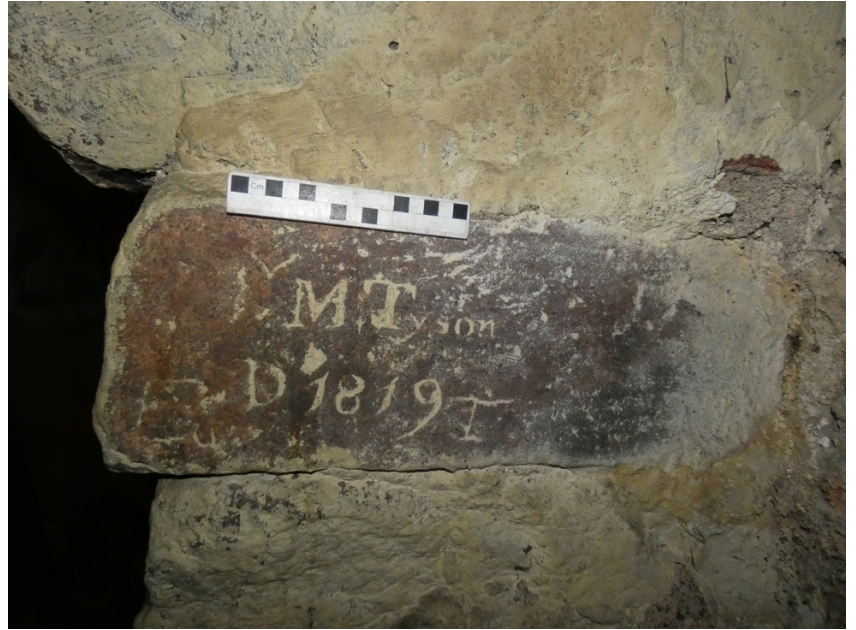
Plate 37 (left): The opening to the hearth of the drying kiln in Room G1 of the mill

Plate 38 (right): Graffiti 'M Tyson D 1819 T' scratched into the west jamb of the opening to the hearth of the drying kiln in Room G1 of the mill

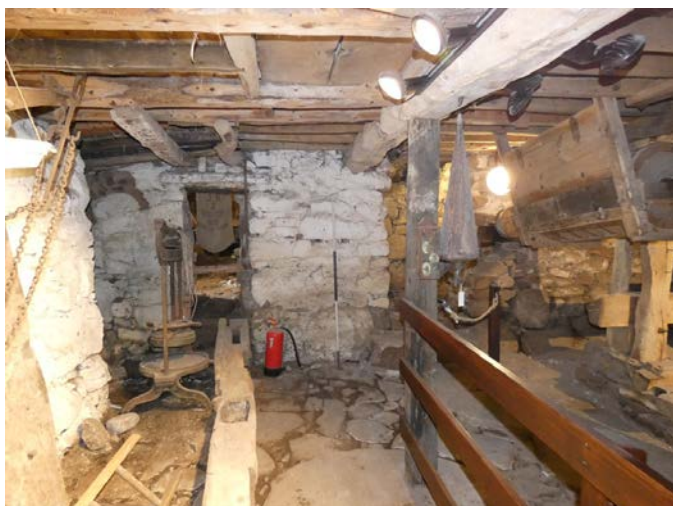
**Plate 41 (left): The north elevation in Room G2 of the mill**

4.2.12 **Room G2 – Mill:** despite having been largely cleared of all loose material it was still difficult to get sufficient photographs of this room to produce complete ortho-rectified images of all of the elevations due to the presence of mill machinery along the east side and the restricted space; these are included in the archive. Nevertheless, general photographs were taken of the whole room (Plate 42 to Plate 47) and the recording also revealed the presence of a Baltic timber mark on the west face of the central beam running north/south (Plate 48).

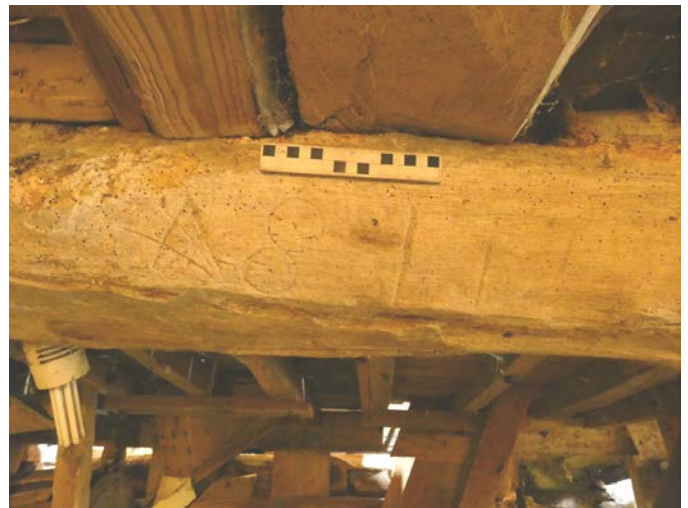
**Plate 48 (right): Baltic mark on the central beam in Room G2 of the mill**

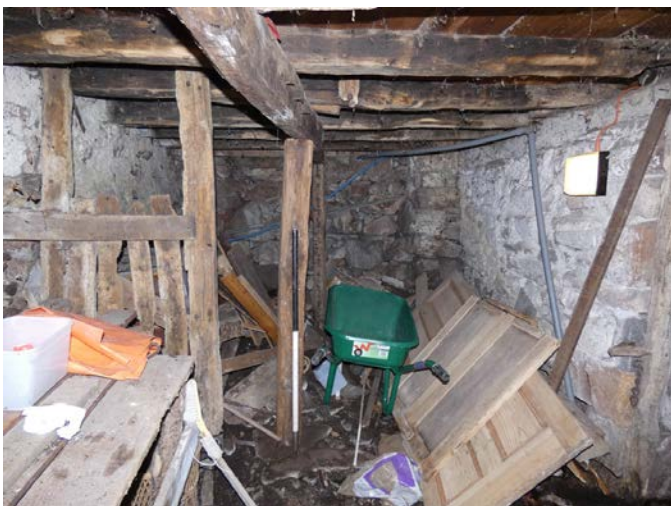
**Plate 49 (left): The west side of the north elevation in Room G3 of the mill**

**4.2.13 Room G3 – Mill:** this area was still largely inaccessible due to the large amounts of timber and other material stored within it, but it was still possible to take photographs of some of the more important features. The room was split into two halves, east and west, by a dividing wall, which appeared to butt the north and south walls and so was presumably a later insertion.

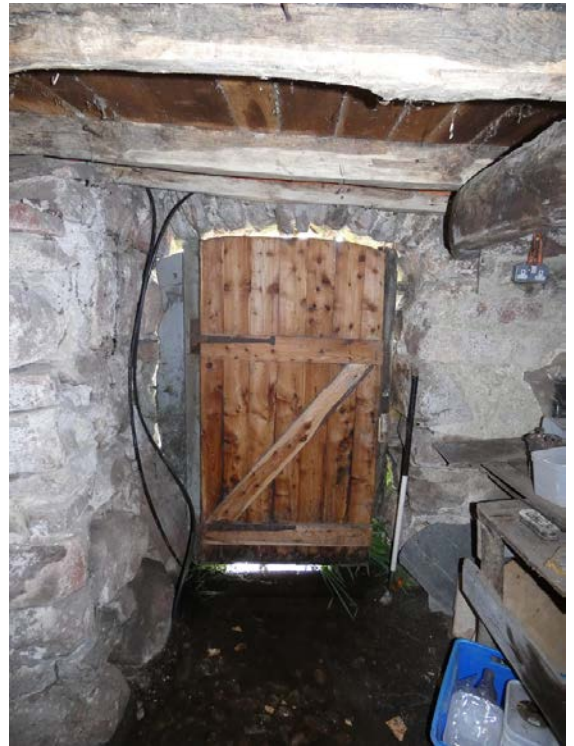
**Plate 52 (right): A doorway on the west side of the south elevation of Room G3 of the mill**

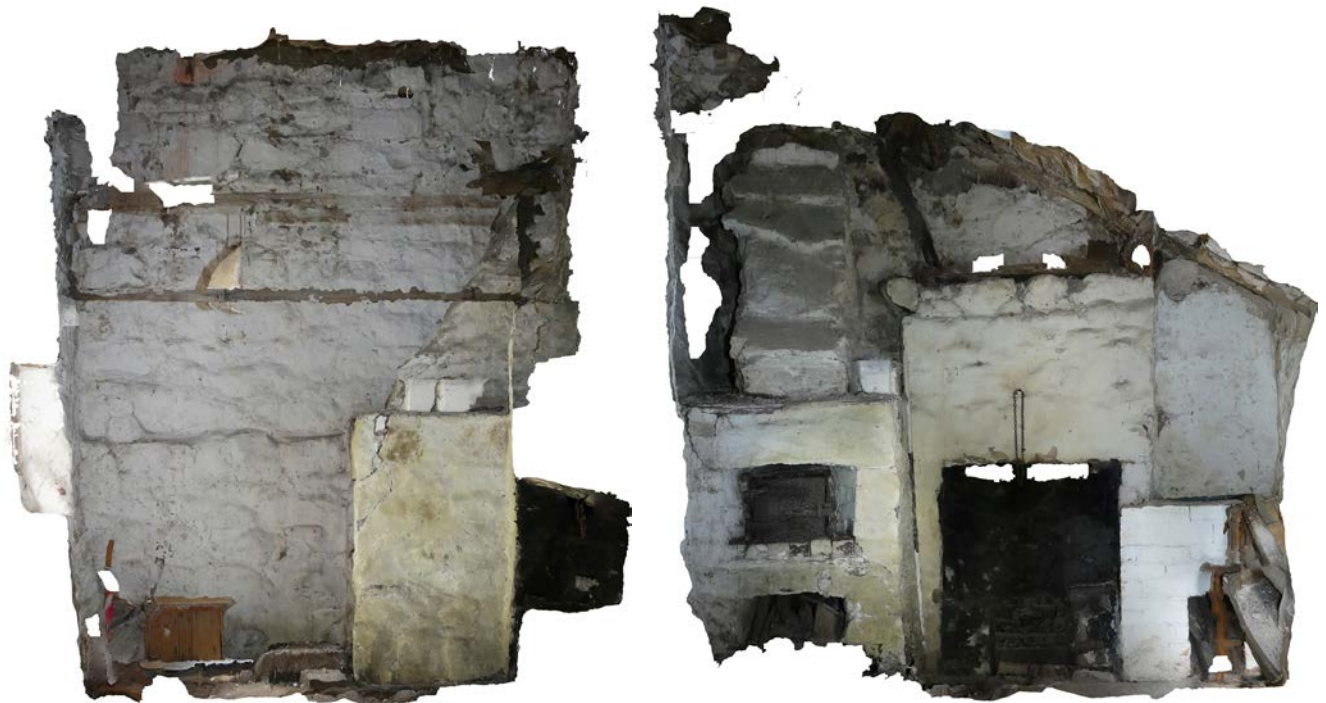
4.2.14 **Room G4 – Mill:** this comprises the small wash house contained within a monopitch outshut at the south end of the building, which houses a large fireplace on the east side and associated ovens and ‘copper’. Despite its size it was possible to produce ortho-rectified photographs of the main elevations (Plate 53 to Plate 56) as well as more general views.

**Plate 53 (left): Ortho-rectified view of the north elevation of Room G4 of the mill**

**Plate 54 (right): Ortho-rectified view of the east elevation of Room G4 of the mill, showing the fireplace, ovens and ‘copper’**

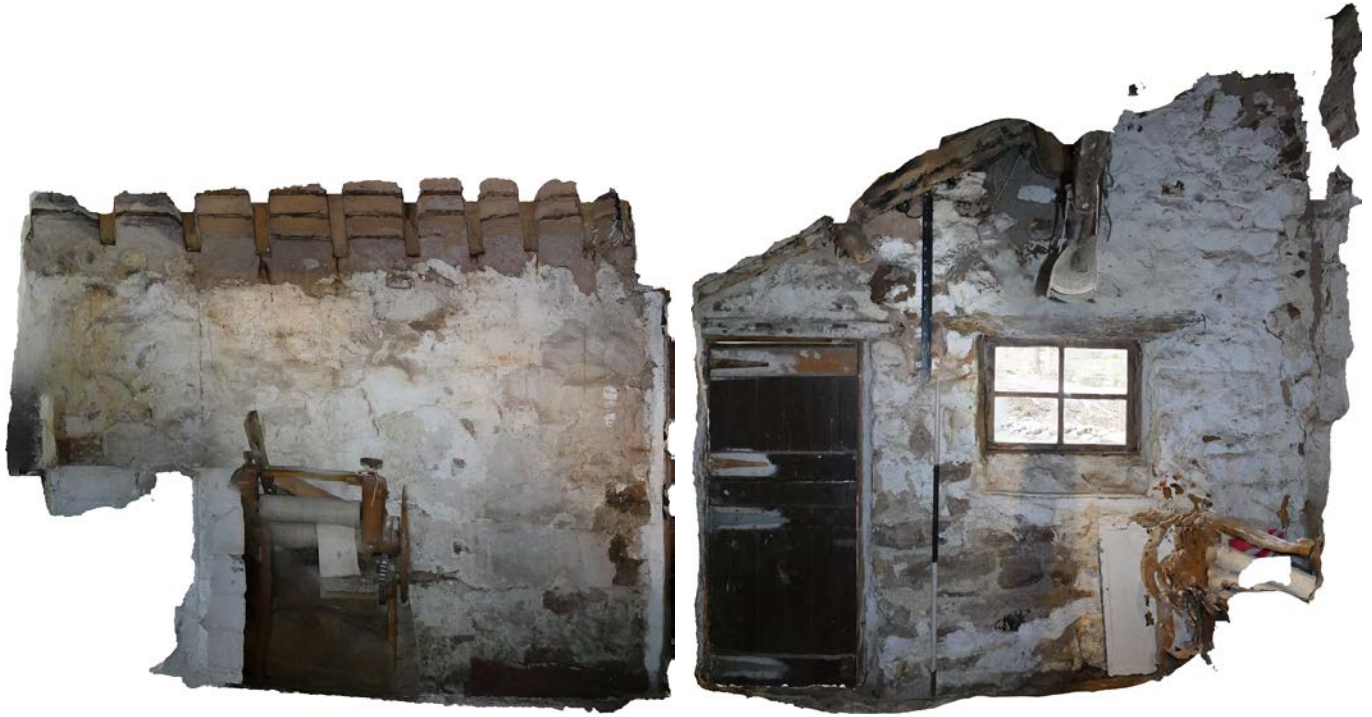
Plate 55 (left): Ortho-rectified view of the south elevation of Room G4 of the mill

Plate 56 (right): Ortho-rectified view of the west elevation of Room G4 of the mill

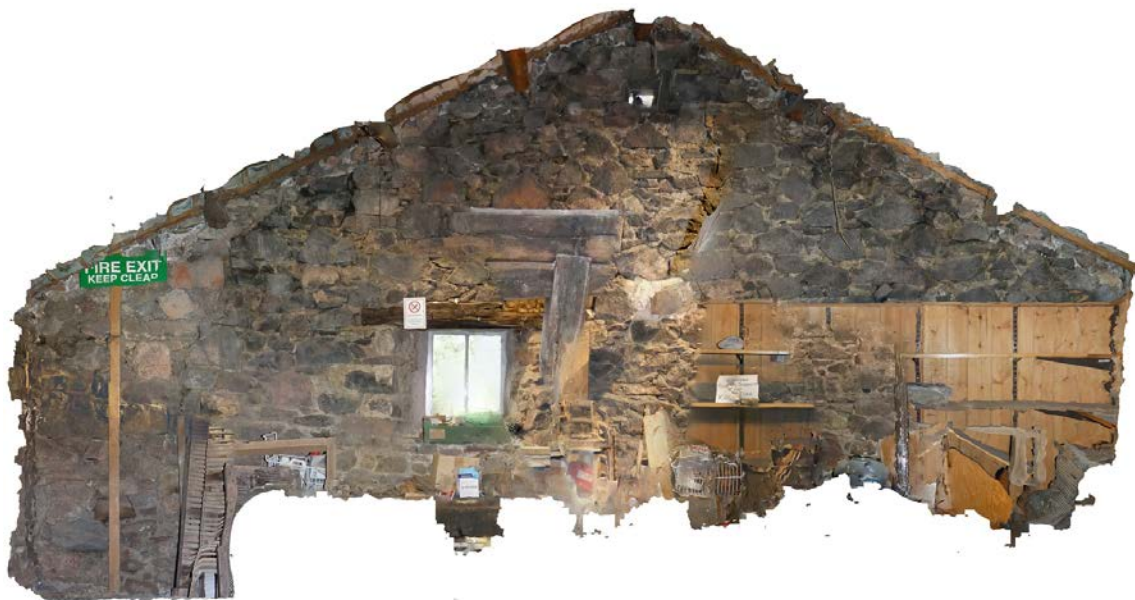
Plate 57: Ortho-rectified view of the north elevation in Room F1 of the mill

4.2.15 **Room F1 – Mill:** this comprises the space above the drying kiln with the drying floor taking up much of the south-east corner. This room was still very cluttered during the first visit and had fixed shelving against the east end of the north elevation so it was difficult to get enough coverage to produce ortho-rectified photographs (Plate 57), but this was easier for the other elevations (Plate 58 to Plate 60). General record shots were also taken of all elevations.

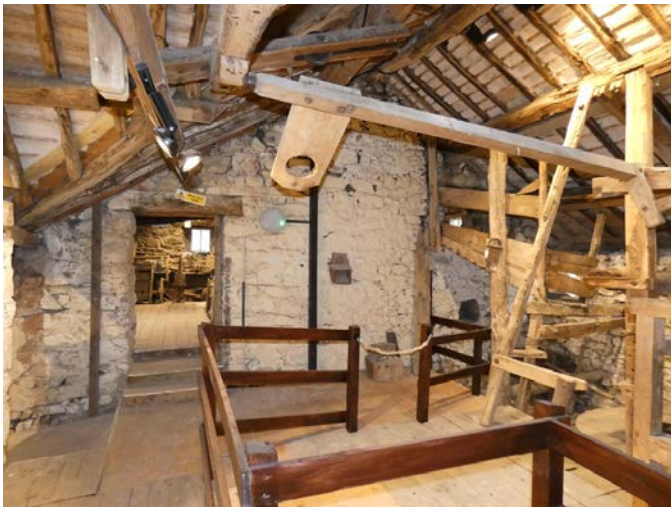
**Plate 61 (left): The north elevation in Room F2 of the mill**

4.2.16 **Room F2 – Mill:** as with Room G2 it was difficult to take sufficient photographs for rectification in this room because of the extensive mill machinery along the east elevation. Nevertheless general record photographs were taken throughout (Plate 61 to Plate 63) and ortho-rectified images produced where possible (Plate 64 and Plate 65). The recording allowed a more detailed examination of some of the elevations and showed that the north end of the west elevation clearly butted the rest, indicating that Rooms F2 and F3 were originally a single L-shaped space that had been subdivided.

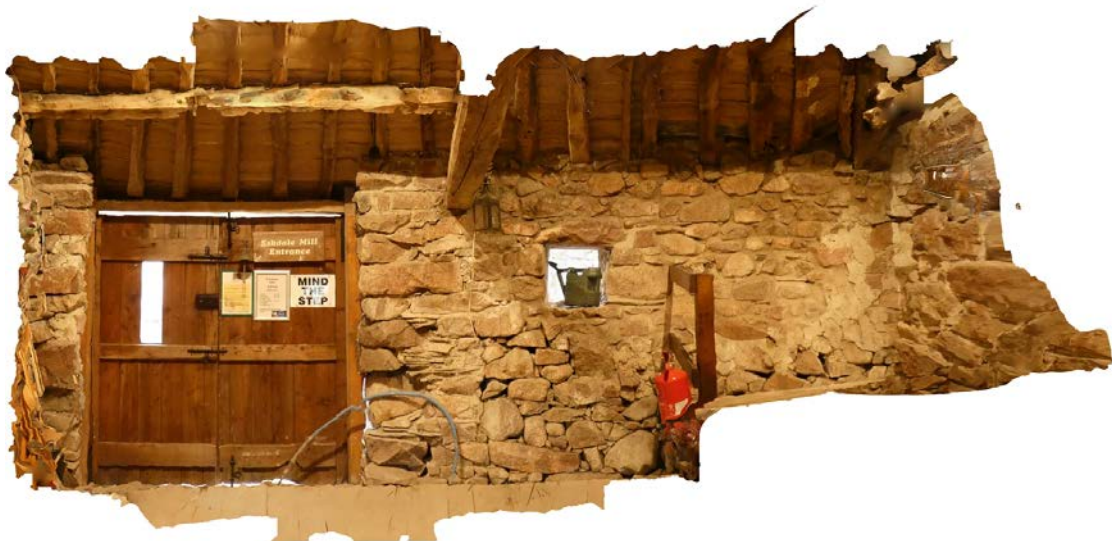
**Plate 66: Ortho-rectified view of the north elevation of Room F3 in the mill**

**4.2.17 Room F3 – Mill:** this initially had a considerable amount of furniture and fixtures obscuring the walls but this was later removed allowing a reasonable coverage of photographs to be taken and ortho-rectified images to be produced of all of the elevations, although these were only successful in some cases (Plate 66 and Plate 67). General record photographs of all the elevations were also taken (Plate 68 and Plate 69) and, in addition, a small alcove was observed on the east side of the south elevation, which was added to the plan (Figure 3) as was a small window in the north elevation that had apparently not been included on the initial drawings (Plate 66). Further Baltic timber marks were also noted on the north side of the west face of the tie beam of the single tie-beam truss (Plate 70) as well as a graffiti rodent scratched into the south side of the same face of the same timber (Plate 71).

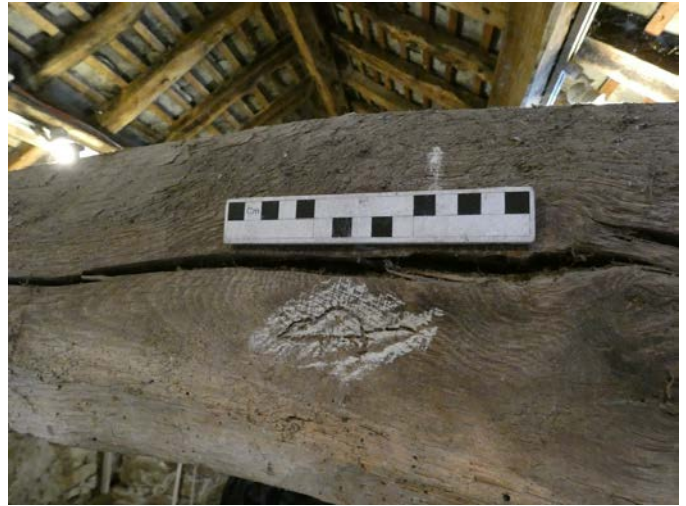
**Plate 71 (right): Graffiti rodent scratched on the south side of the west face of the tie beam of the truss in Room F3 of the mill**

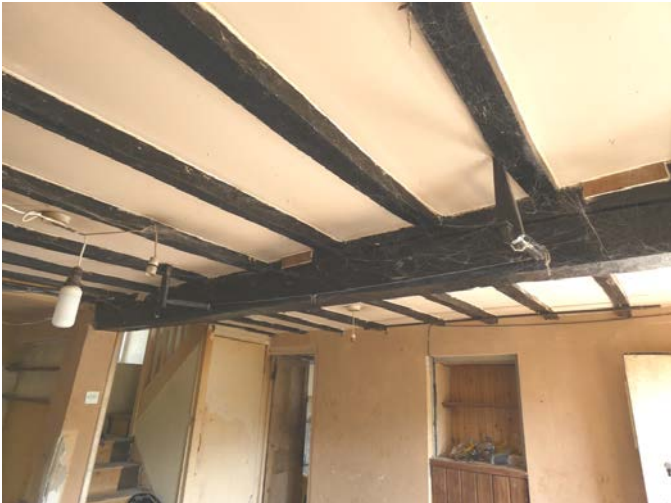
**Plate 72 (left): Beams and joists supporting the ceiling in Room G1 of the cottage**

**4.2.19 *Room G1 – Cottage:*** this represents the main ground floor room, comprising a single large space on the west side of the building. The ceiling was supported by a substantial beam and joists (Plate 72) and there were stairs on the north side (Plate 73) and two doorways to the east (one of which had been partially blocked to form a cupboard (Plate 73). In the west elevation the fireplace and an adjoining cupboard had also been more fully exposed (Plate 75).

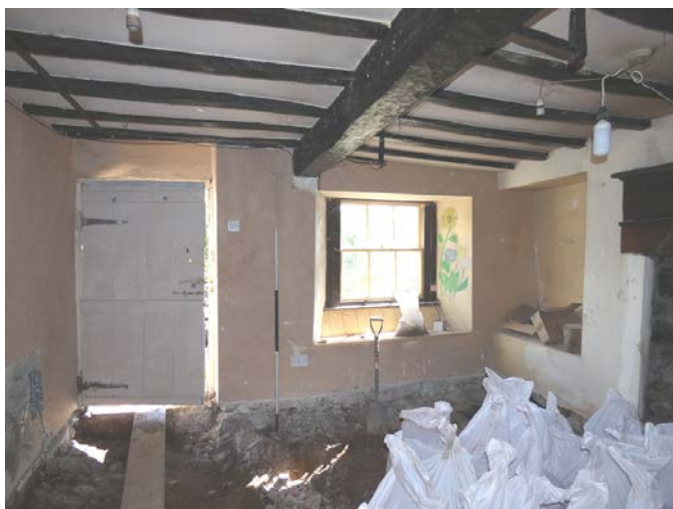
Plate 74 (left): The south elevation in Room G1 of the cottage

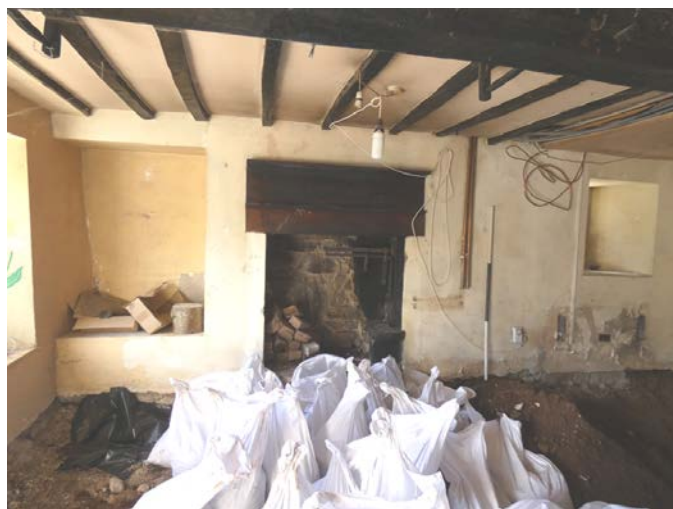
Plate 75 (right): Fireplace and cupboard in the west elevation of Room G1 of the cottage

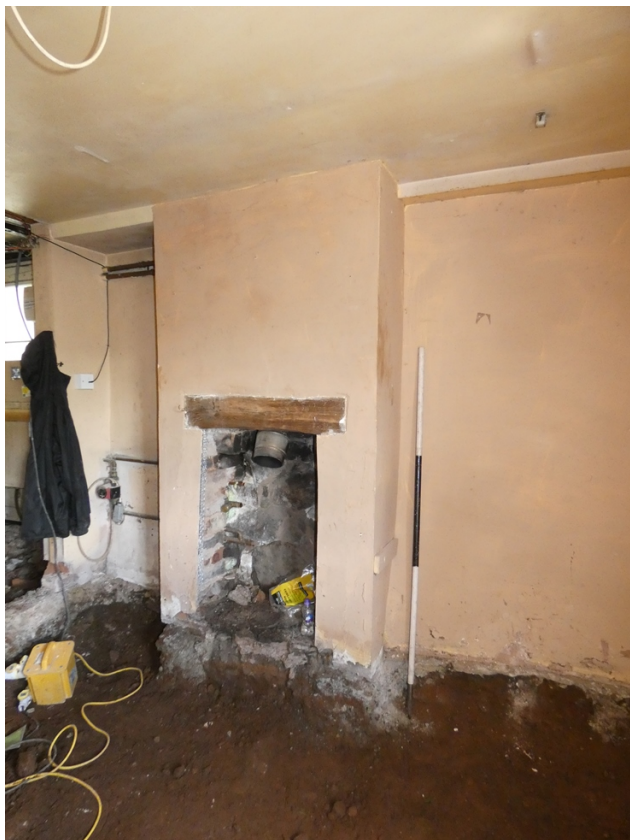
4.2.20 **Room G2/G3 – Cottage:** the partition wall separating Rooms G2 and G3 had been removed at the time of the recording and so photographs of this whole area were taken. Again several features had been more fully exposed as part of the renovation work and so photographs were specifically taken of the fireplace in the east elevation (originally in Room G3; Plate 76) and of the former doorway turned into a cupboard in the west elevation (originally in Room G3; Plate 77).

Plate 76 (left): The fireplace in the east elevation of Room G3 in the cottage

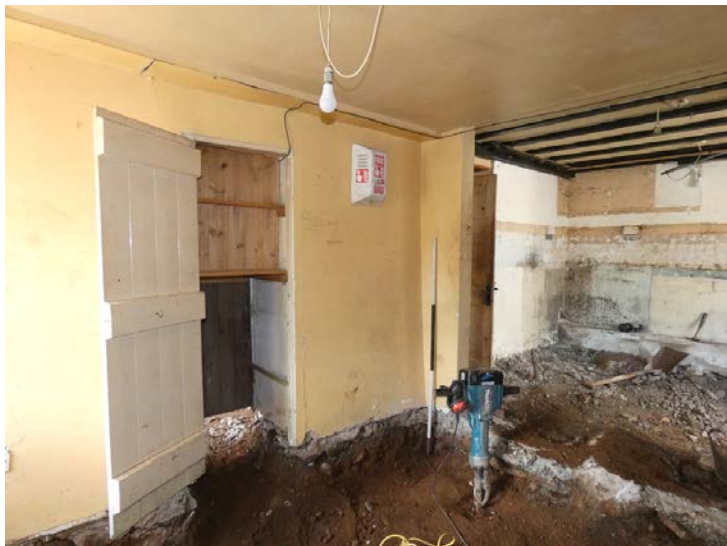
Plate 77 (right): The west elevation of Rooms G2/G3 showing the former doorway now used as a cupboard

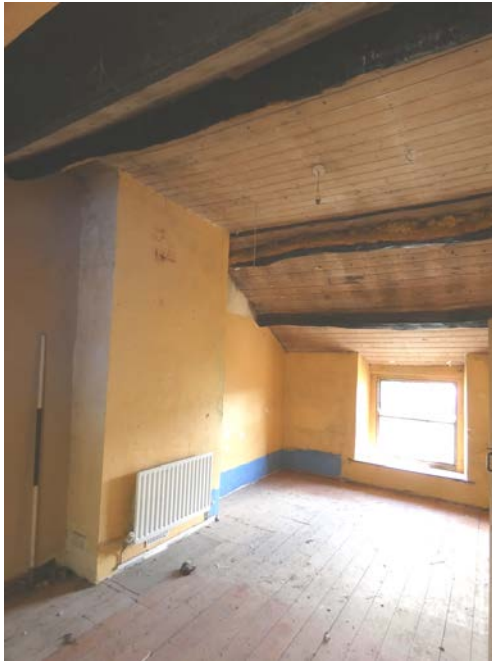
4.2.21 **Rooms F1 and F4 – Cottage:** these had only been stripped of carpets, furniture and fittings revealing the relatively late tongue and groove floorboards and otherwise allowing a record to be made of important features such as the chimney breast and windows (Plate 78 and Plate 79).

**Plate 78 (left): General view of Room F1 in the cottage showing the chimney breast to the east and window to the south**

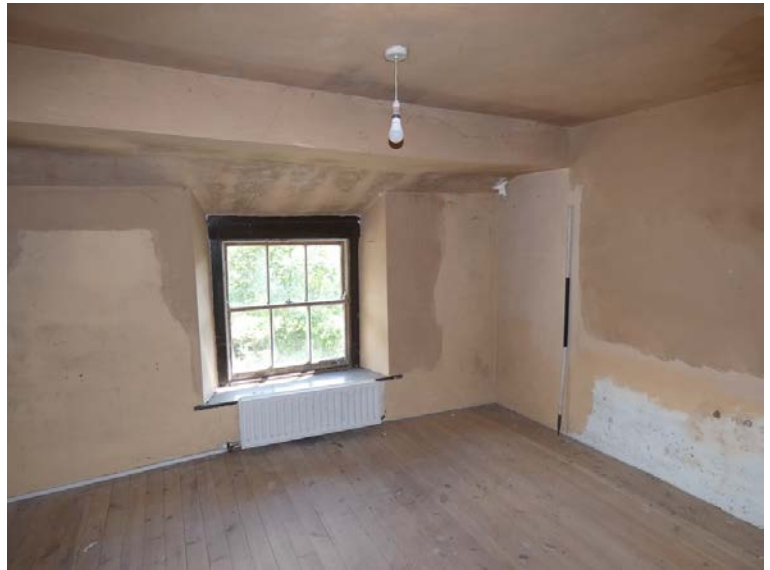
**Plate 79 (right): General view of Room F4 in the cottage showing the window to the south**
