CAMADS Eskdale Mill Visit 27/09/2018

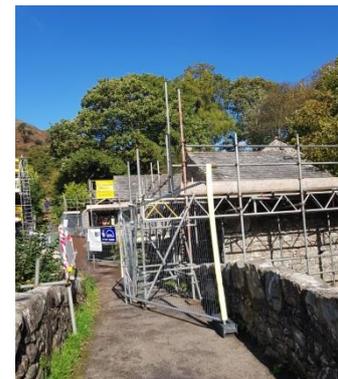
The Cottage overall, is structurally sound. However it needs to be internally stripped and rebuilt with new electrics and plumbing. The main issue facing the cottage is based on the back wall. It is built into the hillside allowing the ground water to flow down to bedrock and therefore move towards the river. This results in flooding in the lower main living area. This is planned to be resolved by allowing water flow underneath the floor; this flow cannot be stopped but can be re-routed to prevent flooding. The majority of the work associated with the cottage is turning it back into a traditional structure, another example of this is in the main bedroom; the expanding foam across the timbers will be removed and more timbers added to keep its authenticity in construction as an 18th century cottage.
