## Eskdale Mill Works Conservation Building Contract

### *Progress report following valuation meeting on 13<sup>th</sup> December 2018*

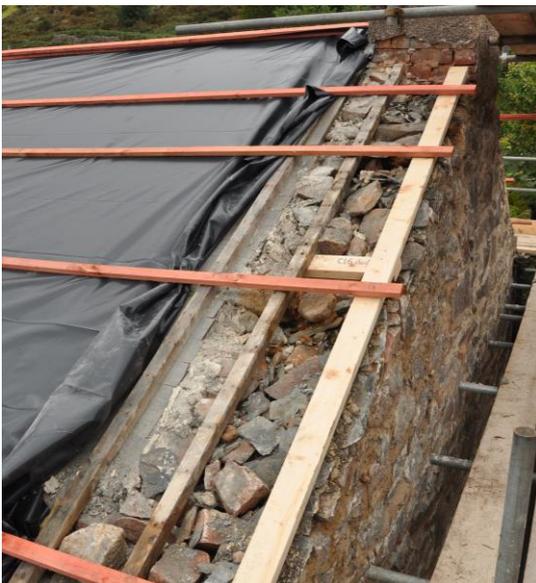
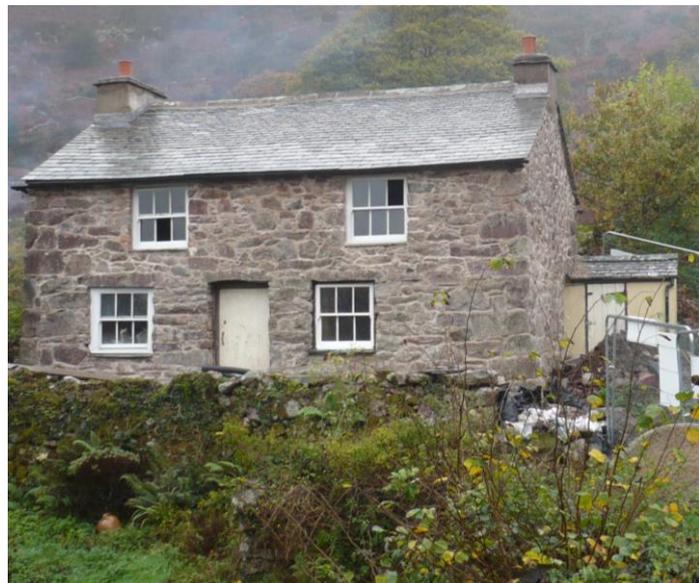
Both roof pitches were re-roofed including salvaged slates as necessary. During a site inspection on 7<sup>th</sup> August 2018 the roofer subcontractor highlighted that the upper courses to the front pitch of the cottage were too small (approx. 8" when the minimum he would use is 10") and it was agreed that those small slates would be discarded and that 10" would be the smaller size used.

Left hand side image: roof under construction, image kindly supplied by Maurice Steele. Right hand side image: south elevation of the cottage after re-roofing and repointing works, 26<sup>th</sup> October 2018

During the Development Stage the total replacement of internal ceilings had been specified, but after the above mentioned site inspection with the main contractor and the trustees it was agreed that the boarded ceiling above the master bedroom could be retained. Therefore, the roof construction specification was amended from PIR along the eaves and mineral wool over the flat ceiling areas to TLX gold along the roof slope (Als no. 1 to no. 4).

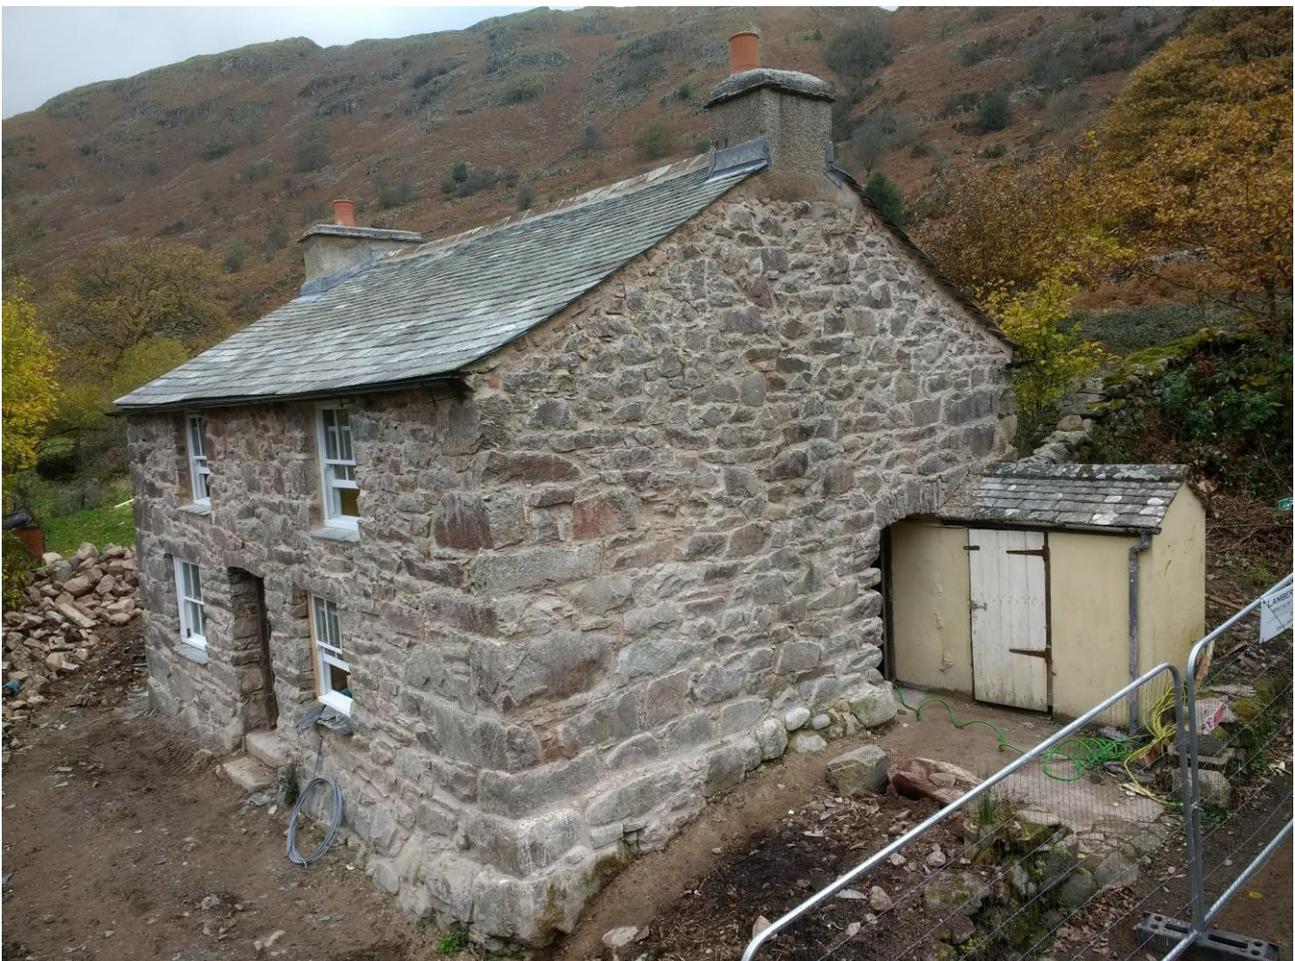
Image of the cottage taken from the scaffold at the mill on 6<sup>th</sup> November 2018

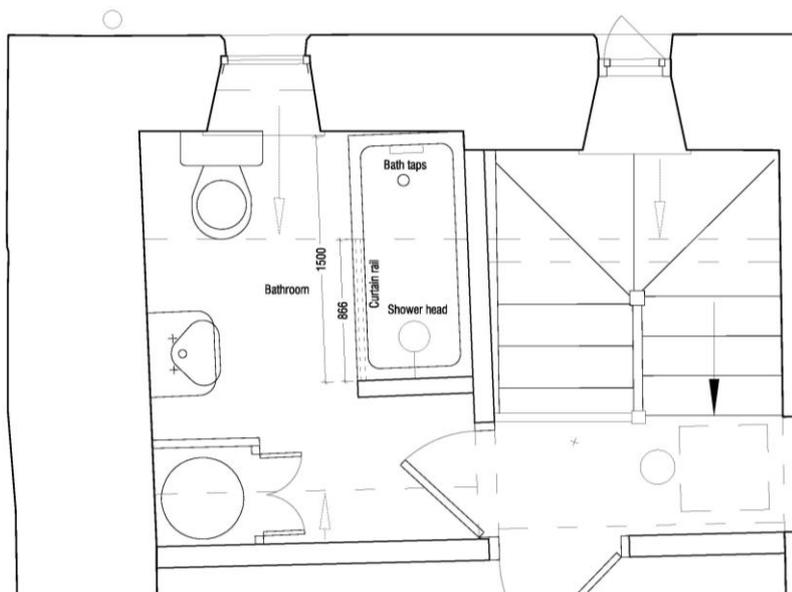
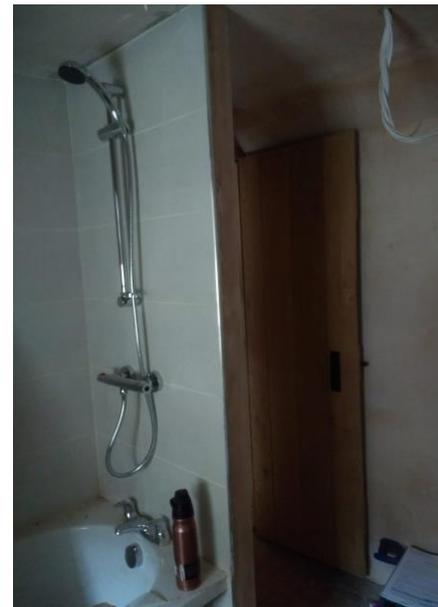
In the case of the bathroom, the area around the bath was re-designed to incorporate a shower fitted onto a new stud wall. Also, the specifications of the hot water tank were reviewed with the plumber who is aware of the space limitations and will install the tank to maximise the circulation space.

Left hand side image: revised proposed drawing sent to contractor on 9<sup>th</sup> November 2018. Right hand side image: image of the bathroom on 13<sup>th</sup> December 2018

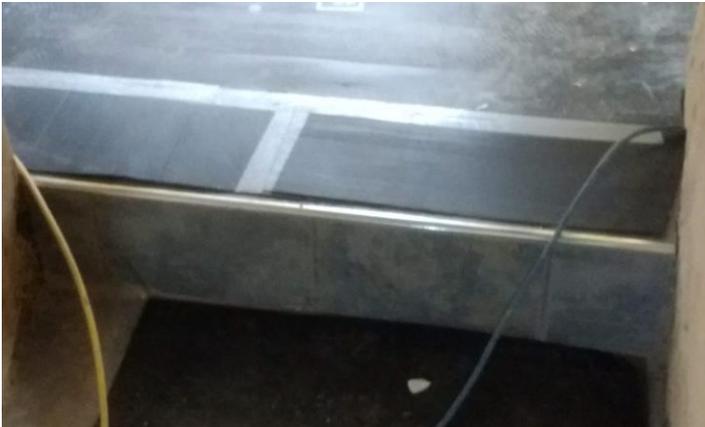
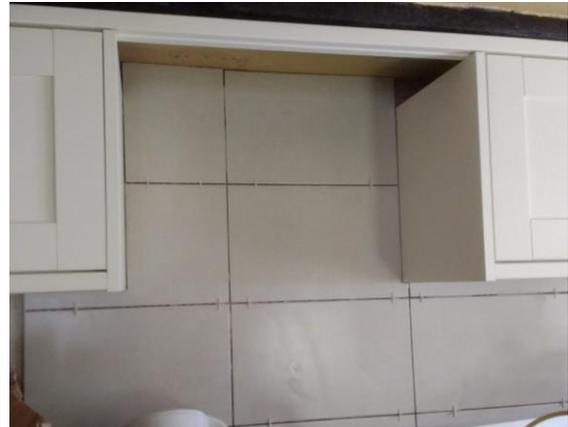
Floor and wall tiles were installed during the last week of November (AI no. 9 and no. 10).

*Left hand side image: image of the tiled step between the living room and the kitchen. Right hand side image: image of the kitchen wall tiles. 13<sup>th</sup> December 2018*

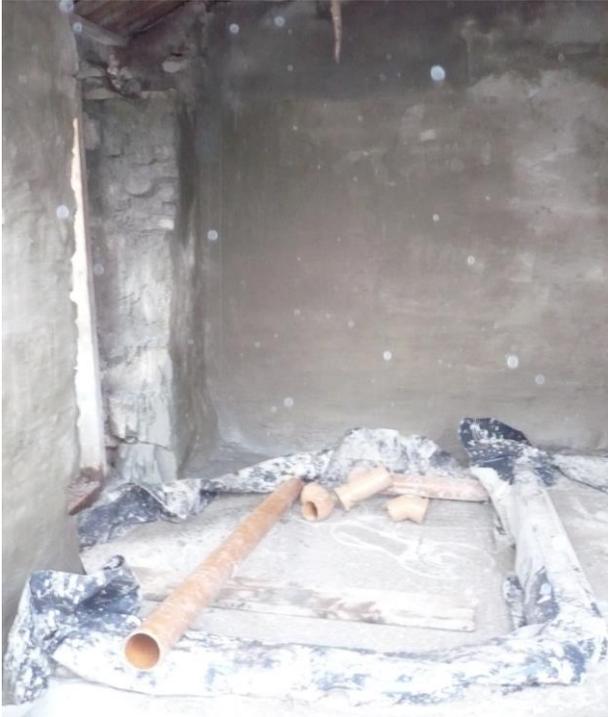
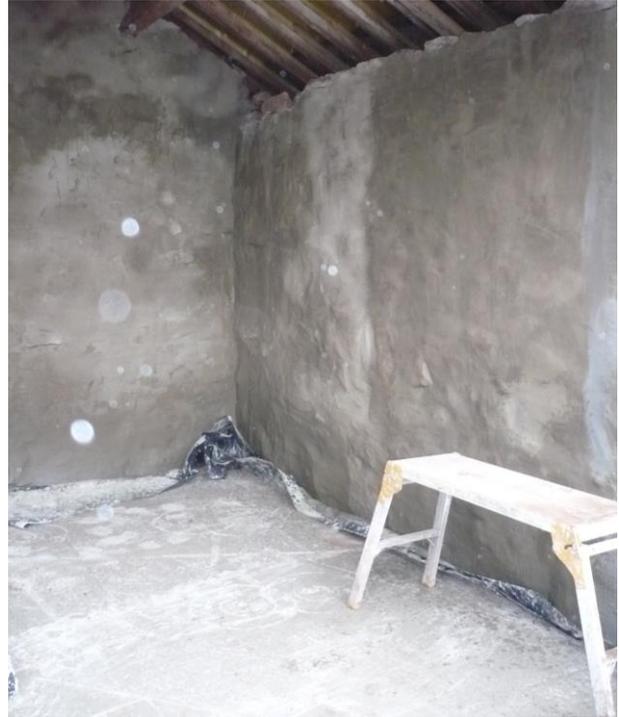
The cart shed is built into the bed-rock of a bankside and installing an external perimeter french drain was not a viable option. The Development Stage specification included for tanking the masonry external walls with Sovereign's Hey'di K11 system, but during the excavation of the floor water from the fell seeped through the rear wall, which was similar to what happened in the cottage).

*Image of the concrete slab to the cart shed and the tanking to masonry wall on 26<sup>th</sup> October 2018*

A new drain was introduced below floor level to drain the area (AI no. 10).

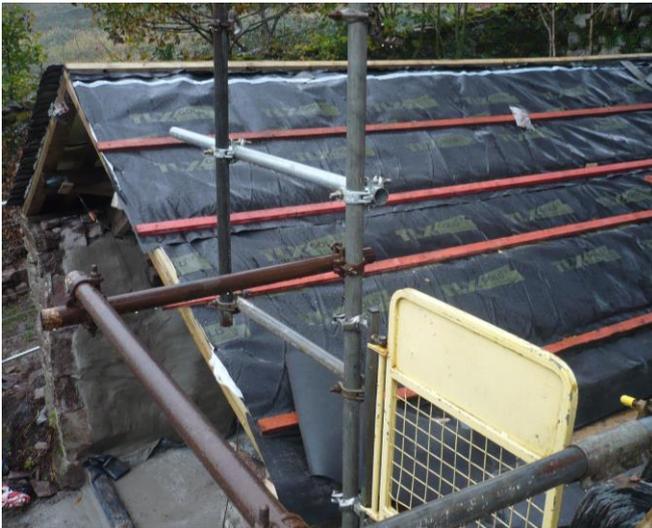
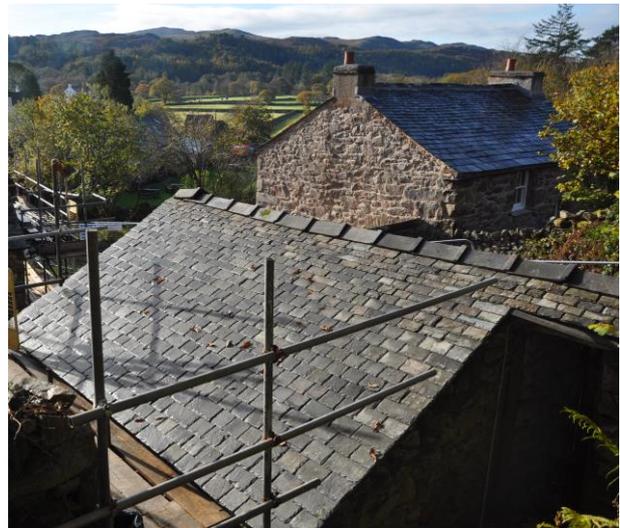
*Left hand side image: roof to cart shed under construction on 26<sup>th</sup> October 2018. Right hand side image: image of the finished roof kindly supplied by Maurice Steele*

The roof insulation specification to the cart shed was amended to substitute TLX gold instead of PIR insulation between rafters (AI no. 7) and salvaged roofing slates were re-fixed over new battens. The roof to the privy was also re-roofed with salvaged slates fixed onto new battens.

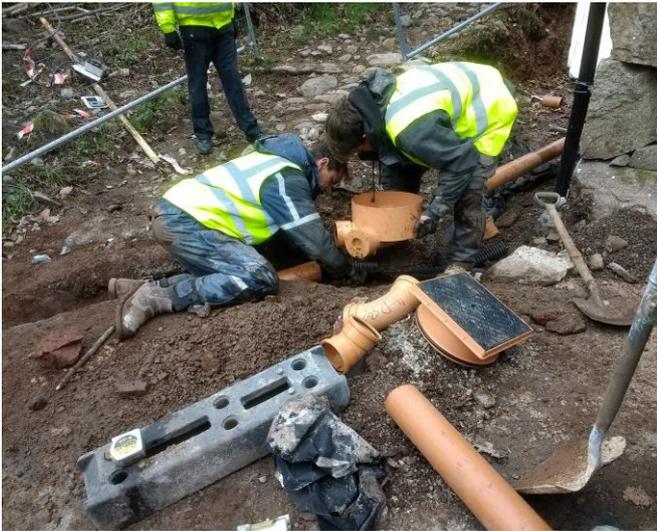
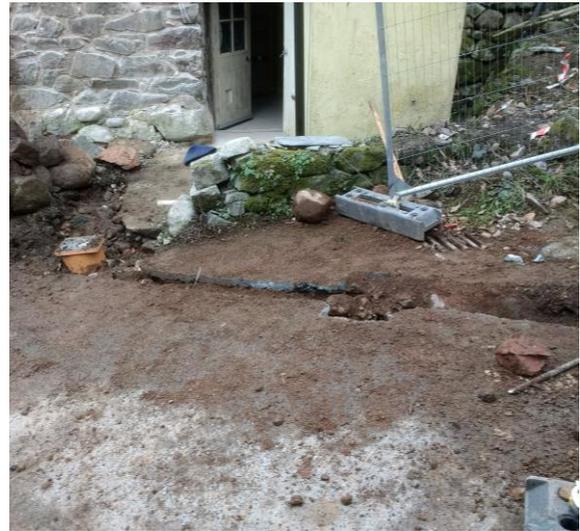
The new foul drainage for the wheelchair accessible toilet has been laid down ready for connection onto the existing cottage drain. The picture on the right hand side below shows the new inspection chamber next to the cottage's outbuilding where both systems will be combined before discharging onto the new sewerage treatment plant (which will replace the existing septic tank in the garden).

*New foul drainage system to the wheelchair accessible toilet, 22<sup>nd</sup> November 2018*

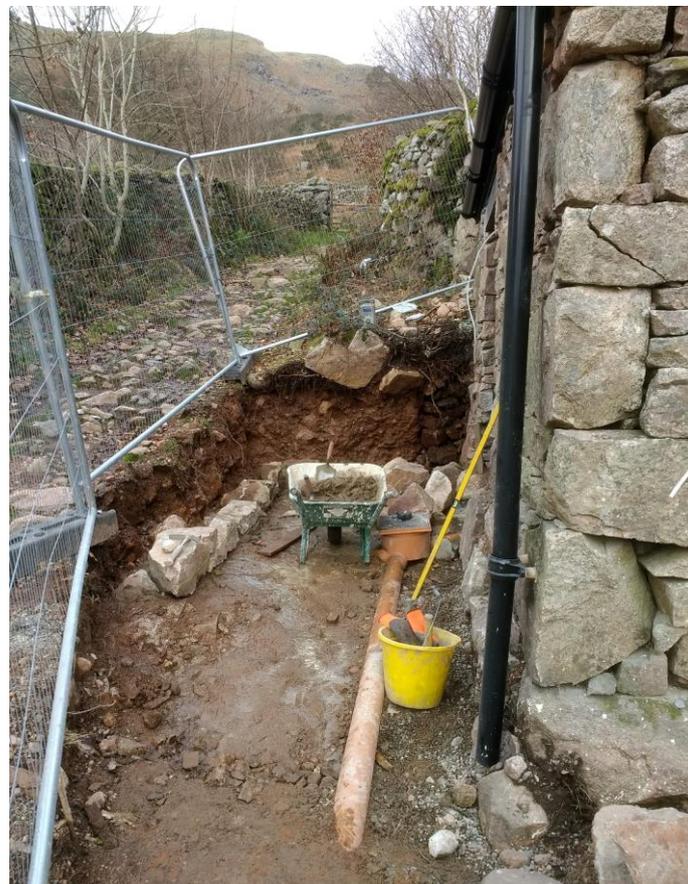
The area for the access ramp to the wheelchair accessible toilet was excavated in November. Although during the value engineering exercise it had been agreed that a concrete retaining wall finished in render could be appropriate, the contractor suggested re-using the salvaged stone on-site (obtained from the ground excavations to the cottage and the cart shed and also from digging out the area for the ramp). The design team accepted the suggestion and designed a granite retaining wall with a timber guarding and a perimeter french drain. The design was approved by the conservation structural engineer and works to build the wall have commenced.

*Image of the setting out of the retaining wall, 13<sup>th</sup> December 2018*

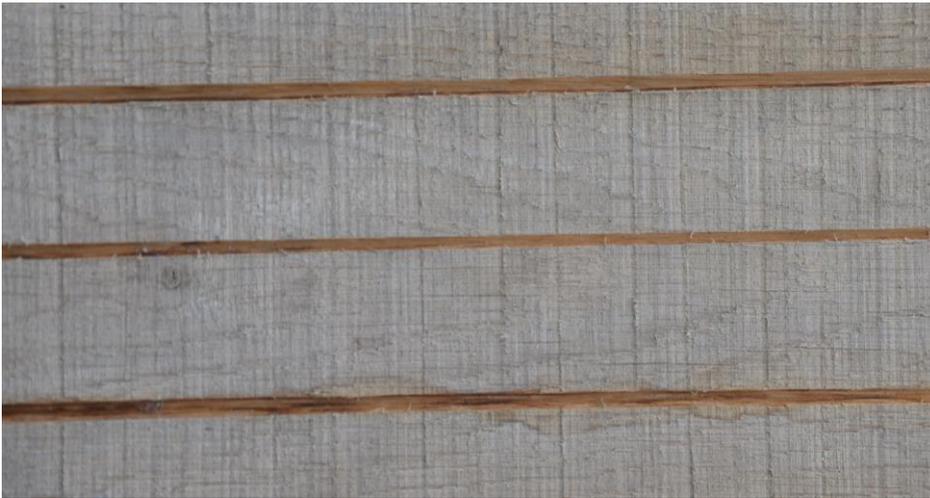
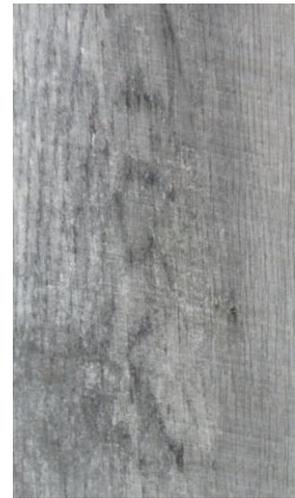
The new south elevation to the cart shed / reception was designed keeping in mind the original appearance of the building. A vertical oak cladding has been proposed, with cover laths between the boards creating a ventilated system to enhance the life of the timber sections. The finish of the cladding will be rough sawn oak, which will weather in time to a dull grey that will blend with the granite stones around the site.

*Left hand side image: colour of rough sawn timber board newly installed. Right hand side image: expected colour of weathered rough sawn timber board*

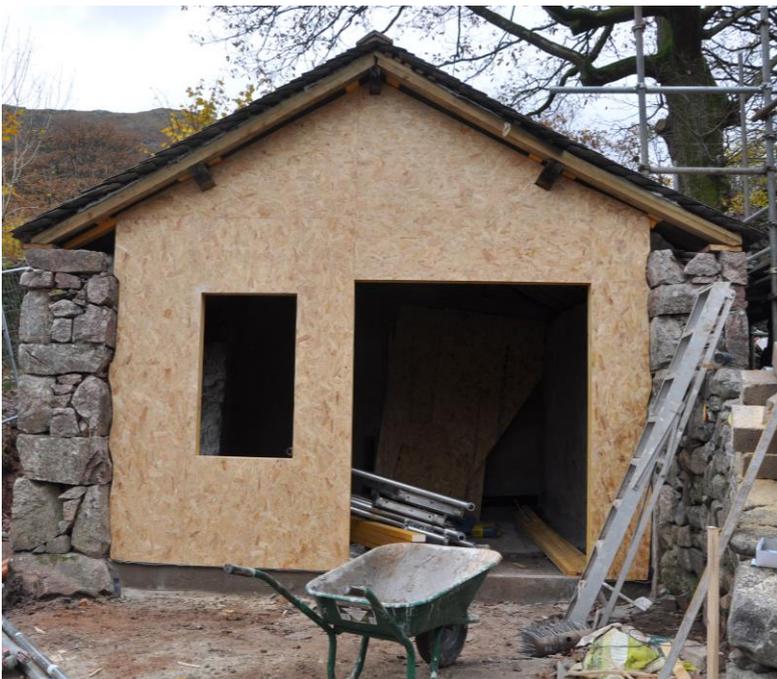
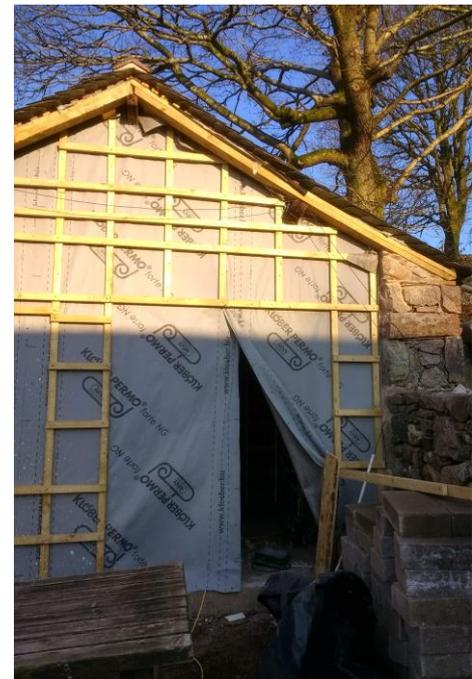
The main structure of the elevation has been built, including the internal thermal insulation and the external battens ready for the cladding being fixed.

*Images of the timber cladding to the south elevation under construction. Left hand side image: image kindly supplied by Maurice Steele. Right hand side image: the south elevation on 22nd November 2018*

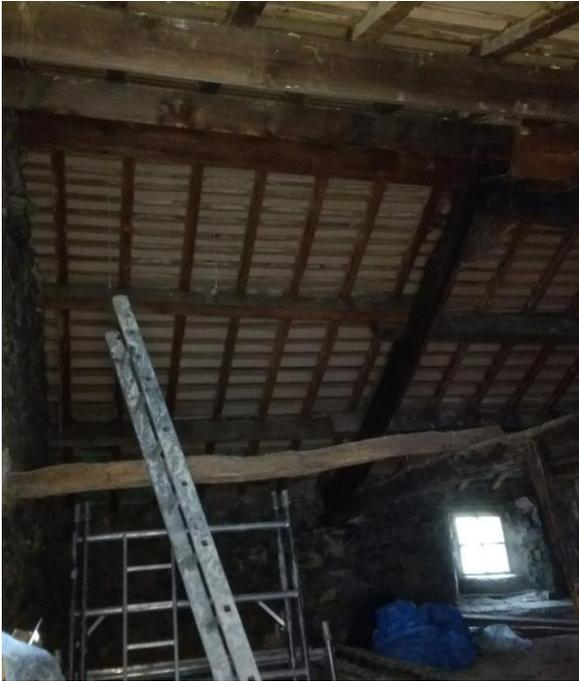
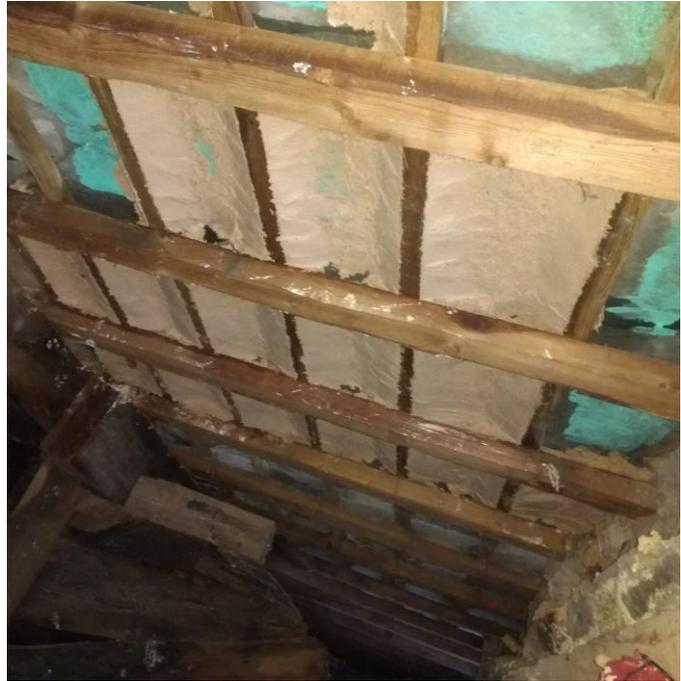
Internally, the application of a lime torching to the underside of the slates will not only help to keep the slates in place but will also prevent wind driven rain getting into the buildings.

*Images of the torching to the underside of the roof above the Drying Room, 22nd November 2018*

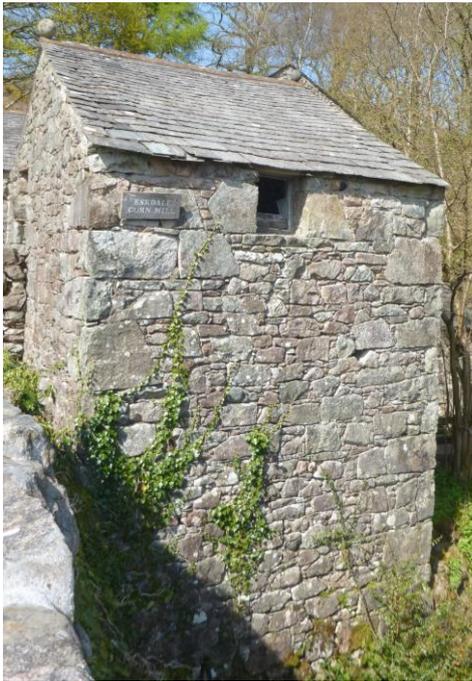
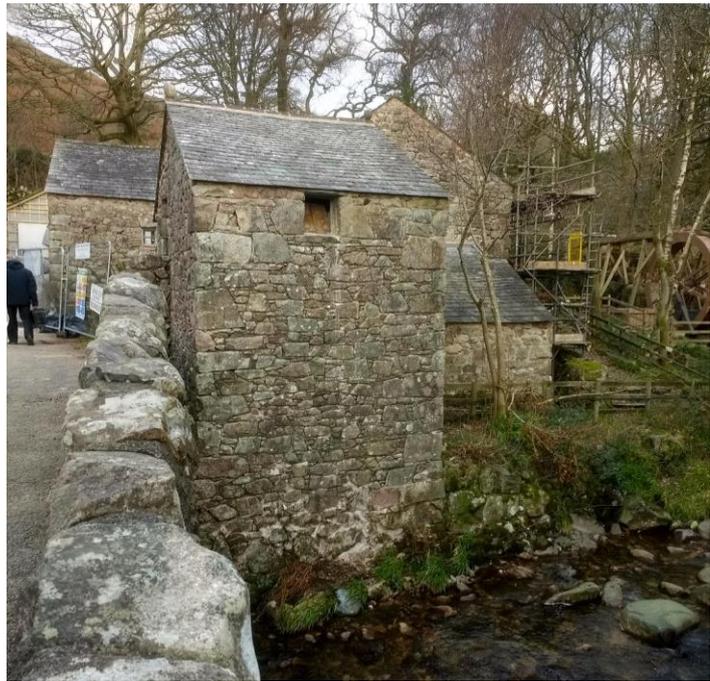
Similarly, to work undertaken to the mill and the bakehouse walls, the walls to the stable/hayloft, which were not exposed to splashing from a nearby watercourse were deep-tamped with NHL 3.5 lime mortar, including for pinning and galleting as necessary. Where the west and south walls meet the watercourse, lime pointing with NHL 5 was specified.

South elevation to stable/hayloft. Left hand side image taken on 5<sup>th</sup> May 2016. Right hand side image taken on 13<sup>th</sup> December 2018
