ESKDALE CORN MILL MACHINERY AND MILLWRIGHT PROGRESS

December 2018

3. Progress – work to December 13th 2018

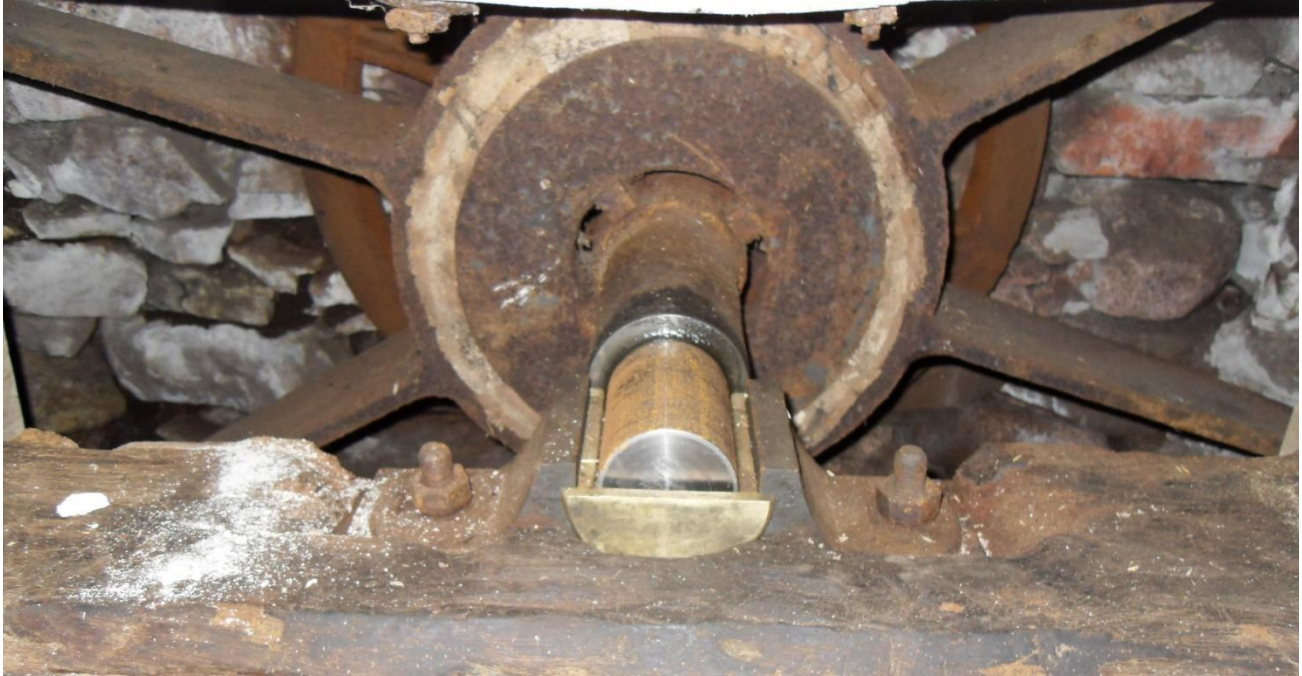
1. The upper mill stone nut has been cleaned and the millwrights have sourced the hornbeam timber for the replacement cogs
2. The upper mill millstone shaft has been cleaned and the foot bearing inspected and found to be in good service
3. Upper waterwheel shaft was raised to inspect the bronze/brass bearing shells. They were found to be worn so the millwrights made new wooden casting patterns, then produced new brass cast bearing shells and bored them to fit the existing waterwheel shaft journal. The bearings are now fitted and awaiting the bearing caps to be fitted and lubricated.
