Eskdale Mill Works Conservation Building Contract

Progress report – December 2018 to June 2019

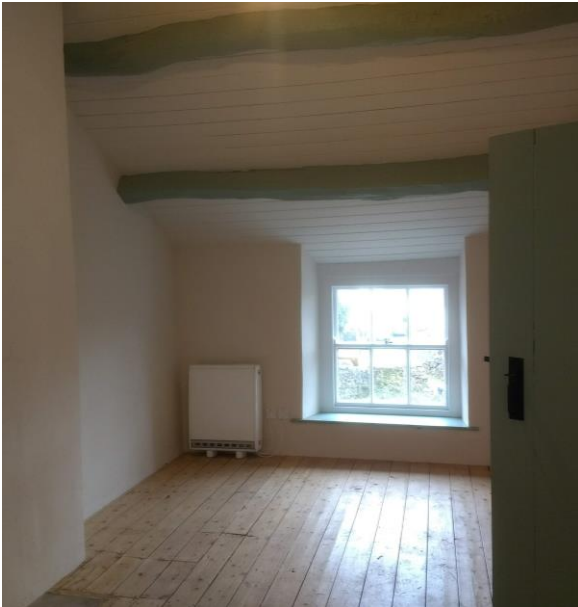
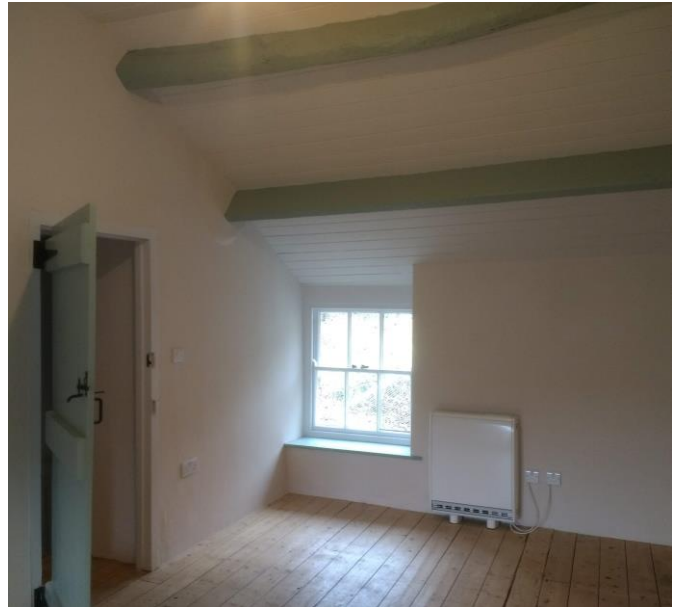
Images of the refurbished eastern bedroom on 1st March 2019

Internal decoration and refurbishment of external joinery was completed during the months of February and March. Second fix for water and electricity was undertaken, along with the installation of the storage heaters and the wood burning stove.

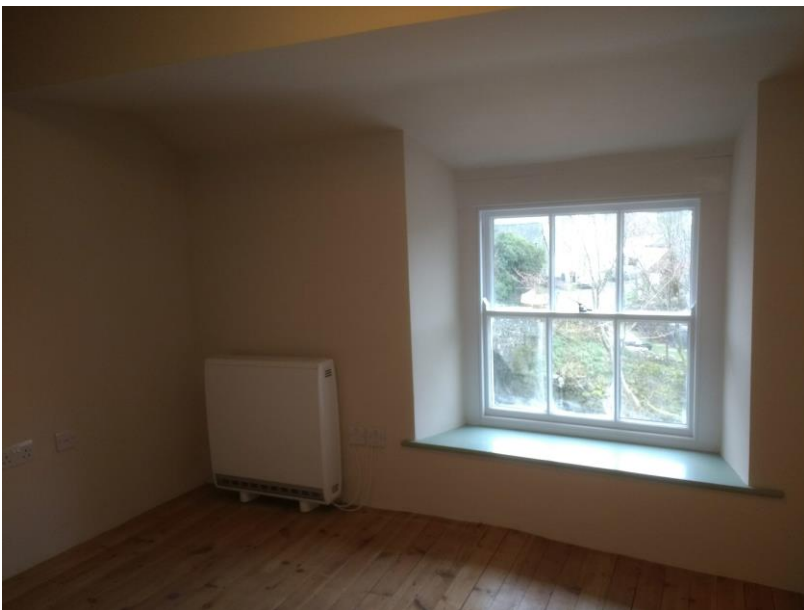
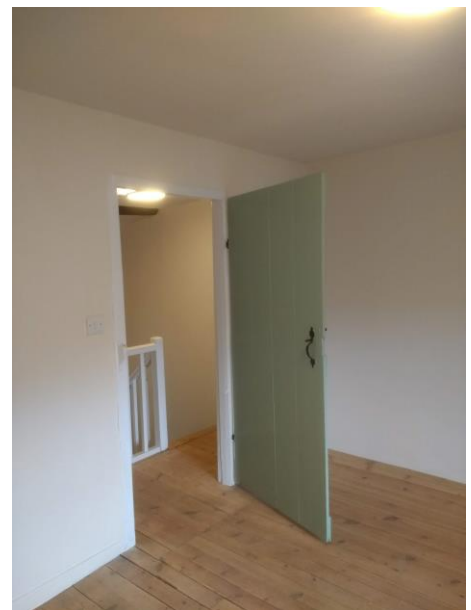
Images of the refurbished western bedroom on 1st March 2019

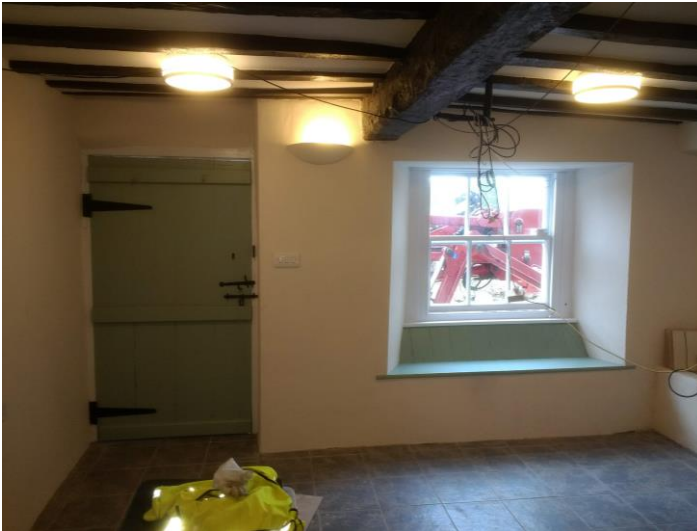
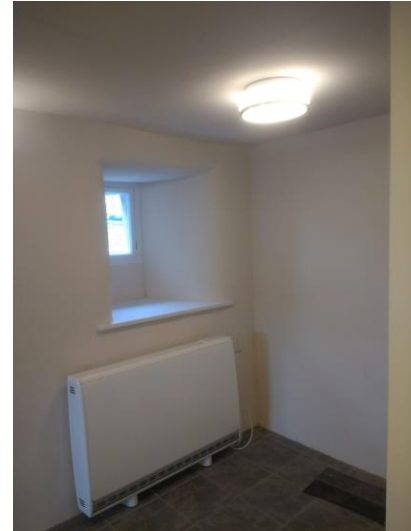
Please note that the pictures shown below were taken before the BT engineer had visited site and before the mains water supply had been undertaken. Thus, the services second fix was not completed at the time.

Images of the refurbished living room on 1st March 2019

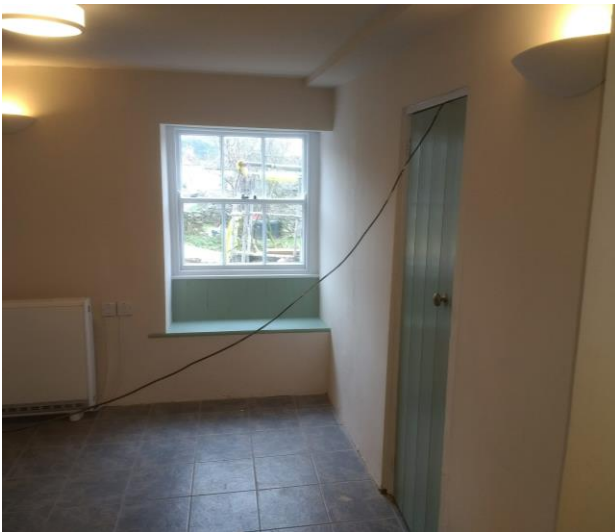
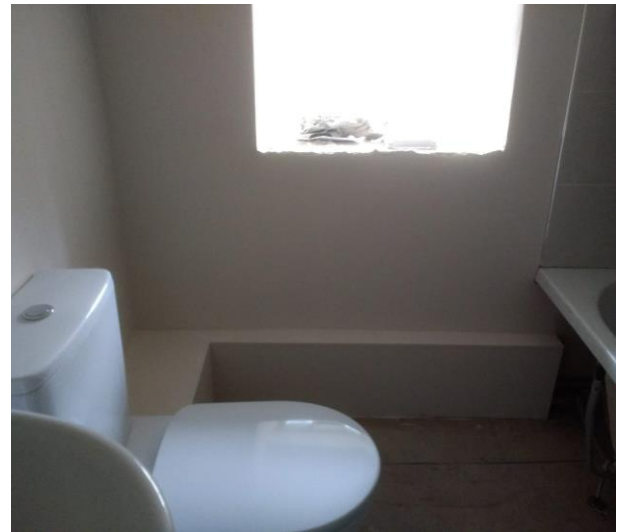
Left hand side image: refurbished dining room on 1st March 2019. Right hand side: refurbished bathroom on 24th January 2019

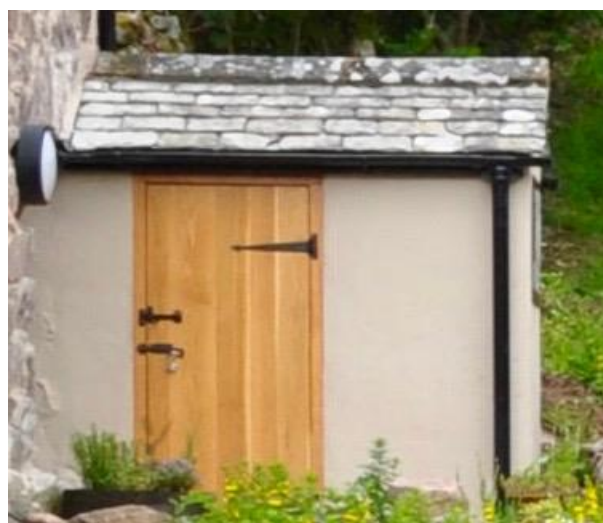
Image of outbuilding

Finally, the outbuilding was reordered to accommodate a laundry room to serve the cottage, including decoration and the installation of a new external door.

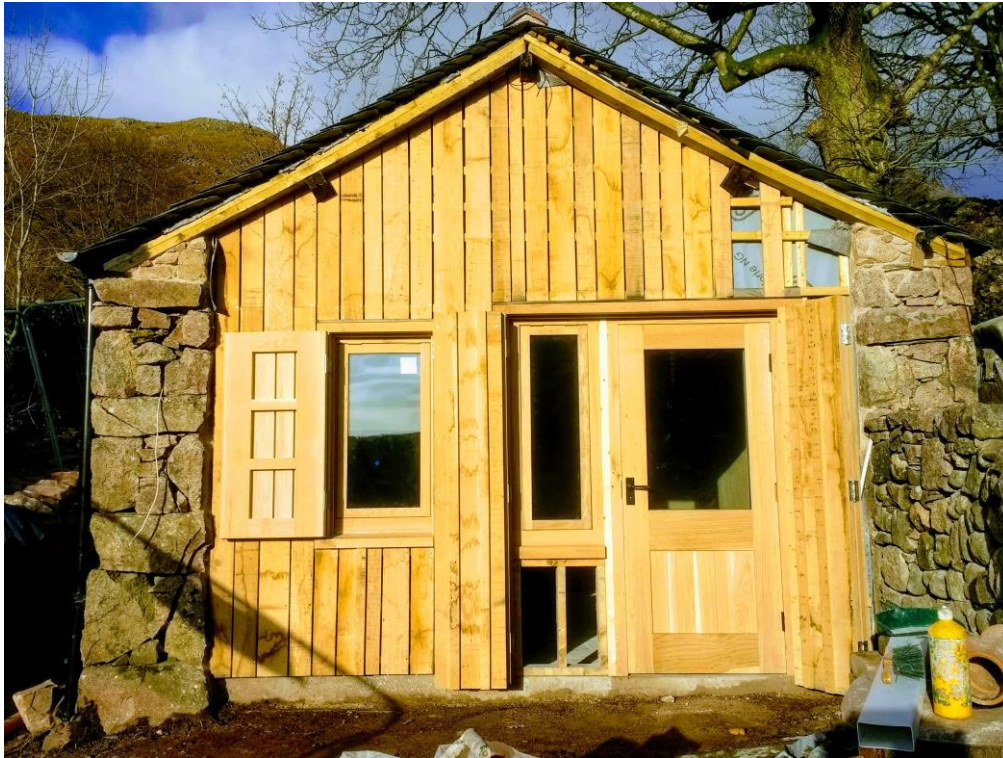
Image of cart shed with open shutters on 8th January 2019

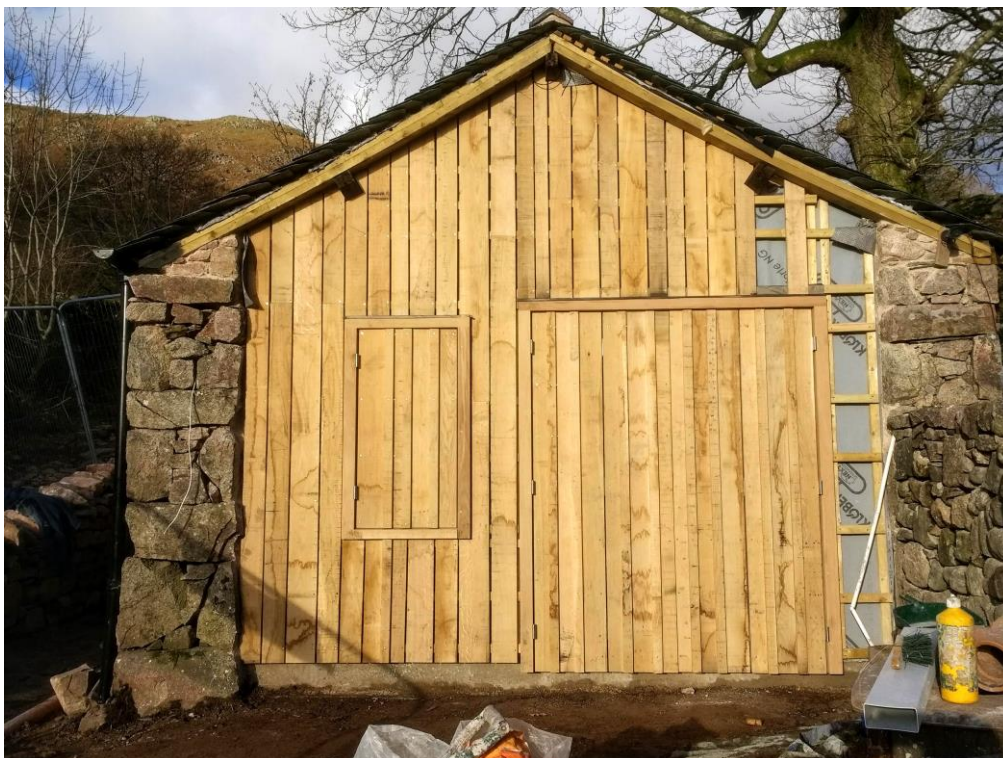
Image of cart shed with closed shutters on 8th January 2019

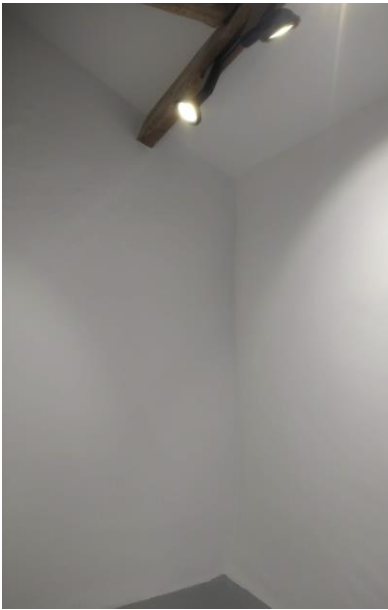
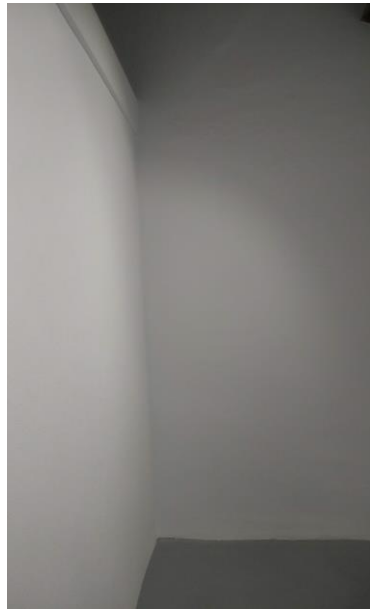
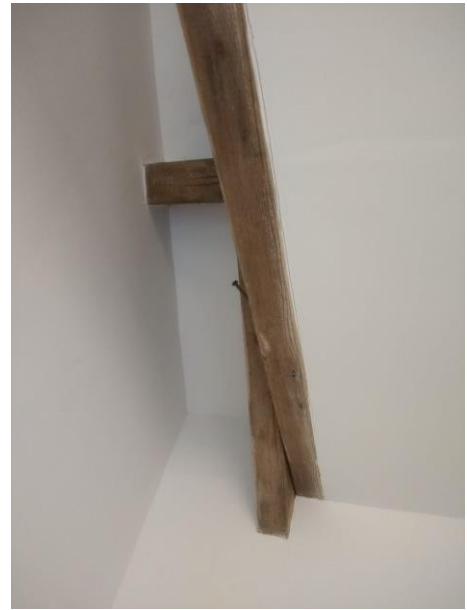
Images of the shop area taken on 14th March 2019

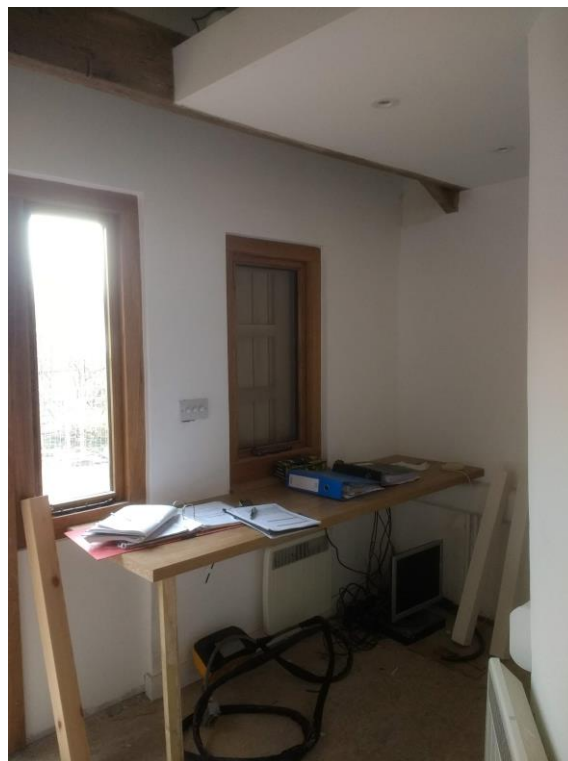
The remnants of the cottage kitchen worktop were used to create a desk for the reception/shop area.

Internal image of the cart shed taken on 1st March 2019

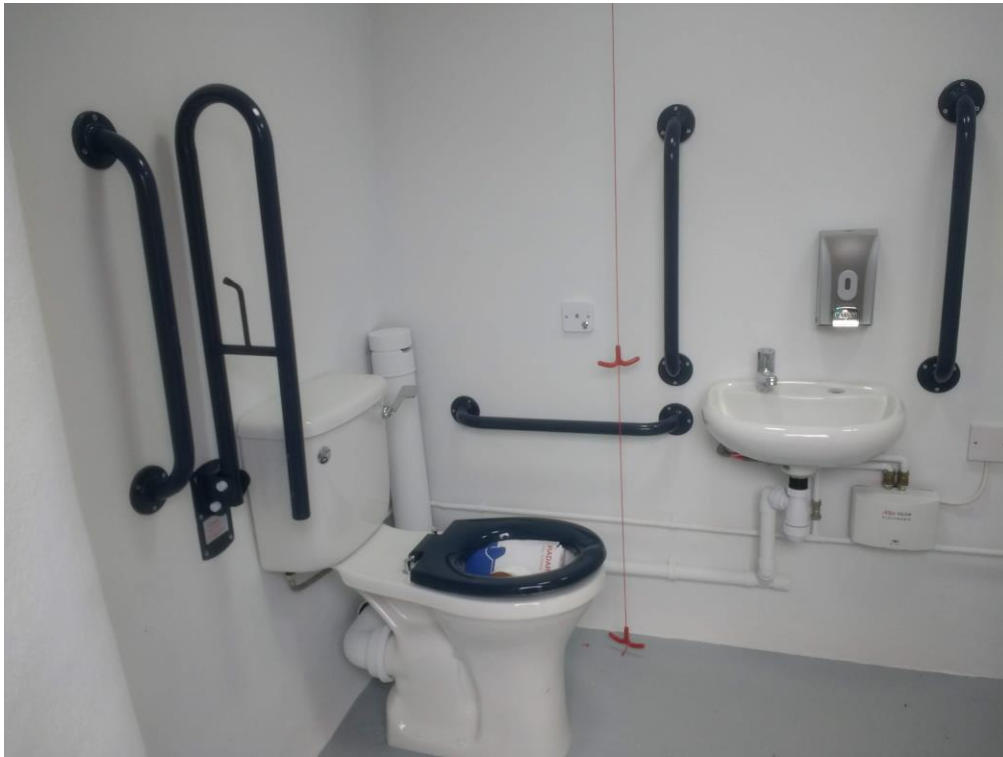
The sanitary fittings to the wheelchair accessible toilet were installed.

Image of the interior of the wheelchair accessible toilet compartment taken on 14th March 2019

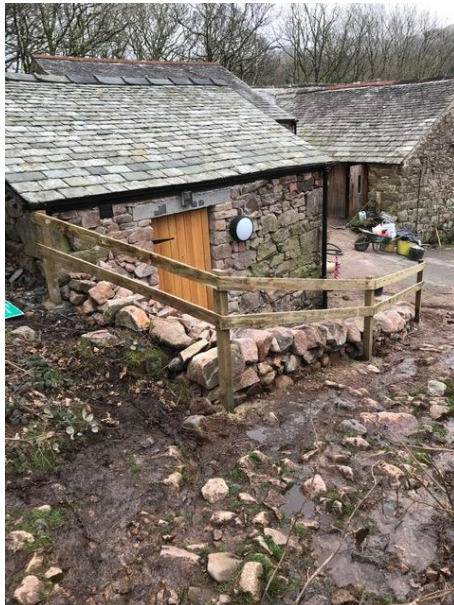
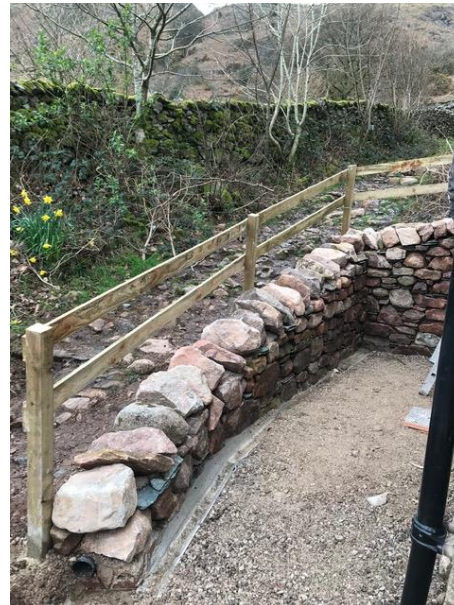
The retaining wall and guarding surrounding the access to the wheelchair accessible toilet was built (approval of discharge of conditions granted on 21st March 2019).

Images of the access area taken on 21st March 2019, kindly supplied by John Lambert (main contractor)

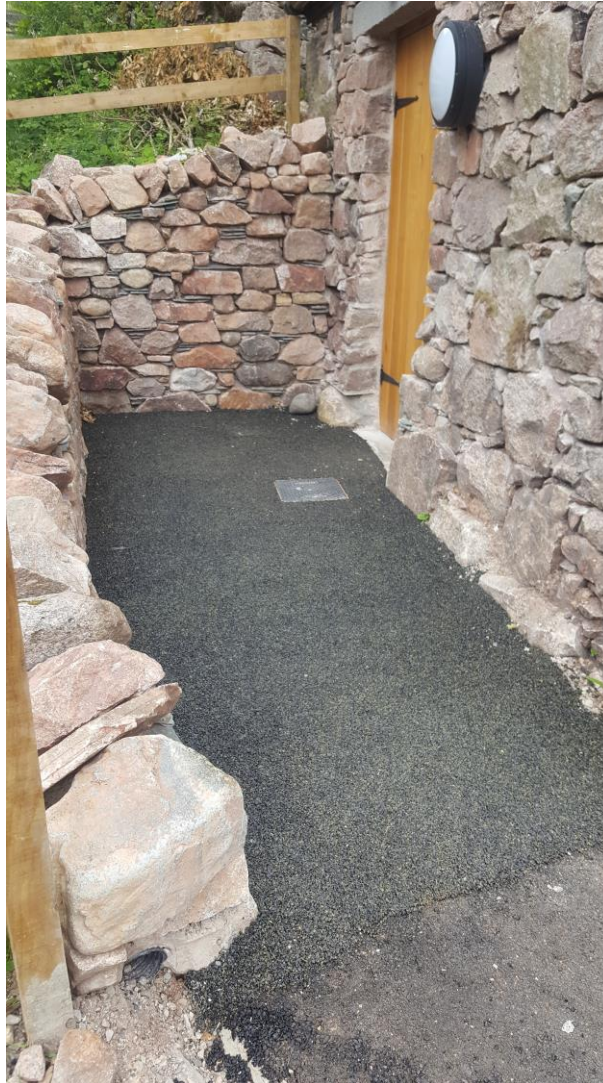
Image of FlexiPave to entrance to wheelchair accessible toilet taken on 4th July 2019

The application for using FlexiPave for the wheelchair access into the wheelchair accessible toilet was submitted on 25th January and approved on 21st March 2019.

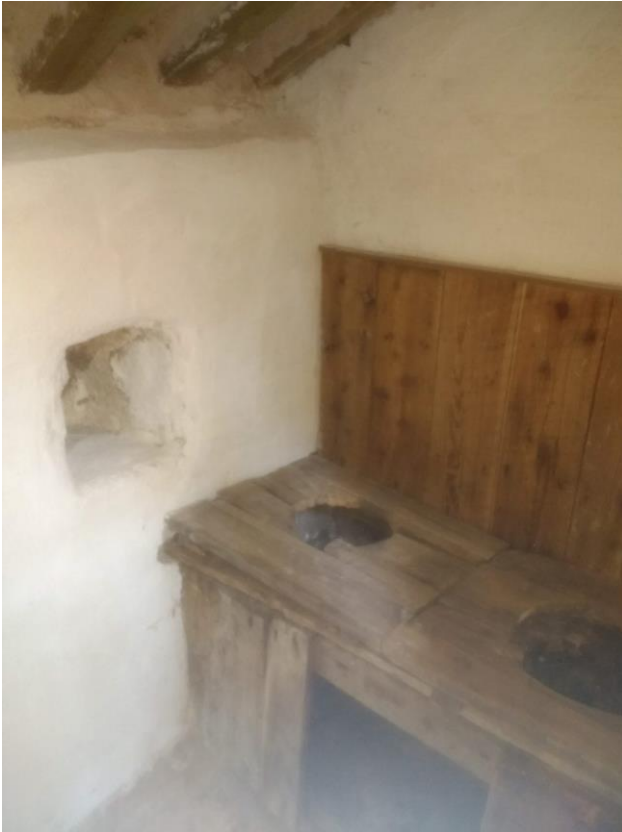
Internal image taken on 21st June 2019

Works to the privy were also completed, including the installation of a new external door, the internal torching to the underside of the slate roof covering and repair works to the privy joinery.

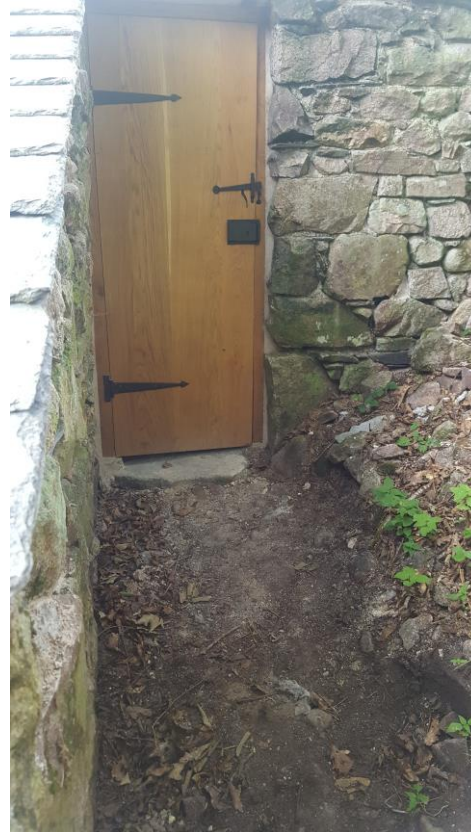
External Image taken on 4th July 2019

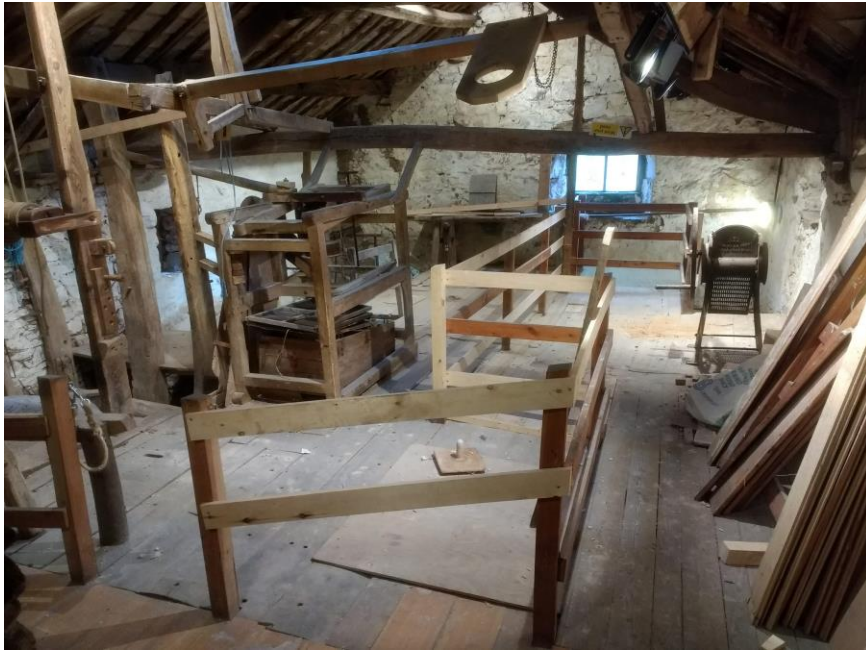
New visitor guarding was installed in the Milling Room and the Hurst floor to maximise the area accessible for the public while retaining a safe working area for the mill manager.

Image of Milling Room guarding on 14th March 2019

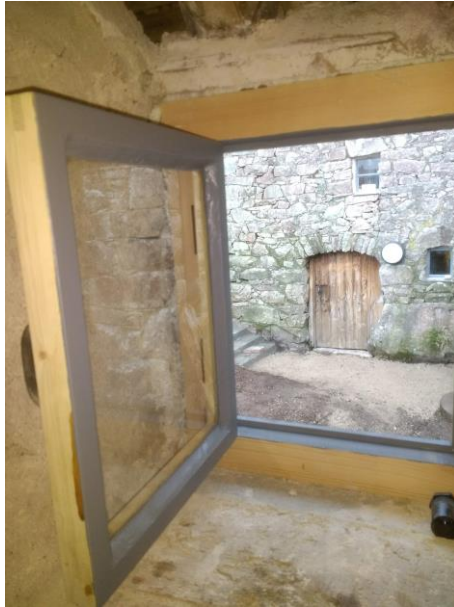
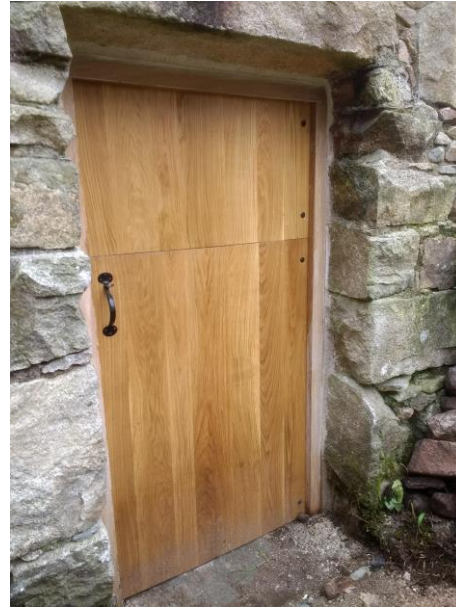
The new external joinery was manufactured and installed as per architect's specifications.

Left hand side image: new northern window to hayloft. Right hand side image: stable door.
Both images taken on 1st March 2019

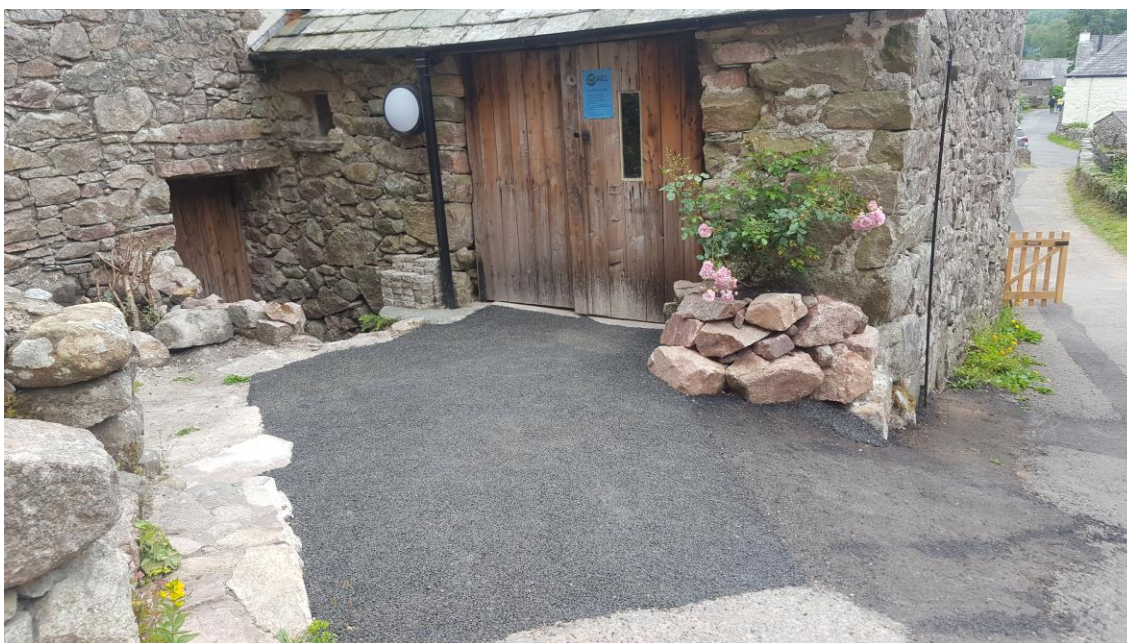
Image of FlexiPave to facilitate access for wheelchair users into exhibition room, taken on 4th July 2019

The application for using FlexiPave for the wheelchair access into the Exhibition Room was submitted on 25th January and approved on 21st March 2019. Works were undertaken in June 2019.

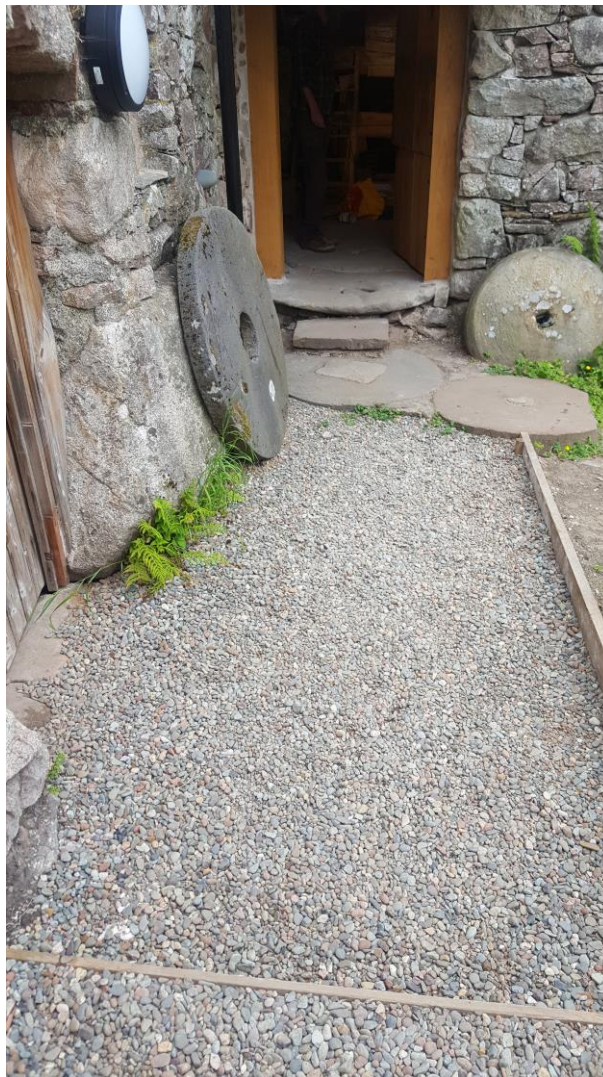
Image of path between byre and hurst floor doorway taken on 4th July 2019

The response from the advisor was favourable and the application for discharge of conditions was submitted on 8th February 2019, proposing to incorporate gravel in the areas next to the external doors. Approval was granted on 21st March and works were undertaken in June 2019. A culvert collecting surface water from the ground area was built to discharge into the existing open culvert running along the west elevation of the stable.
